PLEASLEY PARK AND VALE CONSERVATION AREA

Appraisal and Management Plan

Adoption Draft

January 2009

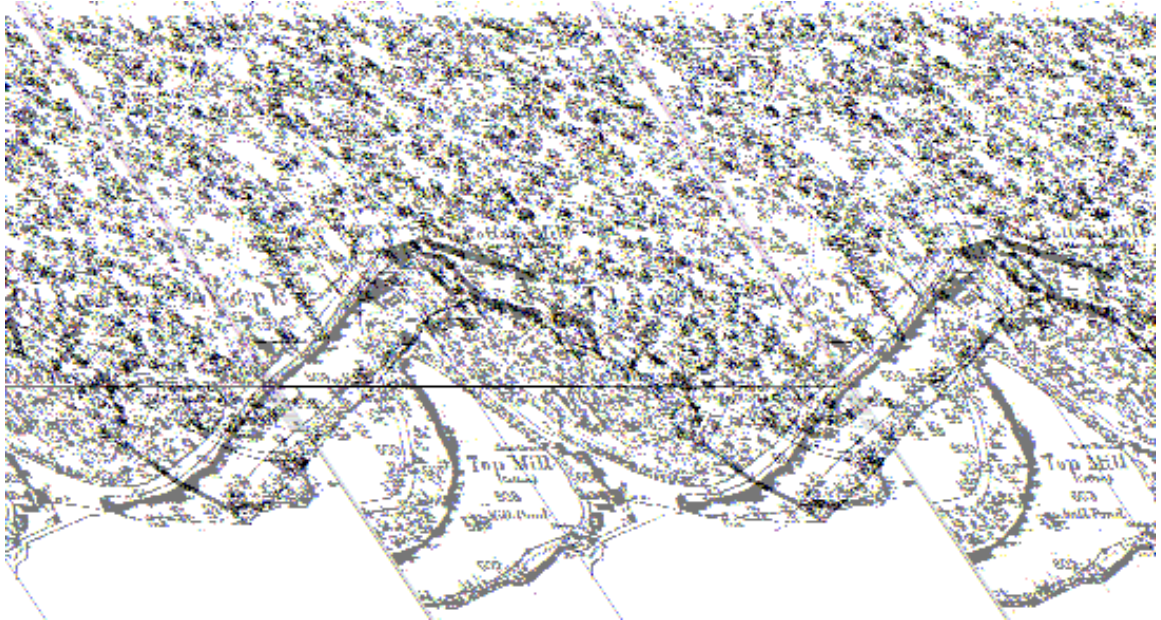
Extract from the 1875-1879 Ordnance Survey

- 3.14 In addition a grease working department, engine house, baths and wool room were constructed in the lower mill between the 1850s and 1880s. Following the sinking of Pleasley Colliery in 1878, the Tibshelf to Pleasley (1883) railway line was constructed and ran along the southern ridge of the Vale to link in with the mill complex.

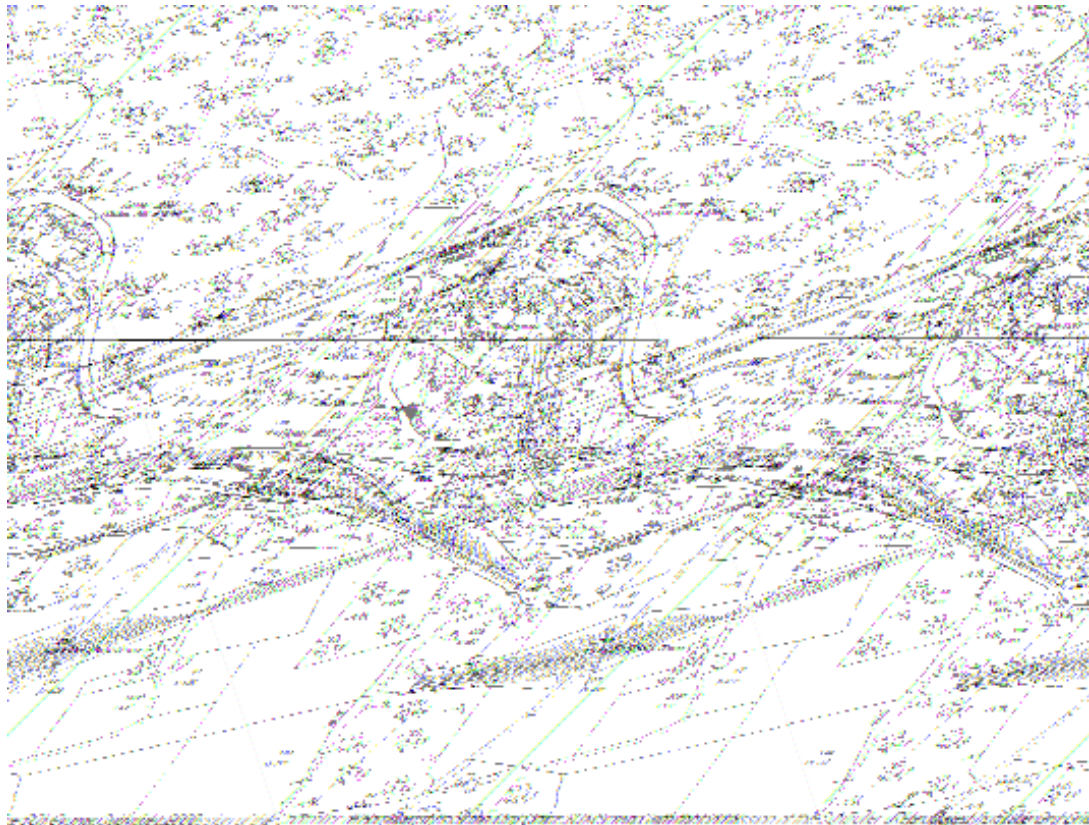
Extract from the 1916 Ordnance Survey

- 3.20 The impact of this success at Pleasley involved the installation of new machinery through the early and mid-20th century and the enlargement of the Upper Mill and a new combing shed just to the south in 1913.
- 3.21 Further extensions to the combing shed (Mill 2) followed in the form of long sheds following the line of the Meden (by 1938) and a two storey extension on top and a three storey extension to the side (by 1952) ⁽⁸⁾.

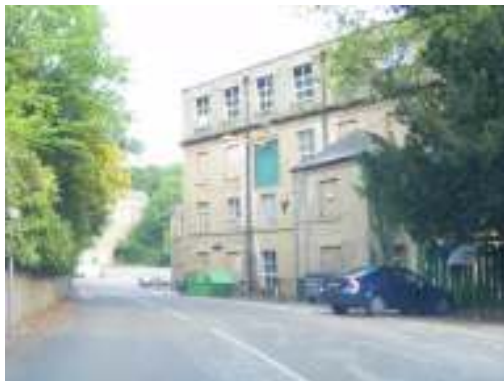
- 6.5 Once past the Lodges the Mill complex quickly emerges and dominates. The first, Mill 1 is the upper mill of 1844 built on the site of the first cotton mill to be built within Pleasley in 1785. The mill has been extensively enlarged. The original section faces the upper mill pond and road and is thirteen bays wide and three storeys high. It can still be deciphered by following the course of its original roof line which is delineated by a projecting band of stone supported by pairs of thin corbels.

- 6.6 Other characteristic features of the original mill are a comparatively smaller size and rougher finish of the stone and the use of flat wedge lintels above the windows. Documentary sources say that there was once a belfry on the building but this has either been lost by the later extensions or a mistake in the description, as there is a possible a belfry still visible on Mill 3.

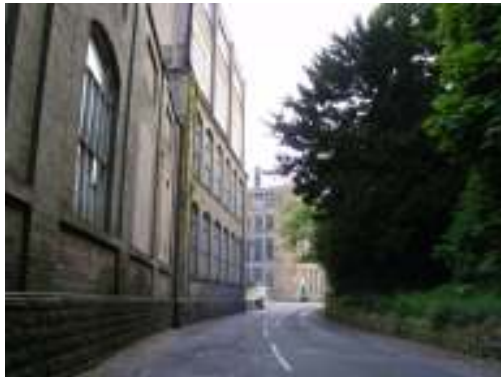
Mill Chimney (part)

- 6.11 Just south west of the Mill and down from the mill pond is the mill-chimney. This is the only remaining chimney from the site. One other belonging to Mill 3 has been demolished. Typically for a mill chimney it is made of brick tapering up to a pronounced and moulded top and is by far the tallest structure in the area. Its height means that it is a landmark structure and the only building within the mill complex that can be seen away from the site.

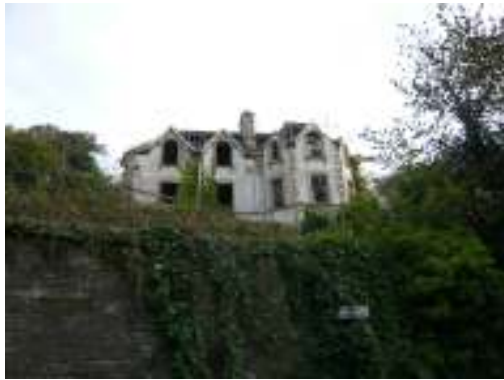
The former Vale House

- 6.15 The house was substantially demolished in 2008 due to it becoming dangerous, resulting in the loss of the most significant non-industrial building within the conservation area. As the home of various managers, most notably William Hollins, it represented the close working relationship between mill owners and their employees that existed at Pleasley from the 18th to 19th centuries, with its closeness to Mill 1 and its elevated position and elaborate gardens showing its top status within the hierarchy of the mill.

- 6.16 The site is now expected to be redeveloped. Any development on the site will need to respect the significance of the former Vale House and be appropriate to this important and prominent site within the conservation area.

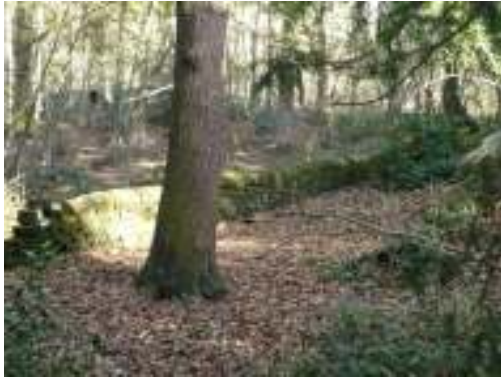
- 6.19 The romantic garden to the rear of the former Vale House site is bounded on the northern edge by Pleasley Park and a low stone wall divides the two. This wall had been repaired as part of a Countryside Stewardship Scheme but has since been broken in places. Despite this, there is an obvious entrance between the park and garden and located here are the remains of a small

circular building built in large, random coursed stones. This is presumably the remains of a building for hunting dating from the mid 19th century when the Park was used for game shooting.

Wall between the former Vale House gardens and Pleasley Park

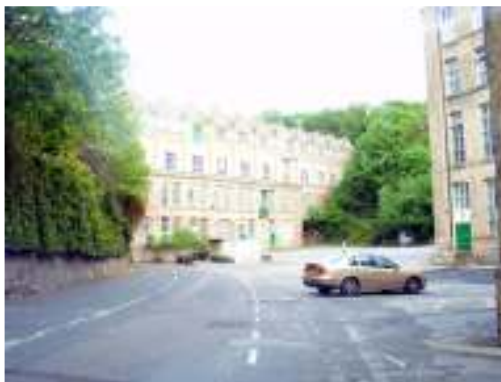
6.20 Directly east of Mill 1 across a tarmac yard is Mill 2. Historically the term Mill 2 is slightly confusing in that it was constructed as a combing shed and consequently ancillary in use to the two original mills. It was only when it was extended around 1952 that it became a mill. The original combing shed was constructed in 1913 and formed part of a considerable investment in the mills that resulted from the success of Viyella.

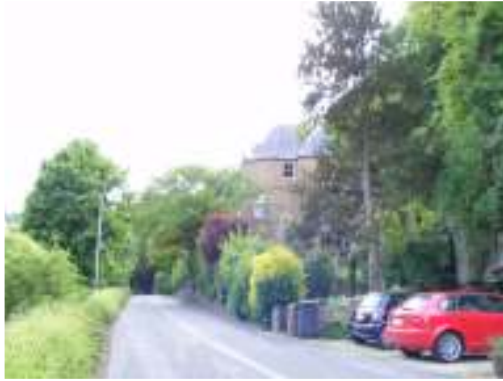
Rock House

- 6.26 Opposite these buildings is Rock House; a detached mid 19th century house built within a gothic style (The property has been subdivided in the past). Its most notable architectural feature is its angular corner bay with its roof of slate laid in a diamond pattern surmounted by an iron lantern.

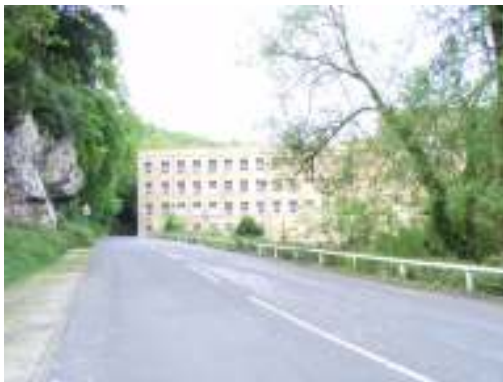
- 6.28 Mill 3 was constructed in 1847 and is by far the larger of the 1840s mills and the best in terms of historical survival. The west elevation facing the mill pond is 31 bays in width. Over the river the mill is of four storeys and then projects forward on the southern bank and moves up to five storeys and continues into the bank. Like Mill 1 there is little architectural detail except for slightly raised areas of stone work to the ends and the centre of the projection on the southern bank. The parapet of the building is simply articulated by two to four stone bands. The windows, modern replications, are of 9 panes with the lower three opening inwards. All windows are surmounted by wedge lintels similar to Mill 1.

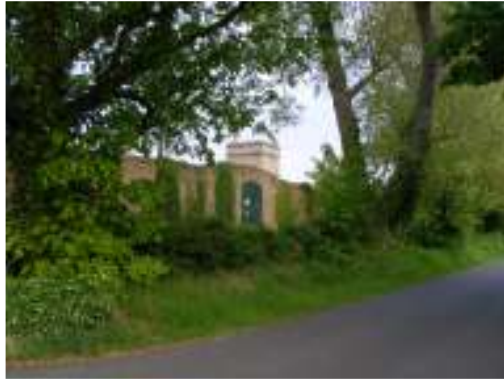
- 7.10 At the top of the road where it meets the course of the former railway line are the remains of the large warehouse site that serviced the mills. At this warehouse, the company would store the famous Viyella cloth prior to being loaded onto trains in a small siding area just to the west of the water tower. The warehouse is now roofless but appears to be stable and in use as a plant nursery, in fact the buildings would look like a walled garden at first glance if it wasn't for the stone water tower.

Former Warehouse and Water Tower

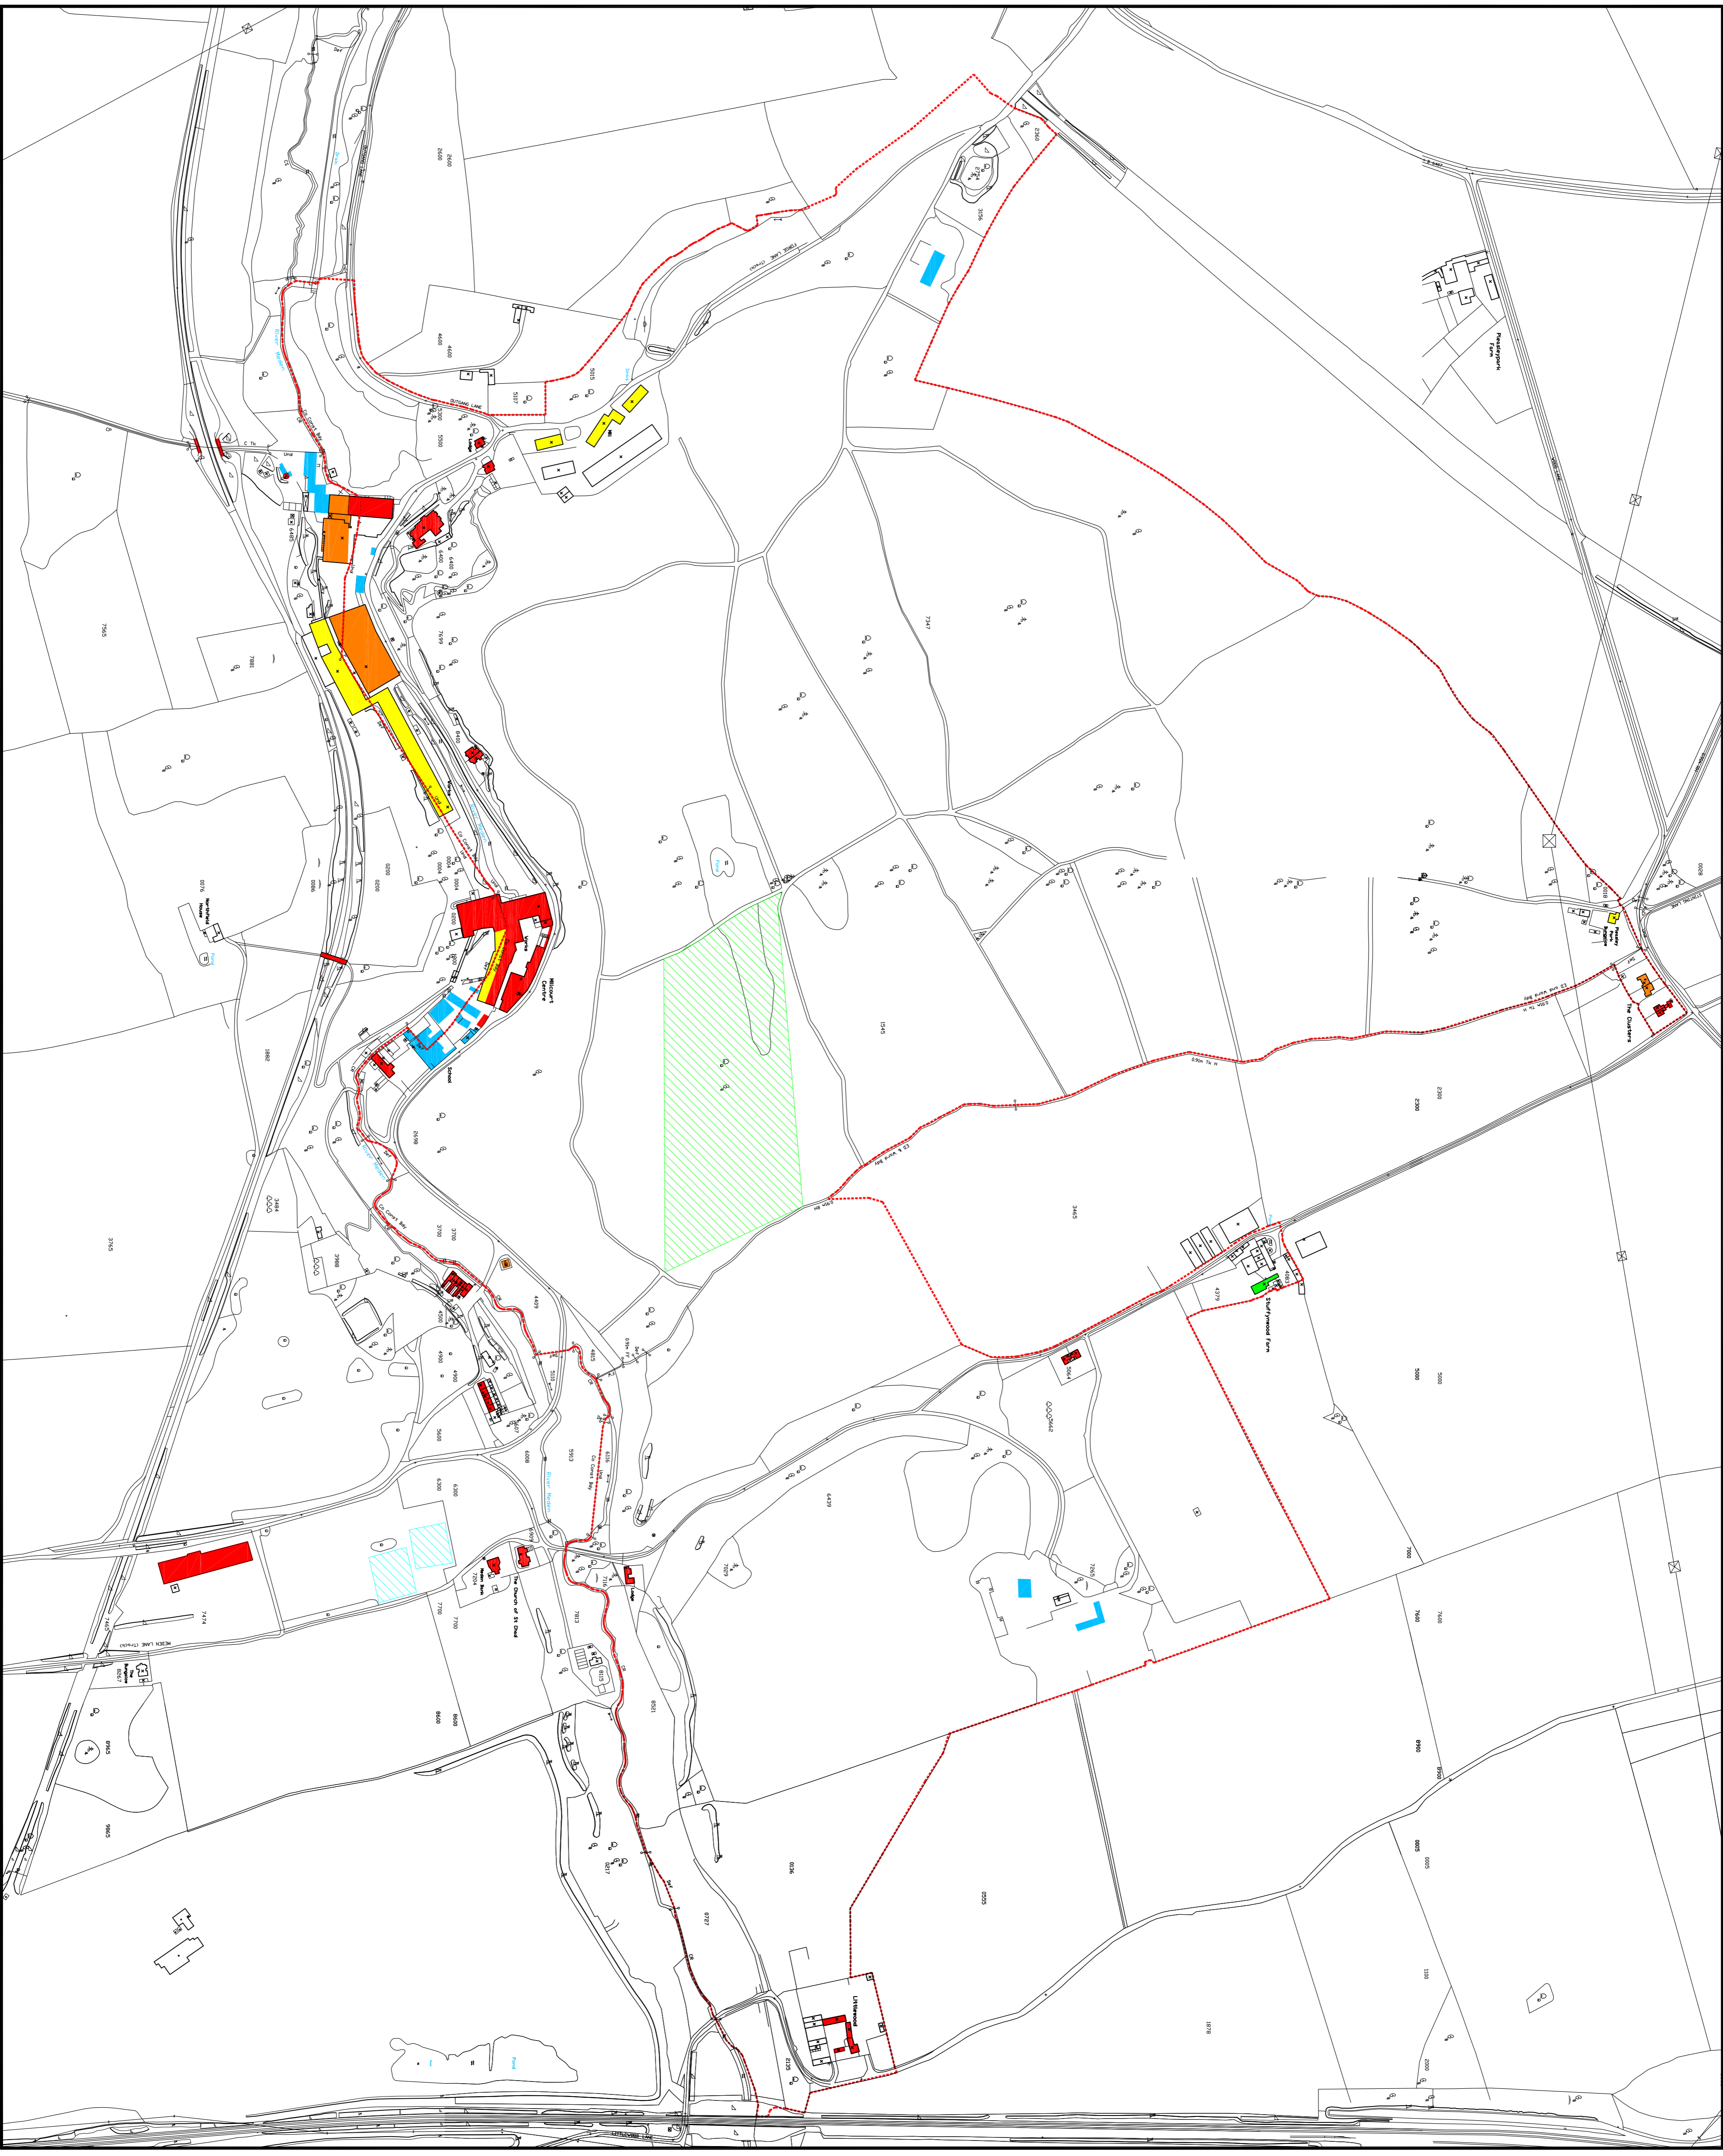
- PHASING PLAN**
- PRE 1800
 - MEDIEVAL ENCLOSURE
 - c1800 - 1900
 - c1900 - 1930
 - c1930 - PRESENT
 - DEMOLISHED BUILDINGS
 - CONSERVATION AREA OUTLINE

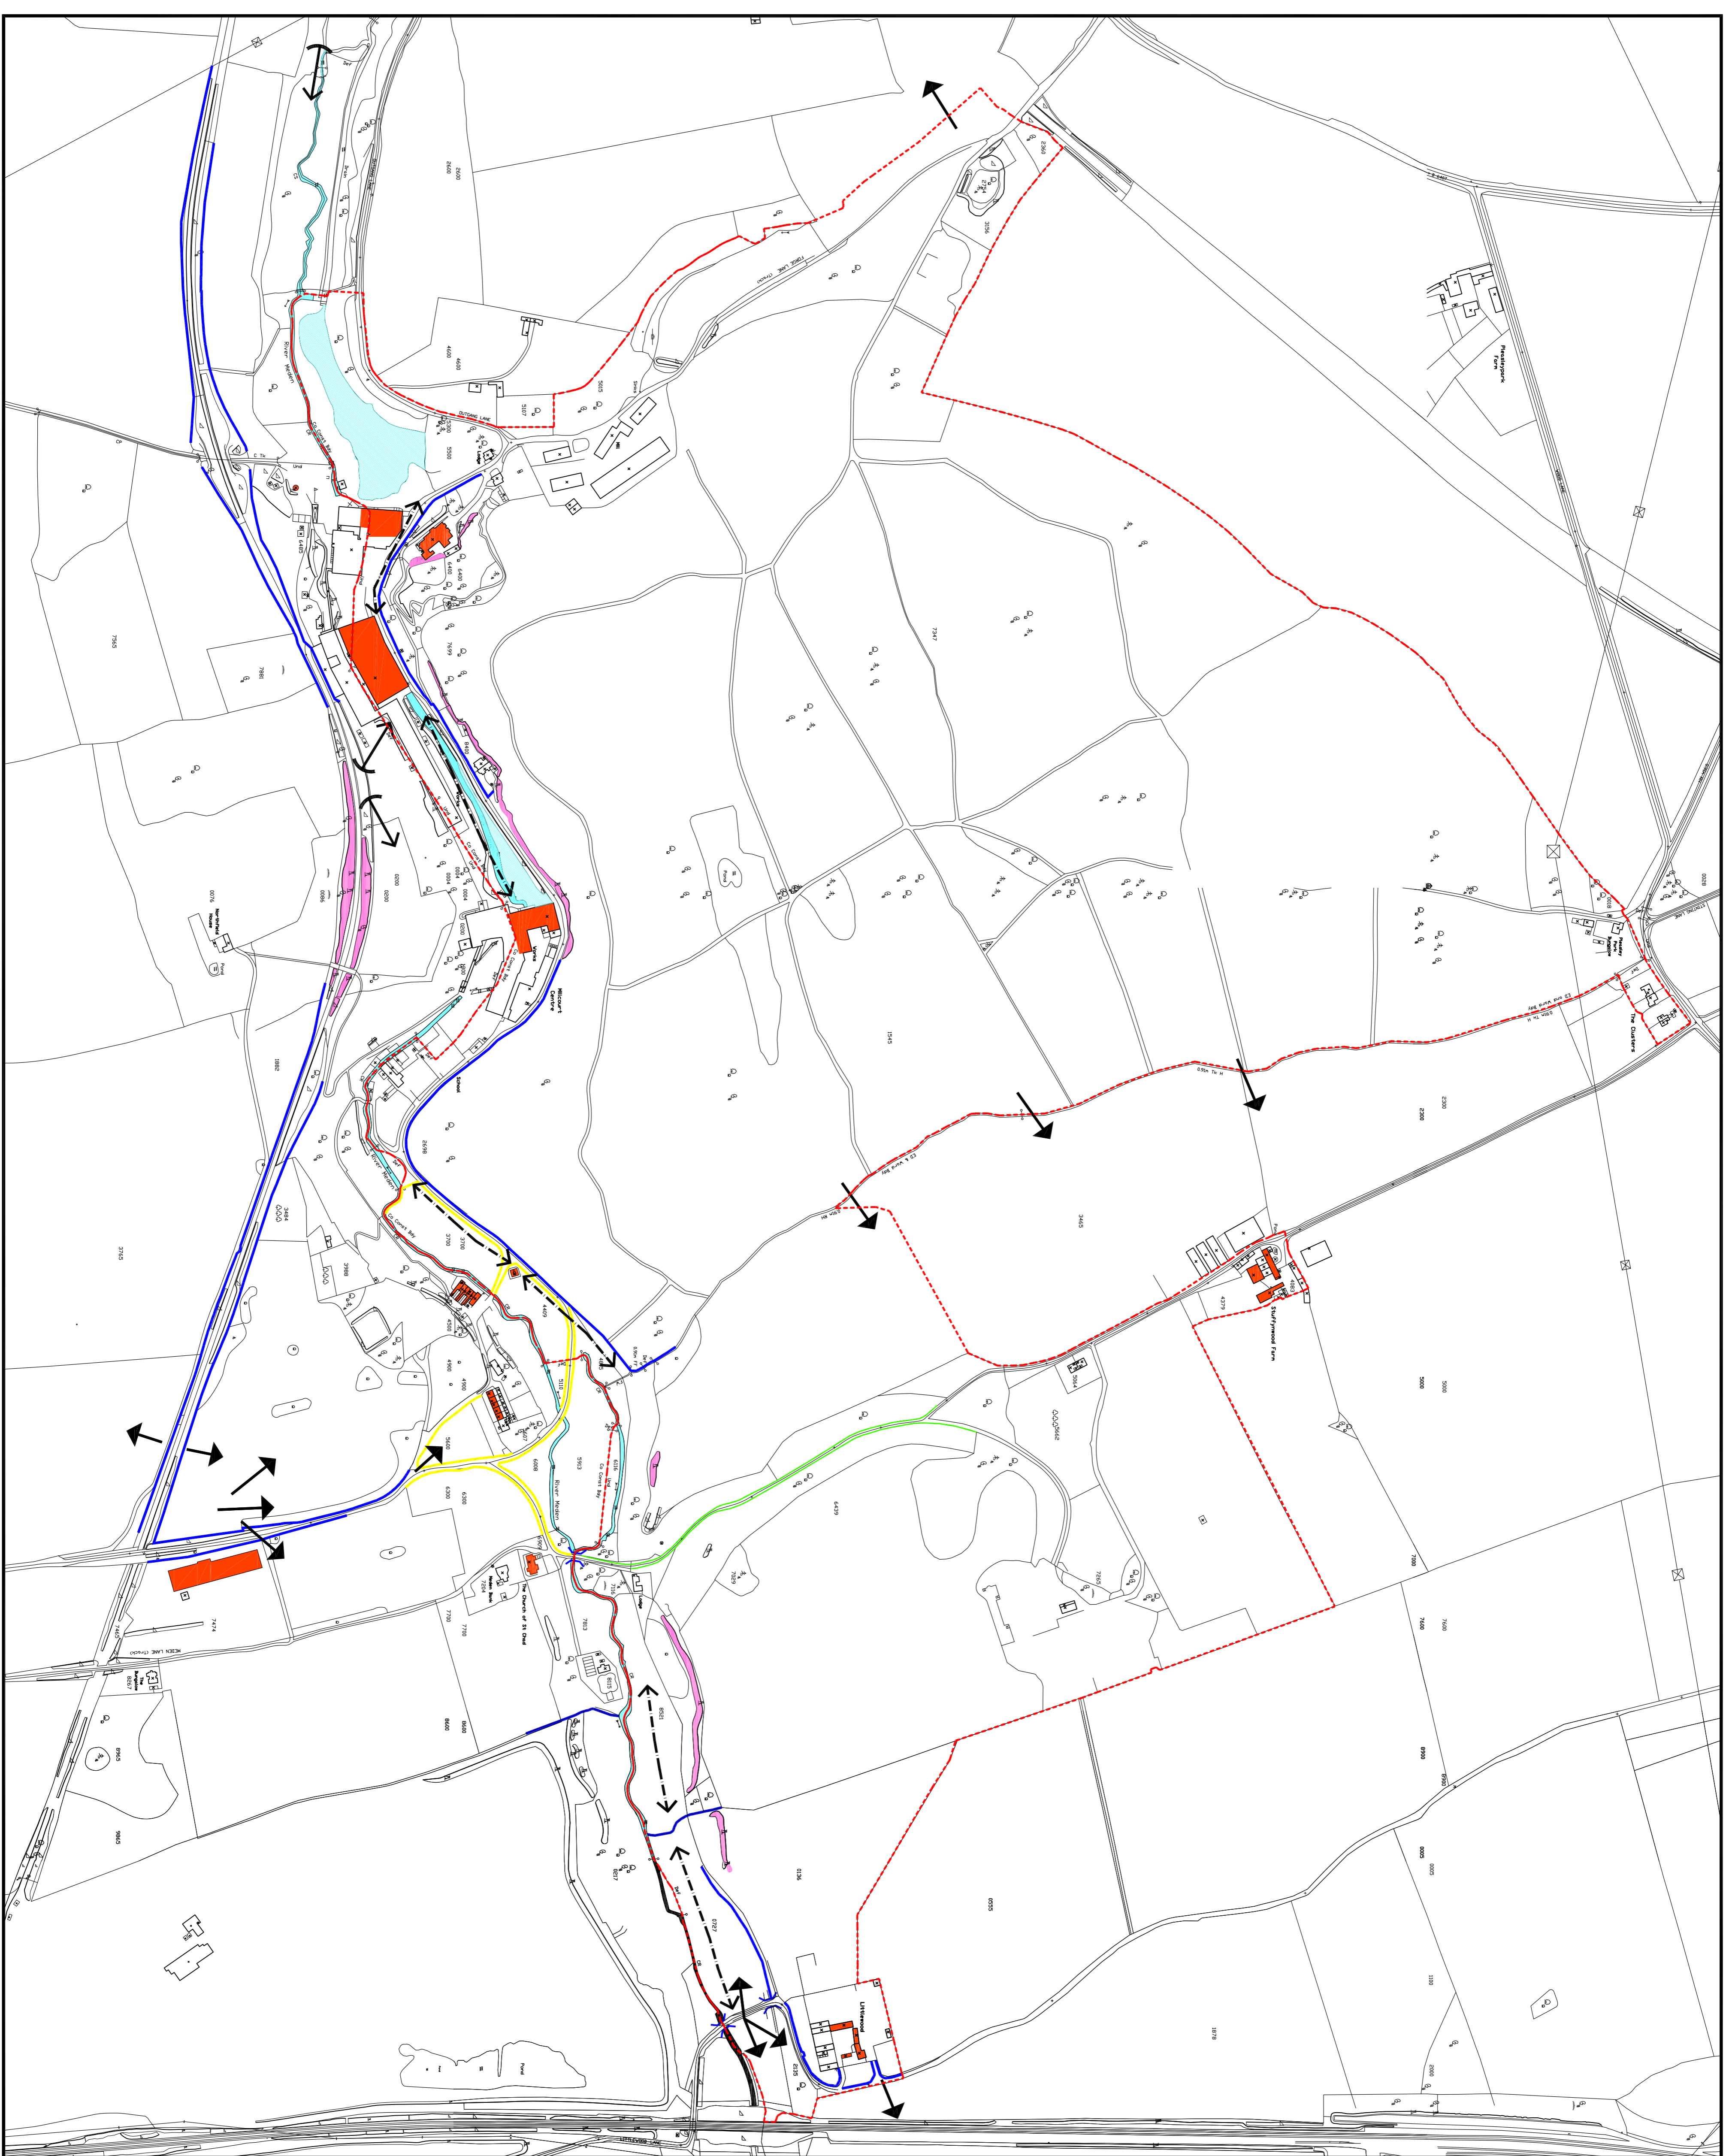
- TOWNSCAPE**
- THE MEDEN
 - STONE WALLS
 - STONE BRIDGES
 - ESTATE RAILINGS
 - TREE LINED AVENUE
 - LIMESTONE OUTCROP
 - LANDMARK BUILDINGS
 - CONSERVATION AREA OUTLINE
- VIEWS**
- STRONG DIRECT VIEW
 - GLIMPSED VIEW
 - VISTA
