HARDSTOFT CONSERVATION AREA

Appraisal and Management Plan

Adoption Draft

February 2010

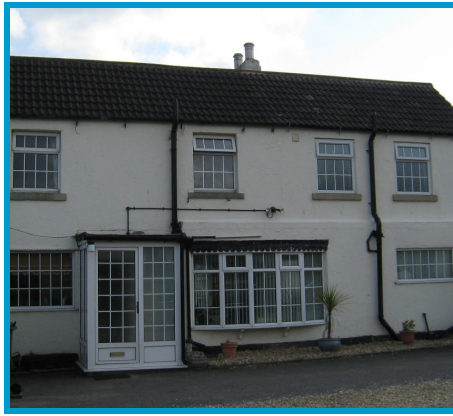
The erosion of the stonework has led to the use of render on some traditional stone buildings and the re-fronting of walls in brick. These are inappropriate methods of repair for walls affected by erosion and should not be used elsewhere in the conservation area as this would detract from the character and appearance of individual buildings and the conservation area as a whole.

Inappropriate rendering of stonework at Stud Farm

Traditional buildings and stone walls will require re-pointing at some time. If a cement-based mortar mix is used, if excessive mortar is smeared over the surface of the stone, or if strap pointing occurs, this can be detrimental to the structural integrity and appearance of the stone or brickwork and detracts from the character and appearance of the conservation area. Pointing should be carried out using a lime-based mortar with a flush finish.

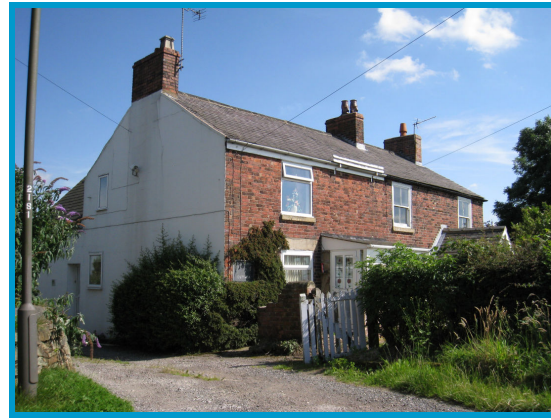
Re-fronting in brick and rendering at Pentuan Cottage and Poplar Farm Cottage

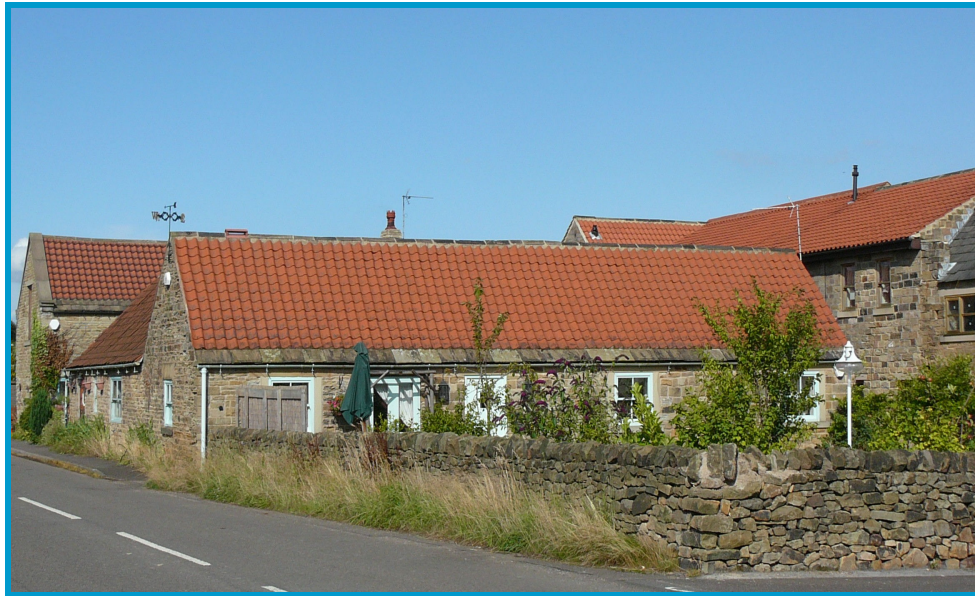
- 6.8 There are cases where traditional roofing materials have been replaced with concrete tiles or other modern alternatives which detract from the character and appearance of the building and the conservation area as a whole.

Clay pantile roofs of converted farm buildings on Deep Lane, some have eaves course of stone slate and stone coped gables

The replacement of concrete tiles and other modern alternatives with traditional roofing materials will enhance the character and appearance of the building and the area.

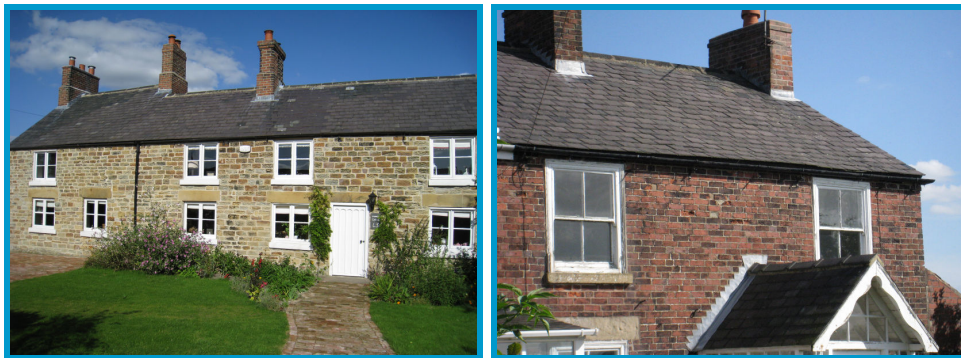
- 6.10 Traditionally, timber side-opening casements with single horizontal glazing bars were the predominant window style throughout the conservation area. Casement windows with stone mullions survive in some of the older buildings at Yew Tree Farm, The Farm and Elder Pay Farmhouse. There are cases where vertically sliding-sash windows are evident, though these are limited to The Famous Shoulder, the attached converted outbuildings, and also at Poplar Farm Cottage where the original sash windows survive. Where original windows and doors remain, or replacements accurately replicate the design of the original windows, they make a significant contribution to the character and appearance of the area.

- 6.11 However, a variety of window and door styles have been introduced; uPVC and other alternative modern materials do not replicate the original details and profiles and detract from the character and appearance of the building. Collectively, these alterations also detract from the character and appearance of the conservation area as a whole.

Traditional side-opening casements Vertical sliding sash windows

The repair and re-instatement of traditional designs and materials for windows and doors would enhance the character of the buildings and the conservation area as a whole.

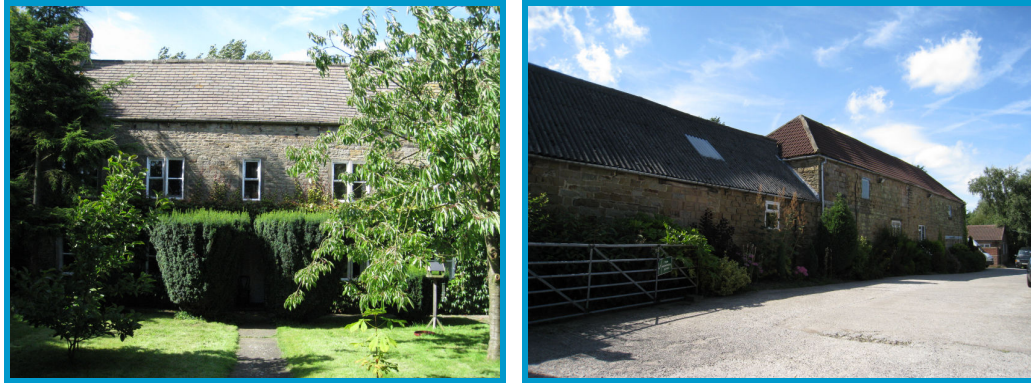
Yew Tree Farm house and range of barns

- 7.7 Yew Tree Farm is one of the oldest and finest farmhouses in Hardstoft and is Grade II listed. It is a two-storey building constructed of coursed squared sandstone. The farmhouse is set back from Deep Lane and hidden behind a row of conifer trees planted in the last quarter of the 20th century for privacy. Despite its seclusion, the farm house makes an important contribution to the character of the area as a former farmstead and as a building in the local vernacular style of architecture of high quality.

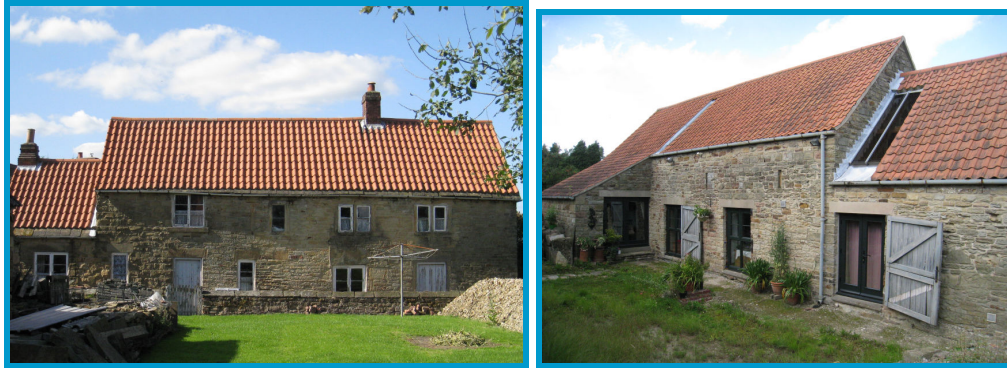
Elder Pay Barn Farmhouse and converted barn

- 7.9 The farmhouse to the north of Elder Pay Barn is an interesting stone building with clay pantile roof which dates from the late 1700s. It appears to retain the original mullioned windows, though these and the timber doors are in a poor condition. The farm ceased to operate in the second half of the 20th century and the farmhouse has been vacant since the 1980s. There are two stone outbuildings opposite the farmhouse which date from the 19th century, one has been converted to residential use and is called Elder Pay Barn, whilst the second outbuilding is in a very poor condition and has seen alterations in red brick.

The lack of use of the farmhouse and the outbuilding will lead to the continuing deterioration of the buildings which will be to the detriment of the character and appearance of the area.

Securing a viable use for the farmhouse and the outbuilding and carrying out the necessary repairs will preserve the character and appearance of the area.

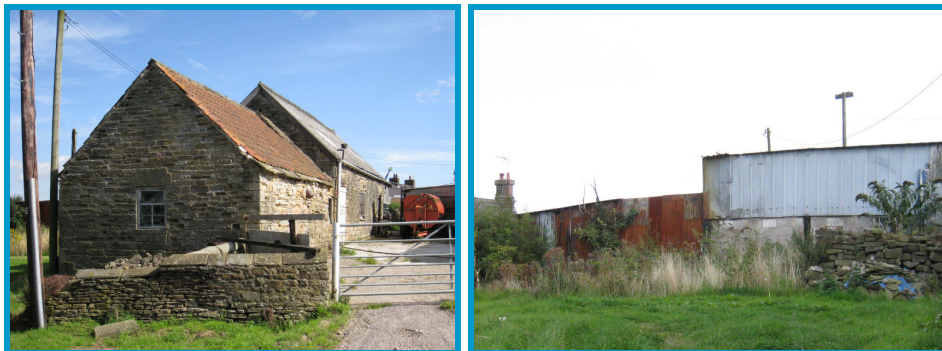
Farm buildings on The Green

- 7.10 There has been a farm on The Green since the late 18th century and today this remains the only working farm in Hardstoft. Only two outbuildings survive, both of which are built of stone and are visible from Deep Lane. The building nearest to Deep Lane has the year 1772 carved into the stone lintel.
- 7.11 Today, the farm has grown into a collection of buildings built mainly of modern materials. Corrugated metal sheeting is used for buildings and as a means of enclosure, some of which is in a poor state of repair and detracts from the appearance of the area.

The removal of any redundant modern buildings, the repair of agricultural outbuildings on The Green, and the use of traditional or natural boundary treatment would improve the overall character and appearance of this area of Hardstoft.

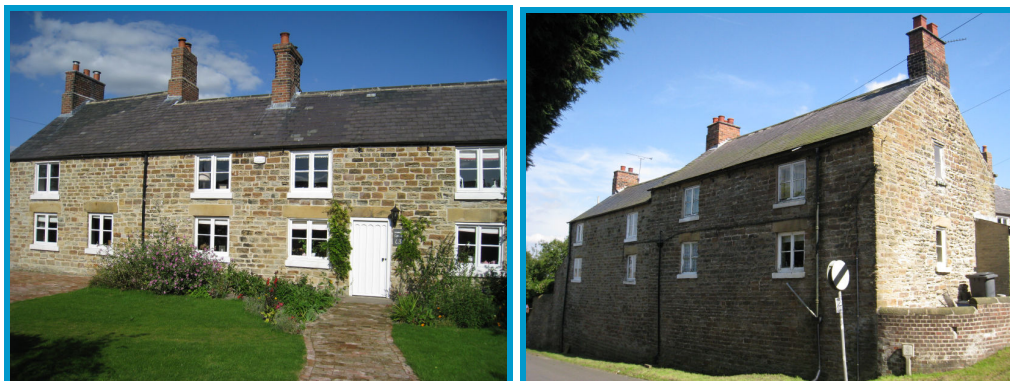
43 The Green, Broom Close Cottage and The Cottage

- 7.12 The Green Area is also characterised by the rows of early 19th century stone cottages at 43-45 The Green and the former row of four cottages overlooking Deep Lane which are now known as Broom Close Cottage and The Cottage. The cottages have slate roofs unlike many of the farm buildings in The Green Area. Many of the windows are also of the original design; side-opening casements with single horizontal glazing bars.
- 7.13 Until the late 20th century there was also a row of stone cottages dating from the early 19th century which ran to the south of Elder Pay Barn. This row was demolished in the mid 20th century and was replaced initially by modern outbuildings and then a new residential property, The Weavers.

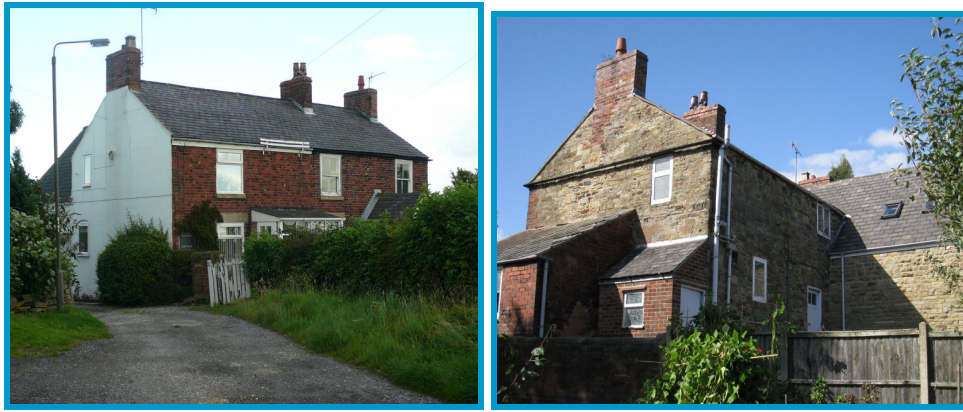
Pentuan Cottage (left) and Poplar Farm Cottage (right)

- 7.14 To the south of The Green lie two adjoining cottages which appear to be 19th century brick cottages. However, closer inspection reveals that these are earlier stone cottages which were re-fronted in brick, possibly using brick from the works on Hardstoft Common. Poplar Farm Cottage has been the least altered and retains its original sash windows, though it now stands vacant.

The condition of vacant properties can deteriorate without regular maintenance and can become targets for vandalism. This can affect the appearance of the building and of the character of the area.

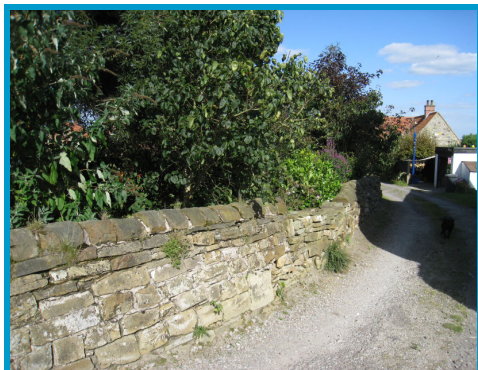
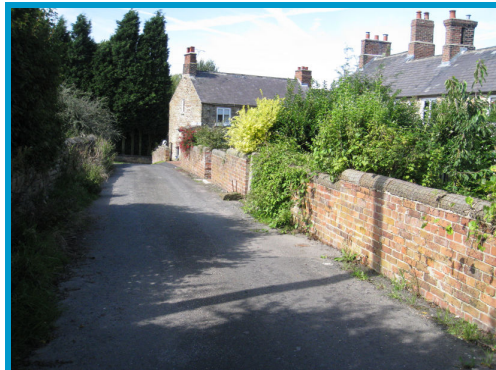
Stone and red brick boundary treatment on The Green

Sections of boundary walls in The Green Area are in a poor condition and require maintenance and repair. The loss of traditional boundary treatment would be detrimental to the character and appearance of the area.

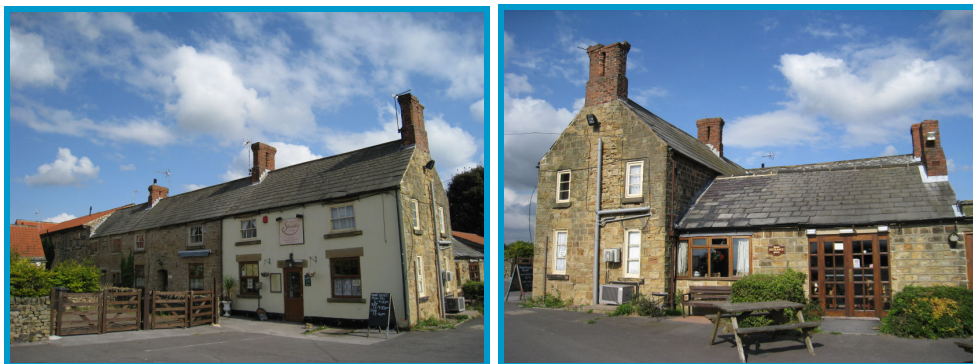
The Famous Shoulder Public House (previously The Shoulder of Mutton)

The Famous Shoulder

- 7.26 The Famous Shoulder is a landmark building in the conservation area. It occupies a prominent corner site at the point where the principle roads in Hardstoft meet. The main part of the building is constructed of stone with a

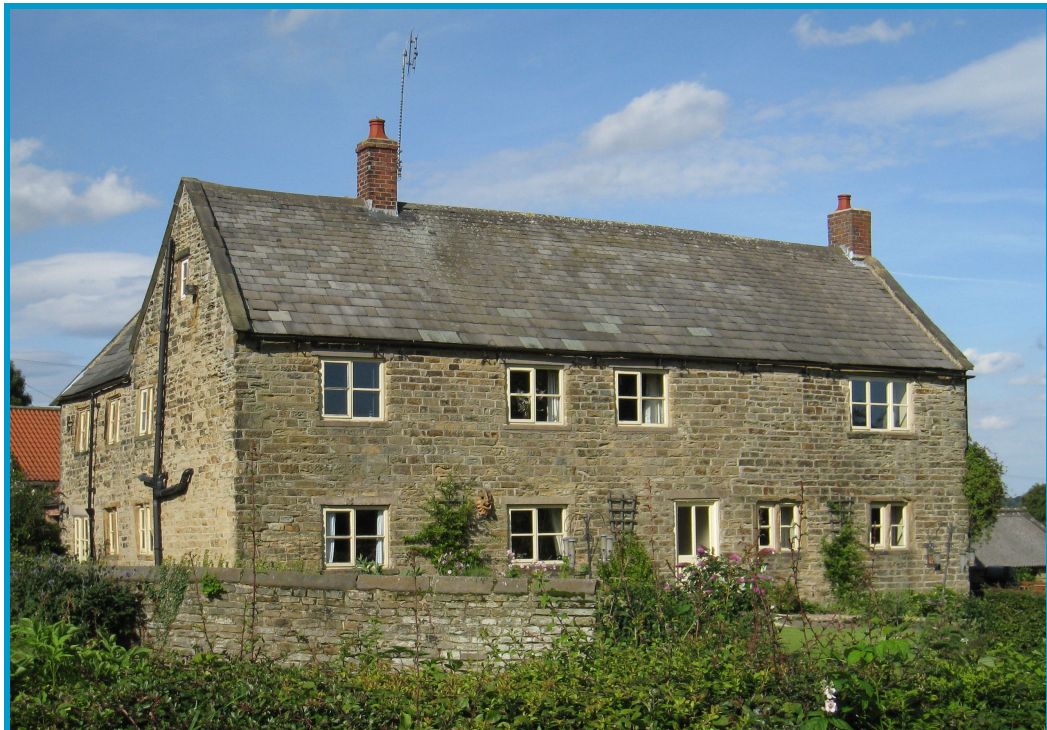
The Farm, Farm Lane

- 7.29 The Farm was built in 1709 and is one of the oldest buildings in Hardstoft. The farmhouse is a large stone building with slate roof and casement windows. The windows on the west elevation are stone mullioned windows

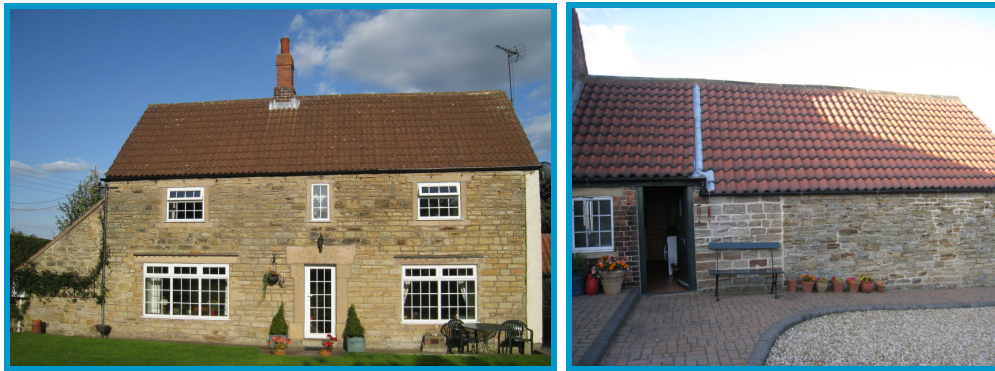
Farmhouse and barn to rear

- 7.31 Farm Cottage is built to a T-plan with the farmhouse facing away from Farm Lane and the barn attached to the rear. This arrangement is not seen elsewhere in Hardstoft. The farmhouse is built of stone and the barn of stone and brick, both with a pantile roof. It has a date stone tucked away to the rear of the farmhouse which is inscribed '1675'. The double-fronted farmhouse has seen alterations to the front elevation, particularly to the size of the window openings and window and door styles.

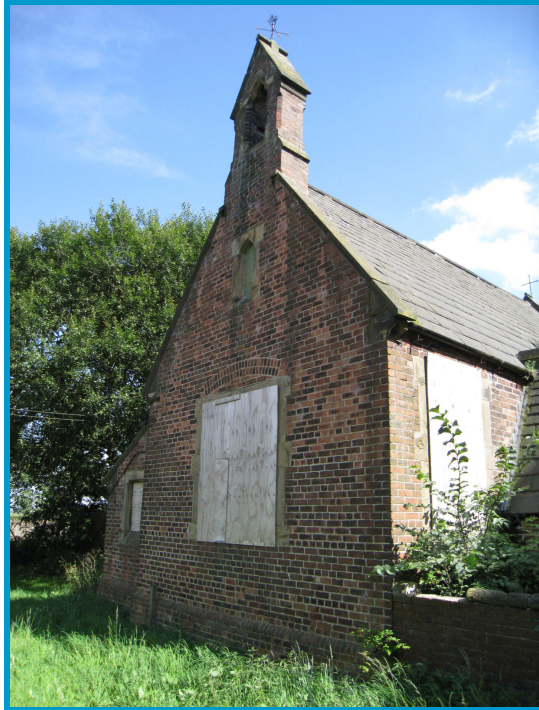
- 7.47 This building was once used as a school and a Sunday school. It is a red brick building with sandstone dressings and a Welsh slate roof which dates from 1858. The roof is of two different heights like the nave and chancel of a small chapel. It is Grade II listed.
- 7.48 The school initially served 80 children, however, following the opening of schools at Stainsby and Doe Lea in the second half of the 19th century and schools in Tibshelf, the numbers of pupils dwindled in the 20th century and the building fell out of use. The future of the building became uncertain during the second half of the century and the building has stood unused for many years. It has also been vandalised.

The continued disuse of the building will lead to further deterioration of the building. In its present state the building has a negative impact on the conservation area, particularly due to its prominent position on Chesterfield Road.

Former Sunday School

An appropriate new use for this building will ensure that the necessary repairs are carried out and that the building makes a positive contribution to the conservation area once again.

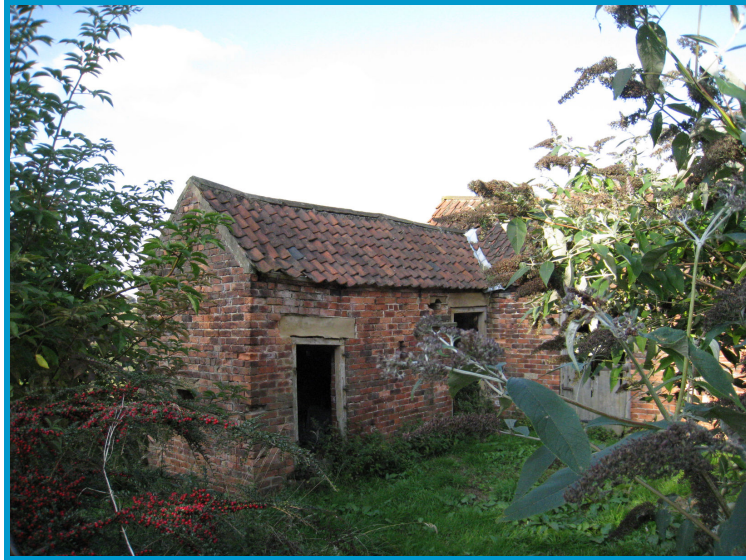
The condition of the two red brick buildings to the rear of School House Cottage is deteriorating due to lack of use and maintenance.

This building is partially visible from Chesterfield Road and in its current condition detracts from the character and appearance of the area. The repair and re-use of the building would preserve the character and appearance of the area.

Former cow shed to the rear of Wayside

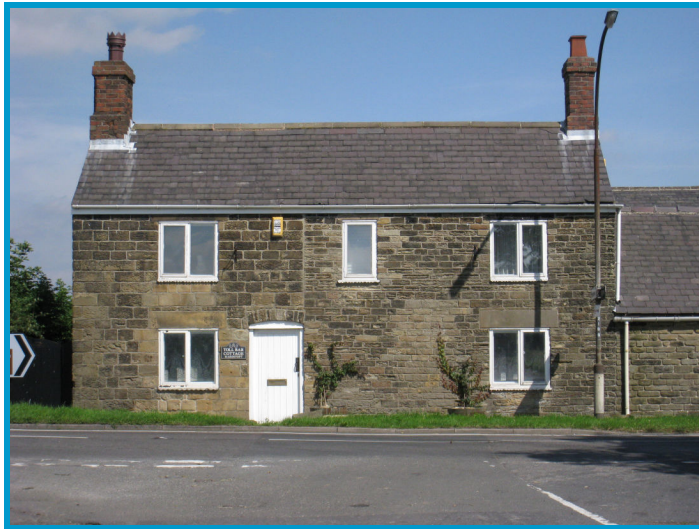
- 7.50 Toll Bar Cottage was built in the 1820s at the same time as the turnpike road and at this time it was the only building in this area. This is because the positioning of the toll collector's house would have been dictated by the location of the toll gate, and the gate would have been erected at the junction between Chesterfield Road and Locko Lane because the road users would have been least likely to evade payment at this point.
- 7.51 The turnpike trust built this cottage in the local vernacular style with sandstone and a slate roof. It fronts directly onto the road with only a narrow grass verge separating it from the road. The cottage has been extended over time and a garage added to the side.

Toll Bar Cottage

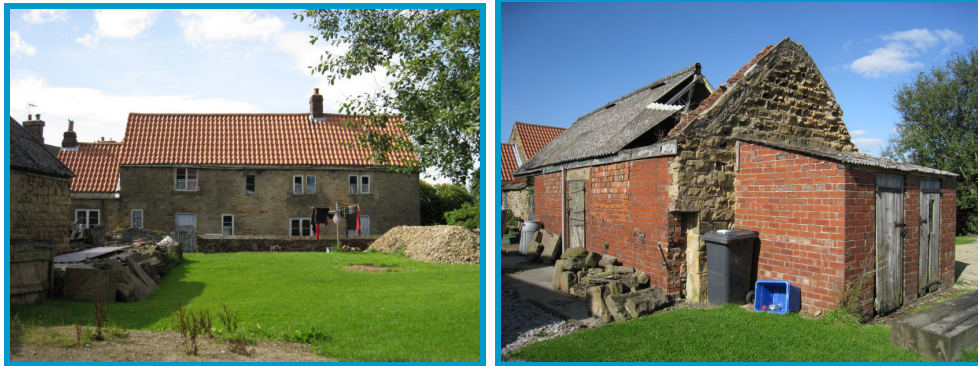
Elder Pay Farmhouse and outbuilding

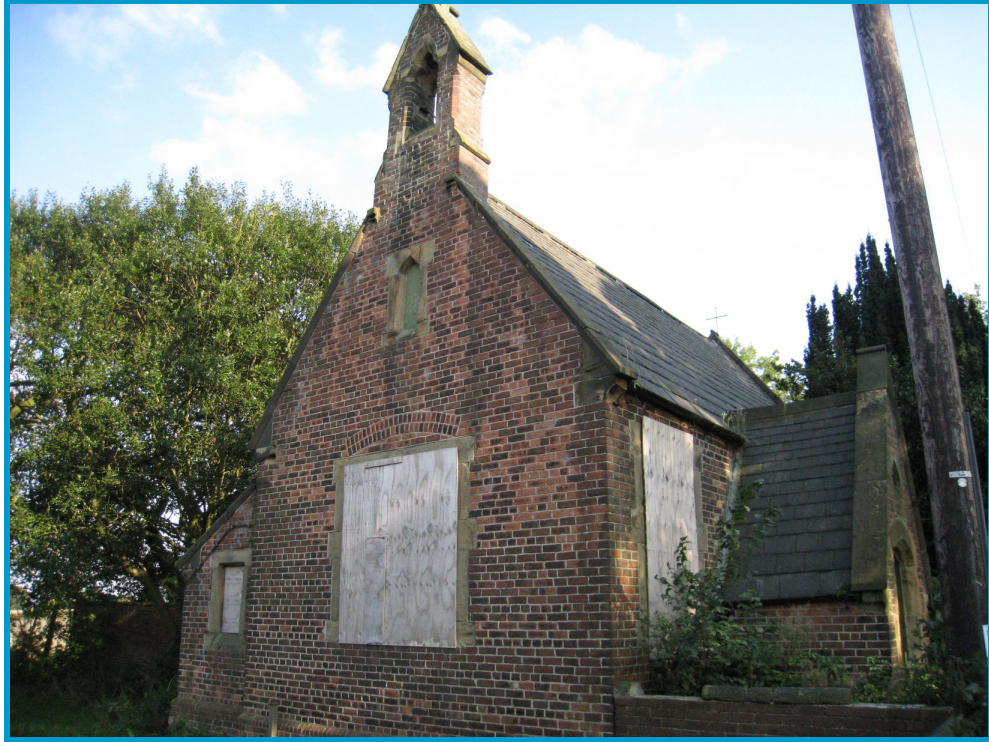
Former Sunday School

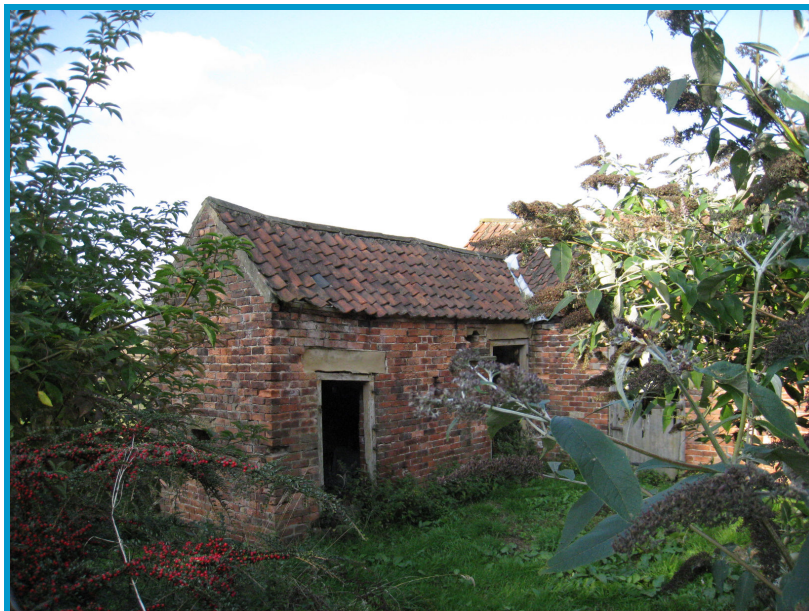
- 10.29 This building has been redundant for a number of years and is in a poor condition as a result. It was once associated with Wayside and used as a cowshed, however the buildings are now in separate ownership.
- 10.30 A long-term use for this building is needed which would secure the preservation of this building without adversely affecting the character and appearance of the area. Therefore it is considered to be appropriate to add the building to the Buildings at Risk Register and to monitor the situation.

Former cowshed to the rear of Wayside

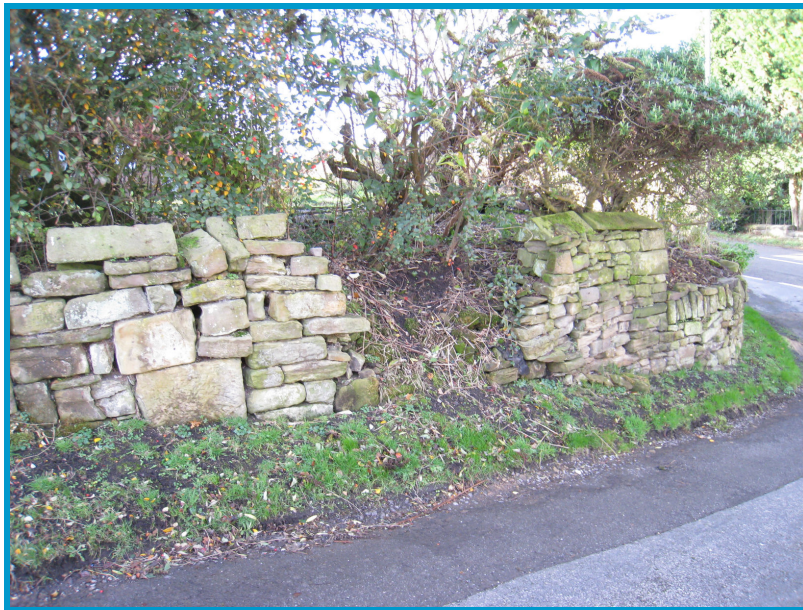
Boundary wall in poor condition at The Green

- 10.31 Both the traditional stone and the brick-built boundary walls have been identified in the Appraisal as an important feature contributing to the character and appearance of the conservation area. However, there are a few places in the conservation area, particularly around The Green and near The Famous Shoulder where their condition is deteriorating and maintenance and repairs are needed.

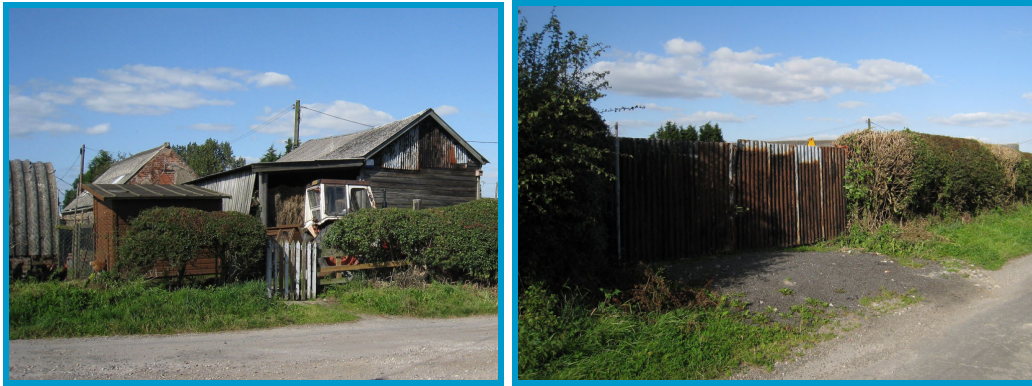
- 11.4 The Appraisal has identified the two historic buildings on The Green as unlisted buildings of merit. Whilst the Council would support the repair and preservation of those traditional farm buildings that are considered to be of historic or architectural interest (Actions 4 & 6) there are several more modern farm buildings in a poor state of repair that are considered to detract from the character and appearance of the area. Non-traditional boundary treatment is also used which is in a poor condition and if replaced with traditional or natural boundary treatment, would enhance the appearance of the area. The site is surrounded by lanes and therefore the buildings and structures are particularly noticeable from the public realm.

Buildings and boundary treatment at the Farm on The Green

- 11.5 It is noted that this site remains the only working farm in the conservation area and that these modern buildings may be used for this purpose. However, where these buildings are no longer required or have been superseded by newer buildings, it is considered that the removal of the modern building would enhance the character and appearance of the area. Where modern buildings are still required, their repair would enhance the appearance of The Green.
- 11.6 Furthermore, should the two historic farm buildings fall out of use, alternative uses should be explored which would secure the long-term use, repair and maintenance of the buildings and preserve or enhance the character and appearance of the conservation area.
