# ASTWITH CONSERVATION AREA

## Appraisal and Management Plan

Adoption Draft

August 2010

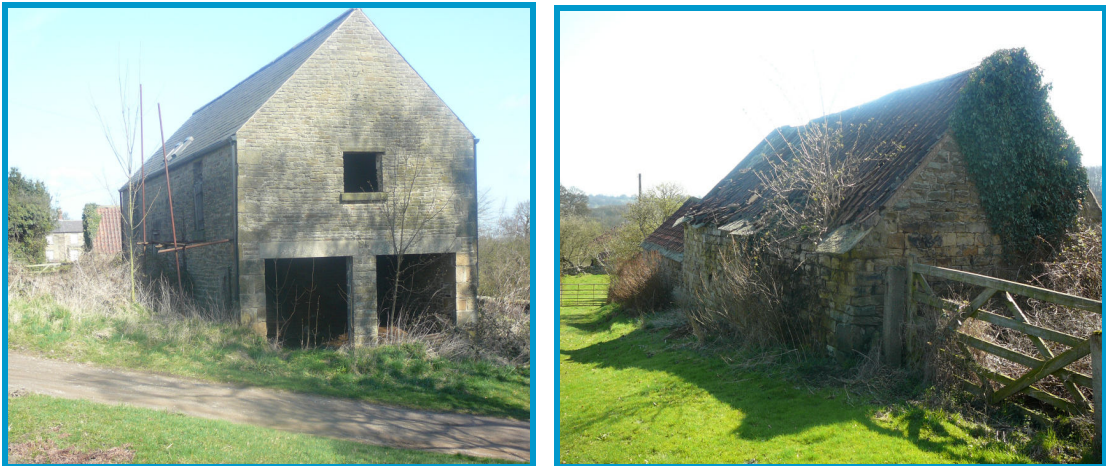
- 7.16 There is a stone-built former barn with a slate roof which has been partially converted to residential accommodation, although progress on the conversion work has been stalled for some time - planning permission was initially granted for the conversion in 1976 and was later renewed in 1982. The other building is stone-built with a pantile roof and is in a particularly poor state of repair. They are shown in the photographs below.

- 7.17 The location of these buildings on the corner of Astwith Lane near Yew Tree Farm means that they are extremely conspicuous and in their current condition are considered to have a negative impact on the character and appearance of the conservation area.

*Buildings at risk in Astwith*

- 7.18 Without a scheme of maintenance, ideally leading to some form of reuse in order to ensure their long-term preservation, these buildings are likely to continue to deteriorate in condition. For these reasons they have been identified as Buildings at Risk and proposals to tackle them are outlined in the Management Plan.

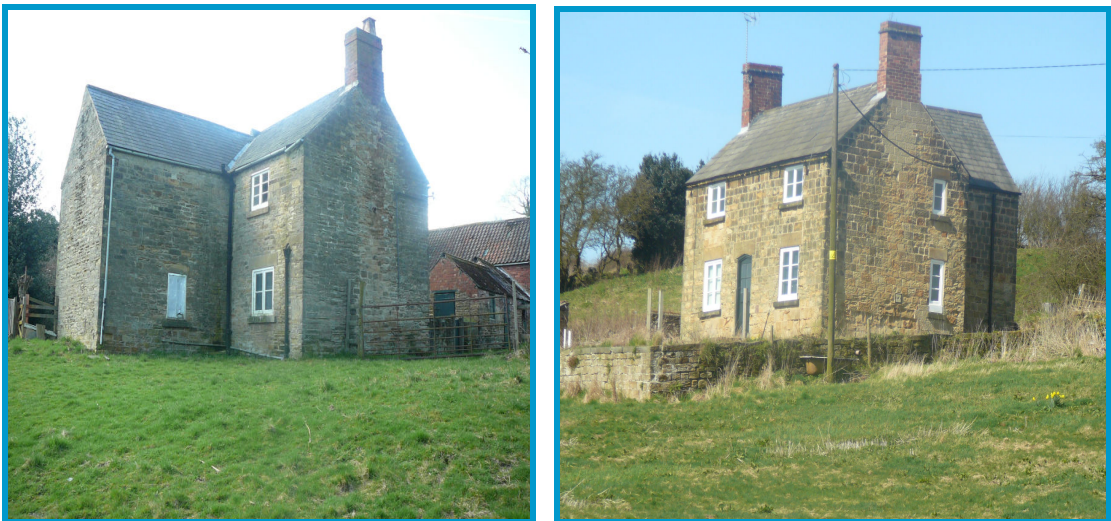
- 7.19 There are two vacant farm properties in Astwith which are owned by the National Trust. Both Yew Tree Farm and The Grange, which forms part of the agricultural tenancy of Park View Farm, are fine examples of traditional estate farms with a range of interesting vernacular features which should be retained.

*Yew Tree Farm and The Grange – vacant farm buildings*

- 7.20 At present the buildings are in a reasonable state of repair, although a programme of low-level maintenance needs to be maintained. There are recognised potential longer-term issues regarding the upkeep and condition of the buildings should they continue to remain uninhabited. The situation is being monitored by the National Trust to ensure that no significant deterioration occurs and it is the intention to bring both buildings back into use.
- 7.21 The repair of Yew Tree Farm and its reuse, together with the reuse of The Grange, would be beneficial to the character and appearance of the conservation area. It would benefit the vacant properties in terms of continued upkeep if they were occupied or used. It will be important to continue to monitor the situation to ensure the contribution to the character and appearance of the conservation area made by these buildings persists.

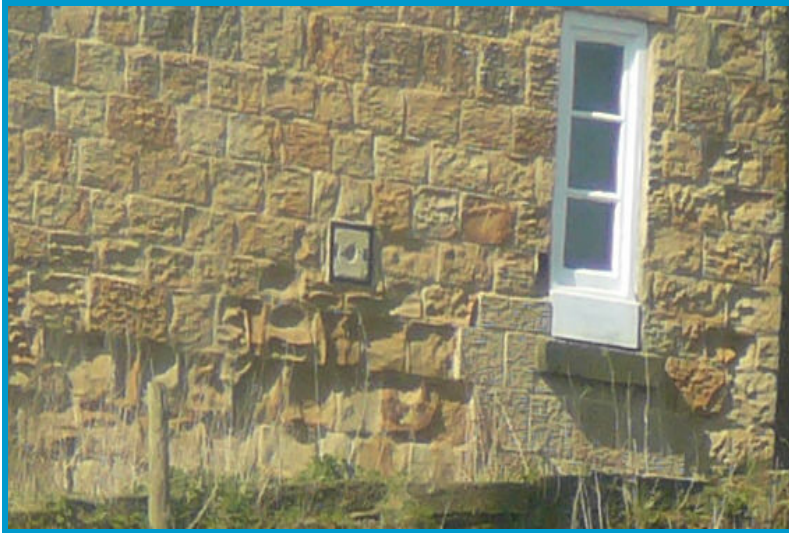
- 7.28 The stone has a warm, honey colour but is relatively soft which makes it susceptible to erosion and evidence of this is found on some of the older buildings in Astwith. The poor quality of the stone often explains why properties are rendered: the render acts as a sacrificial layer to protect the underlying stone. However, there is little evidence of rendered façades in the Astwith character area.

*Example of eroded coal measures sandstone and repair work*

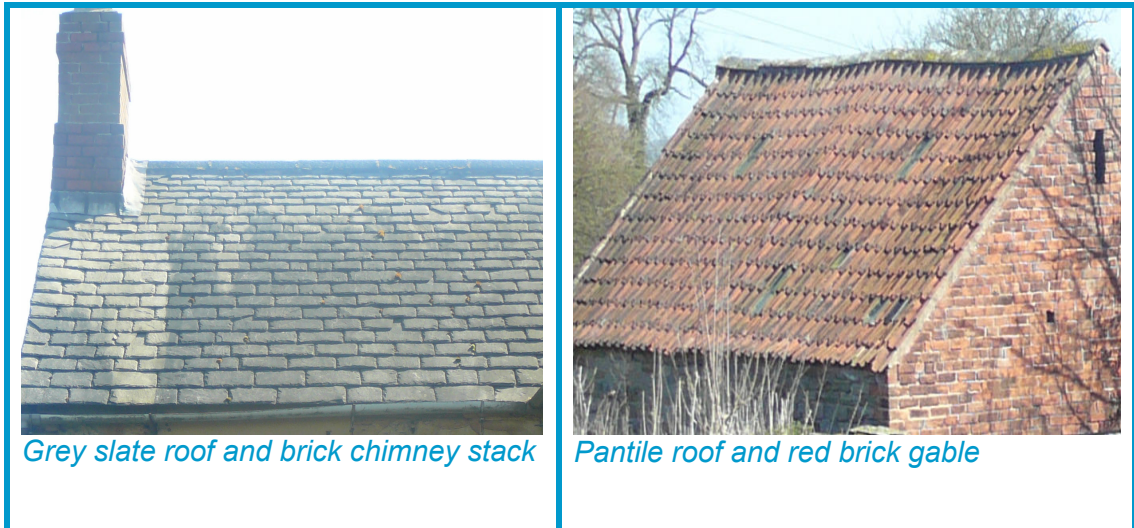
*Grey slate roof and brick chimney stack*

*Pantile roof and red brick gable*

- 7.32 The buildings in the conservation area display a range of roofing materials which in part reflects the different ages of the buildings and their respective uses. Although no single material dominates natural slate roofs in both diminishing and standard courses are particularly evident on the cottages, farmhouses and later Victorian buildings.

- 7.33 By contrast some of the agricultural buildings are roofed in red pantiles. The former brickworks on Hardstoft Common would probably have provided a ready supply of clay pantiles until the late 19<sup>th</sup> century. One of the derelict outbuildings to the west of Yew Tree Farm has an eaves course of stone slate which is quite an interesting architectural feature which should be retained.

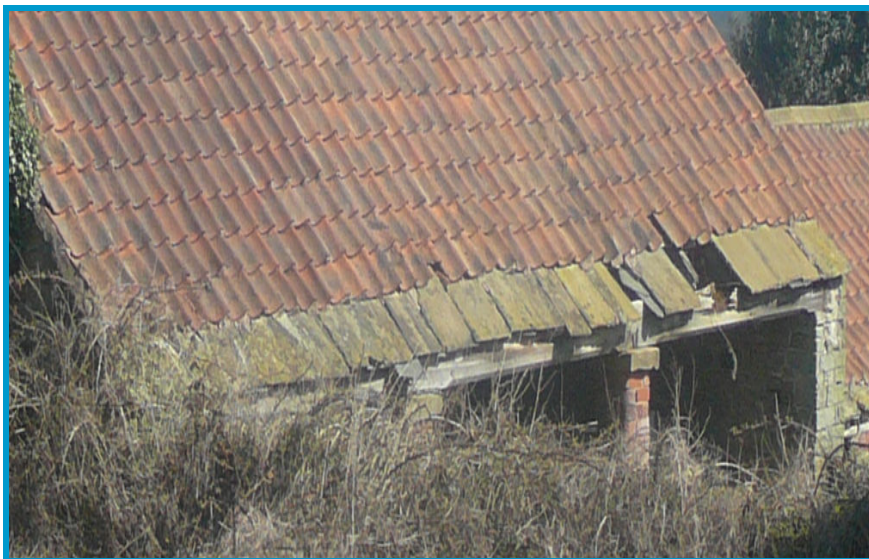
*Pantile roof with stone slate eaves course*

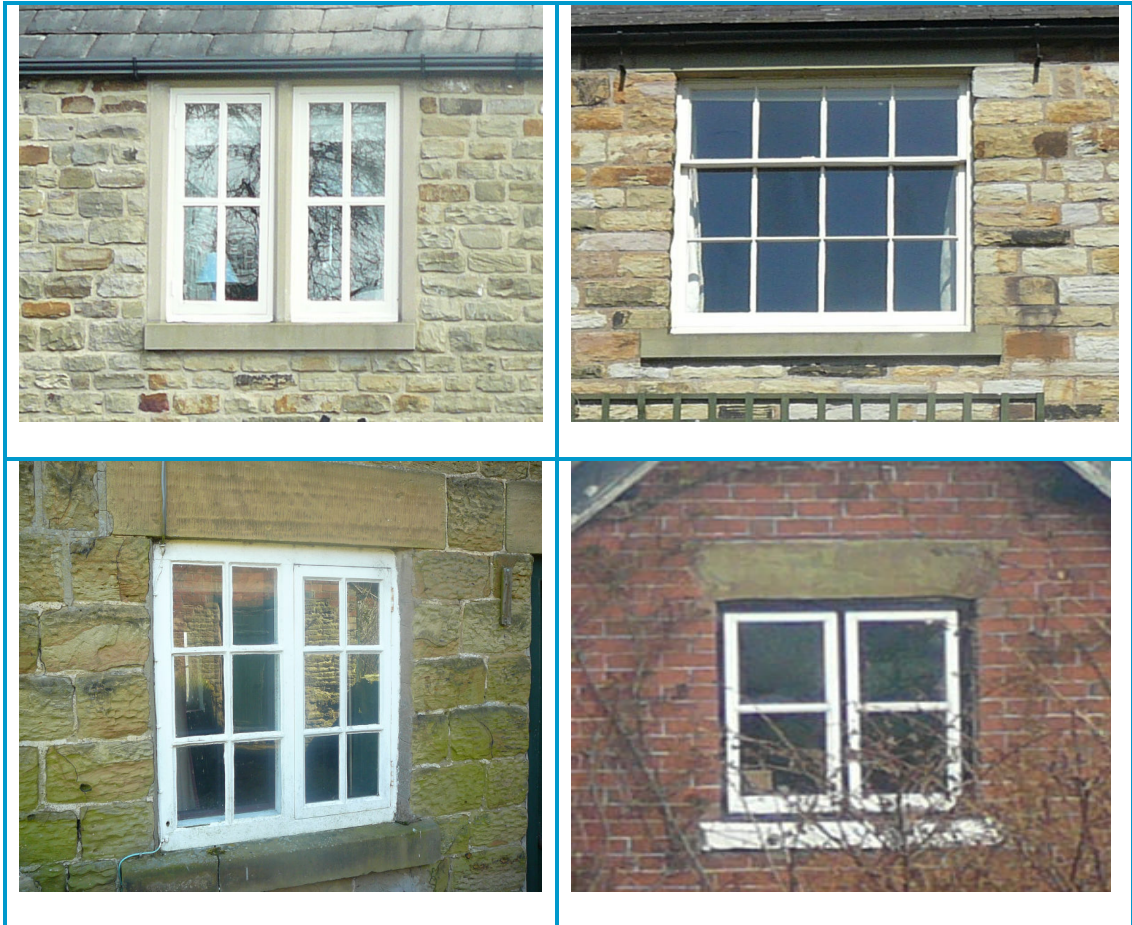
*Examples of window styles found in the conservation area*

- 7.41 Windows and doors are key features which influence the overall appearance of a building and they make a significant contribution to the character and appearance of the area. There is a wide variety of windows and doors on display in the conservation area and some examples are shown below.

- 7.43 The introduction of different window designs, staining colour and glazing patterns affect the appearance of the building and of the area as a whole. Generally, modern windows, particularly uPVC, do not replicate the thickness and moulding of traditional glazing bars, the size and arrangement of panes and the size of window frames. Therefore, decisions about window type and glazing need to be carefully considered.
- 7.44 A variety of window and door styles have been introduced in Astwith which are non-traditional and uPVC replacement windows and doors are evident on some of the properties. Although a large number of the properties cannot be readily viewed from the public realm, from a conservation perspective these alterations collectively detract from the character and appearance of the conservation area.

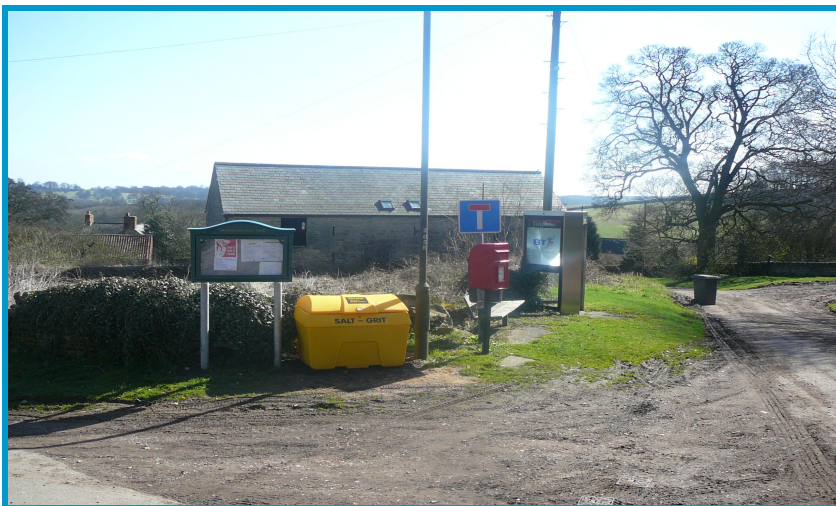
- 7.56 Many streets and public spaces suffer from an over abundance of street furniture and signage. This can present a cluttered look which detracts from the local character of the area. Astwith is fortunate in that it does not have masses of street furniture and signage. However, there is a collection of street furniture - a telephone kiosk, a pole-mounted post box, a parish council notice board, grit bin, litter bin, bench, street light, and telegraph pole - towards the centre of the settlement adjacent Astwith Lane which presents an untidy looking local environment.

*Collection of street furniture, Astwith Lane*

- 7.57 Local residents raised concerns about the look and quality of this area and in particular the modern telephone kiosk (which has been vandalised) and standard yellow grit bin. There was a desire to see these items replaced with examples that are more in keeping with the qualities of the conservation area.

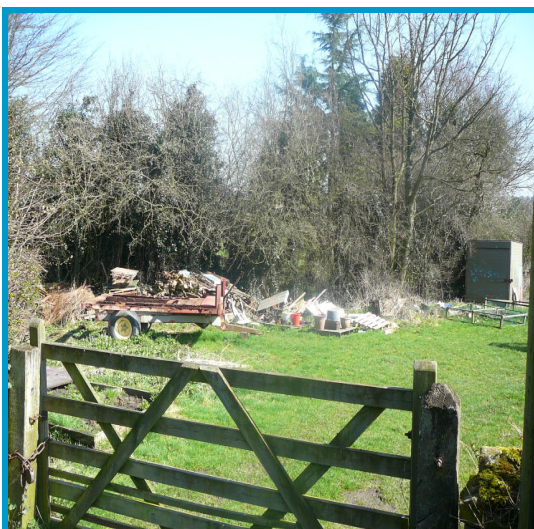
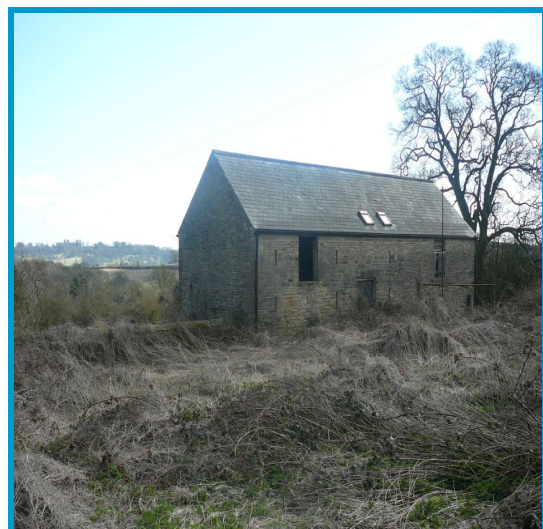
- 7.61 The second area is west of Yew Tree Farm adjacent the partially converted stone barn which has been identified as a Building at Risk. The land is associated with the same ownership as that of the building. The land is overgrown and has an untidy / unkempt appearance.

*Areas of untidy land in Astwith*

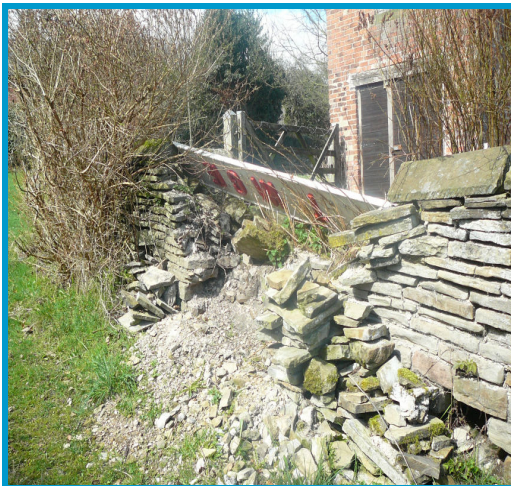
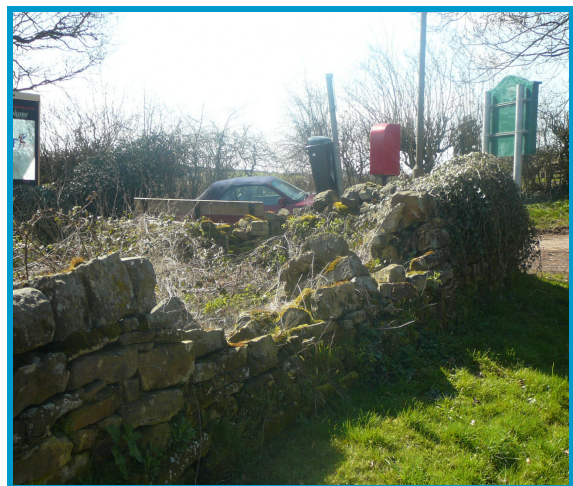
- 7.62 Many of the plot and roadside boundaries are defined by traditional stone walls. Stone boundary treatment helps to provide continuity in the streetscape and is a key characteristic of the area which adds considerably to the character and appearance of the conservation area. The boundary walls are generally well maintained throughout the conservation area although there are a few places where discrete sections have collapsed or they have been replaced with non-traditional boundary treatments.
- 7.63 There is a danger that where walls collapse they will not be repaired or they will be replaced with non-traditional boundary treatments which are not in keeping with the character of the area. This would detract from the overall value of the conservation area.

*Examples of stone walls requiring repair*

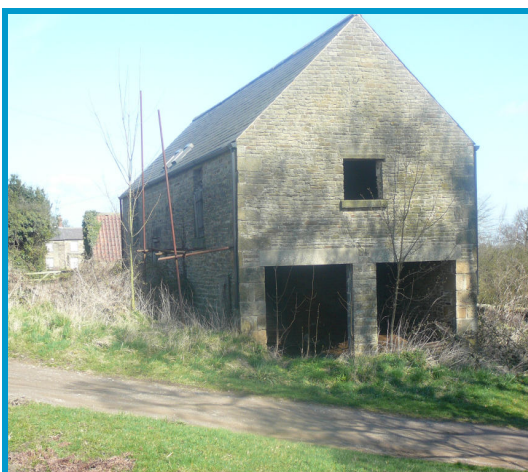
*Building A*

- 11.5 In their current condition they do not make a positive contribution to the appearance of the Astwith Conservation Area. Ultimately they will continue to deteriorate in condition unless action is taken to preserve them.

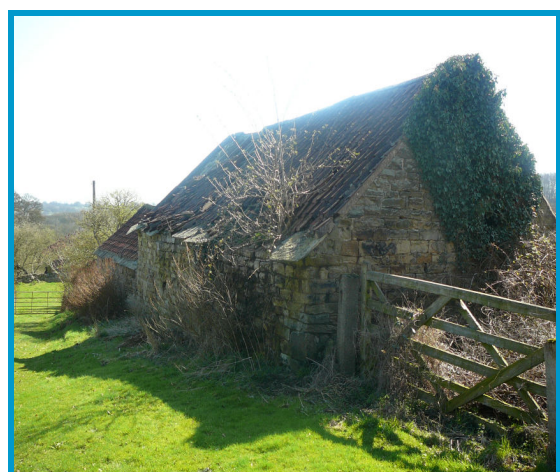
*Building B*

Building B: is a stone-built former barn with a pantile roof and is in a particularly poor state of repair.

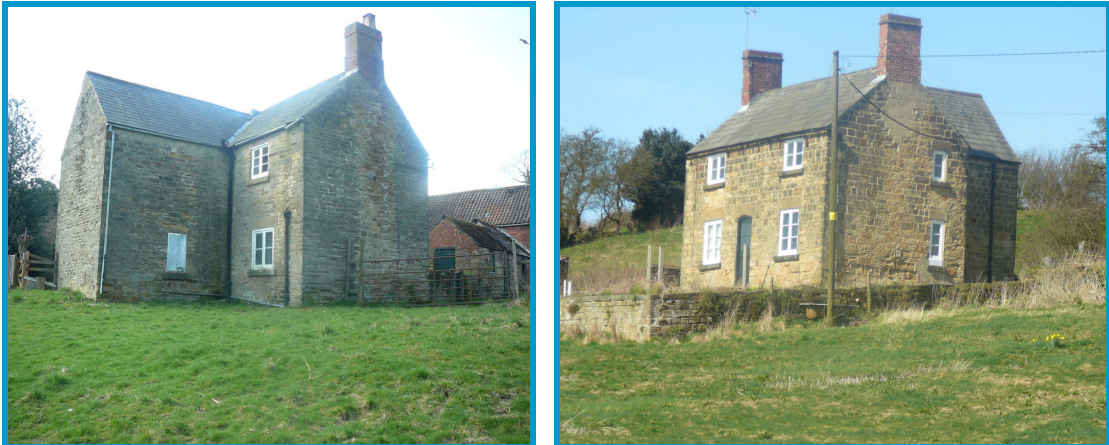
*Yew Tree Farm and The Grange – vacant farm buildings*

monitor the situation to ensure the contribution to the character and appearance of the conservation area made by these buildings persists.

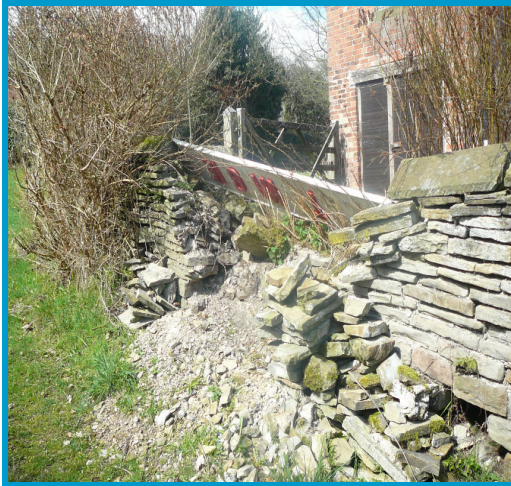
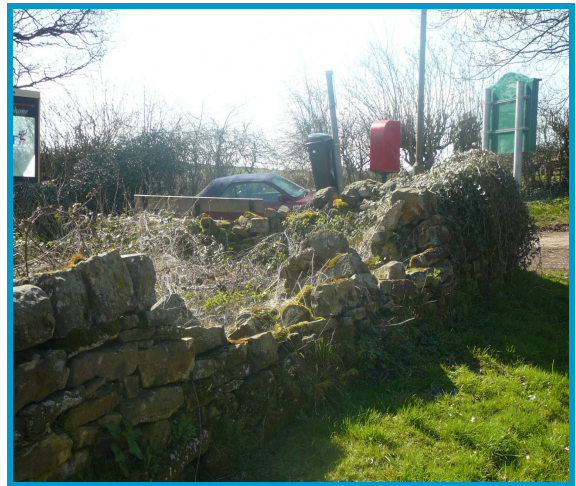
- 11.9 The traditional stone boundary walls have been identified in the Appraisal as an important feature contributing to the character and appearance of the conservation area. However, there are a few places in the conservation area, particularly around the area in the centre of Astwith near the telephone kiosk and parish council notice board, where their condition is deteriorating. The loss of traditional stone boundary walls would detract from the character and appearance of the conservation area.
- 11.10 There is a danger that where walls have collapsed they will not be repaired or they will be replaced with non-traditional boundary treatments which are not in keeping with the character of the area. This would detract from the overall value of the conservation area.

*Examples of stone walls requiring repair*

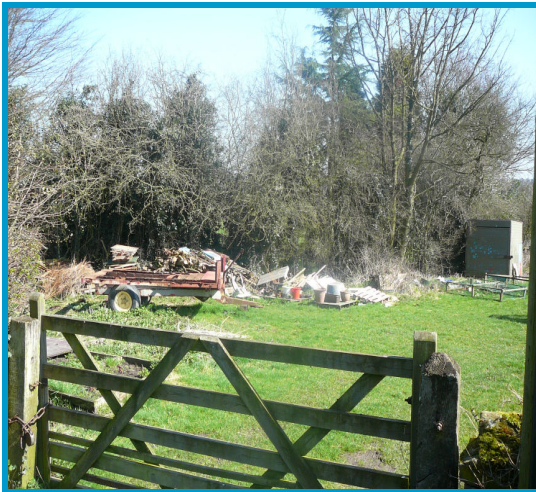
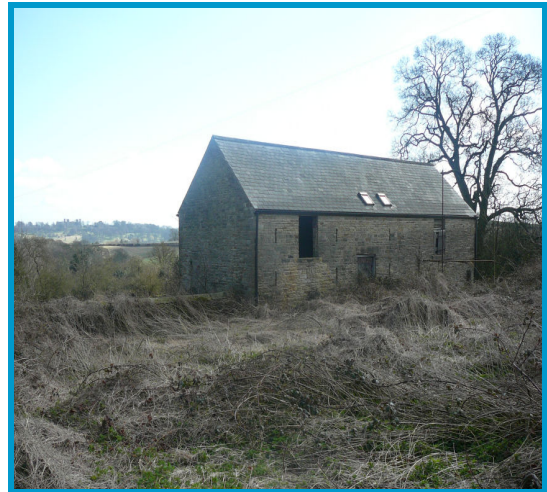
- 12.12 Local residents raised concerns about the condition of two other areas of privately owned land in the conservation area: the first area lies adjacent Astwith Lane to the south of Manor Farm Cottage and is known as Hills Orchard. The Council served a Section 215 Notice on the owner of the land in 2000 in order to get the land tidied of some of the items that were being stored there, including car parts and scrap materials. It may be appropriate to consider issuing a new Section 215 Notice in order secure further improvement to this area of land.
- 12.13 The second area is west of Yew Tree Farm adjacent the partially converted stone barn. Both areas of land can be seen from the public realm and in their current condition are considered to detract from the character and appearance of the conservation area.

*Areas of untidy land*
