BEAUMONT
RIVERS

Invitation to Tender

Pleasley Vale Phase 1 Works:

Version 2

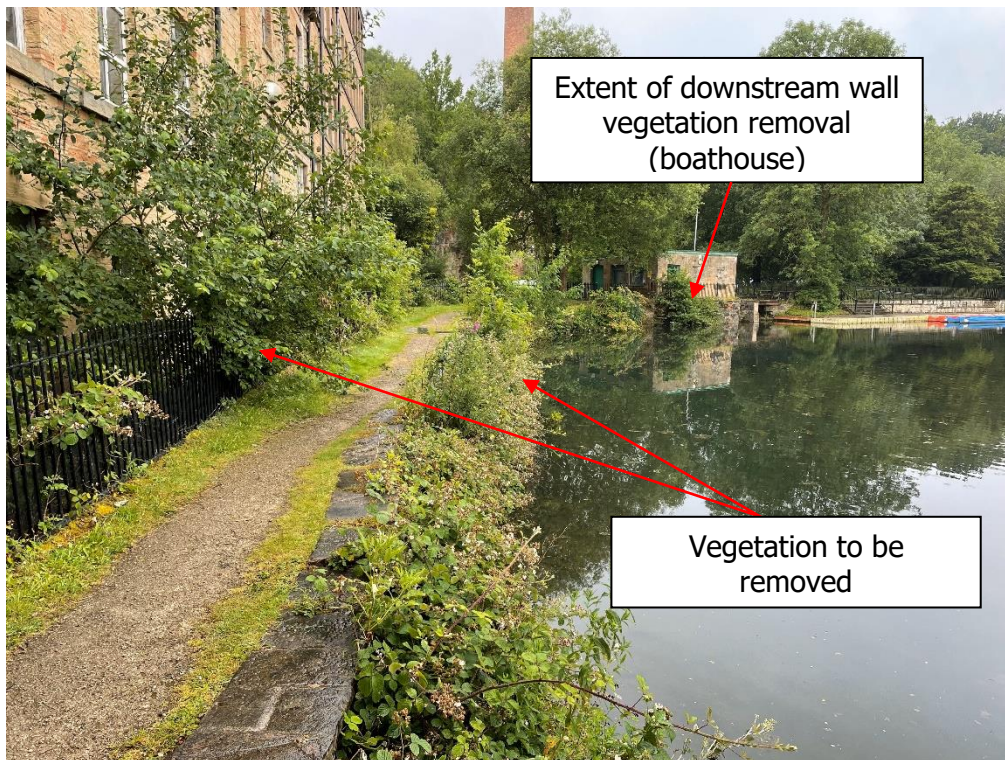
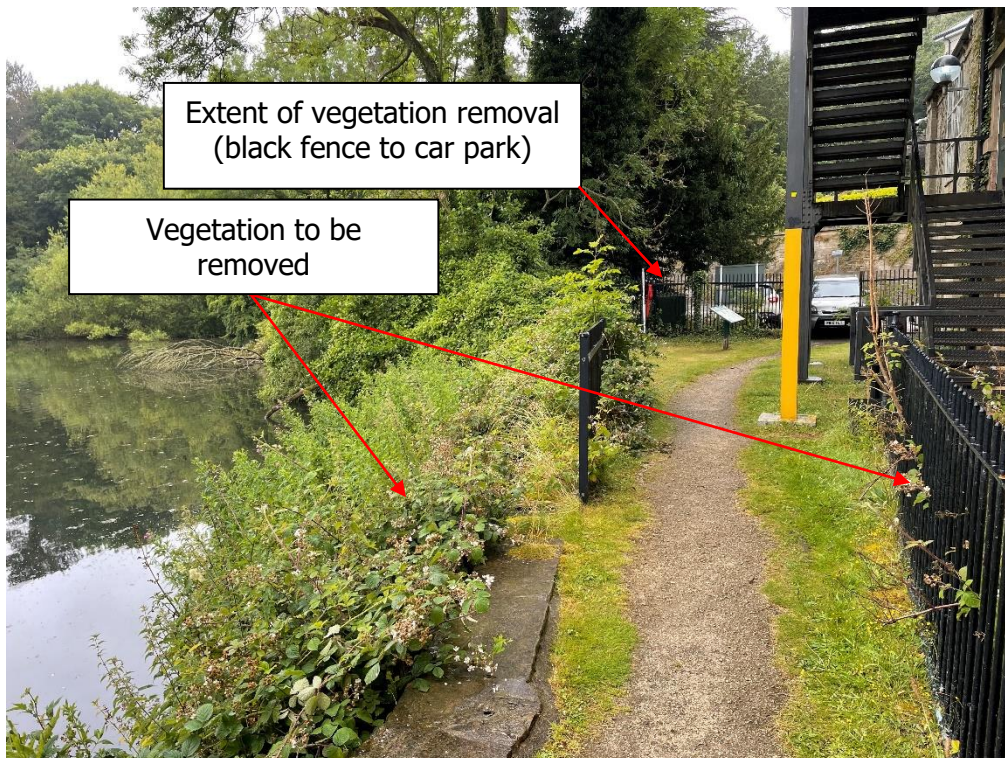
1. Remove all remaining trees from the embankment:
 - a) 67m of clearance of vegetation, particularly woody species along both sides of downstream wall from [outfitter.cages.fail](#)s up to the black steel fence (at car park) at [amuses.connector.choppers](#)

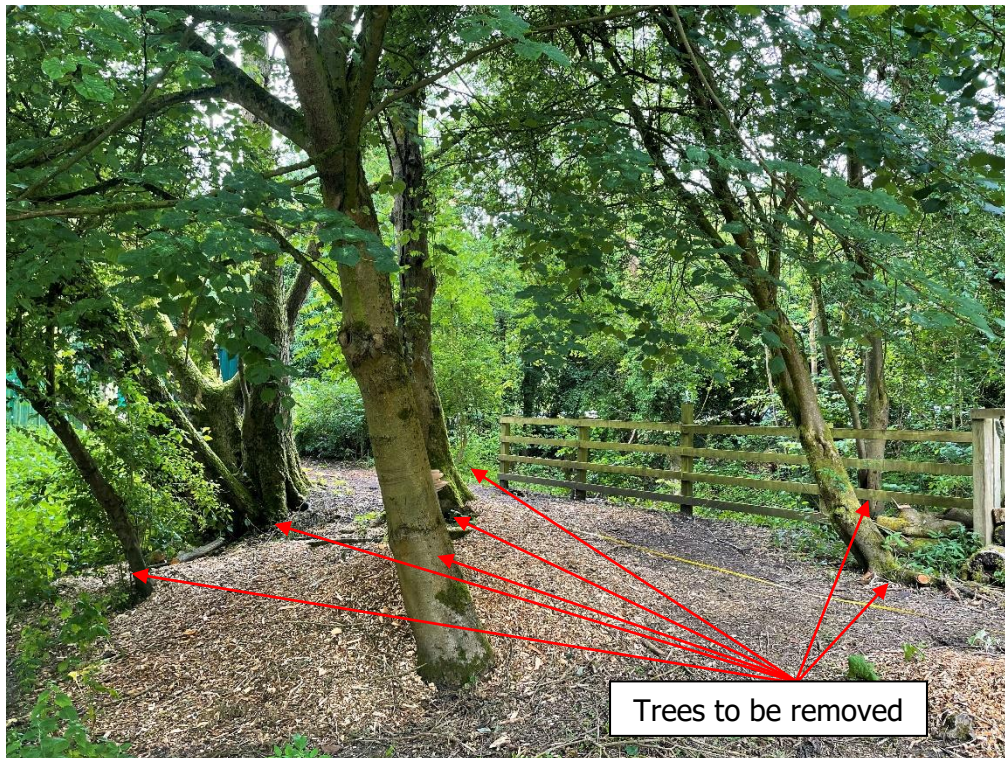
b) Remove 8no. mature trees and 1 sapling from spillway area.

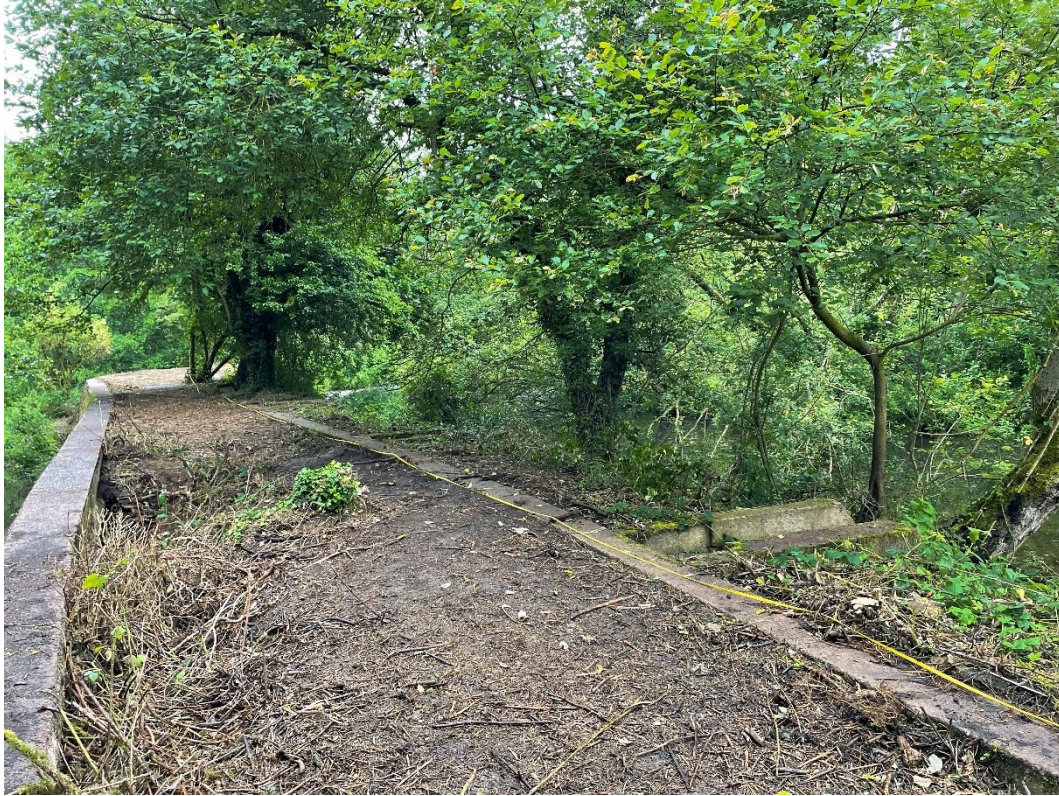
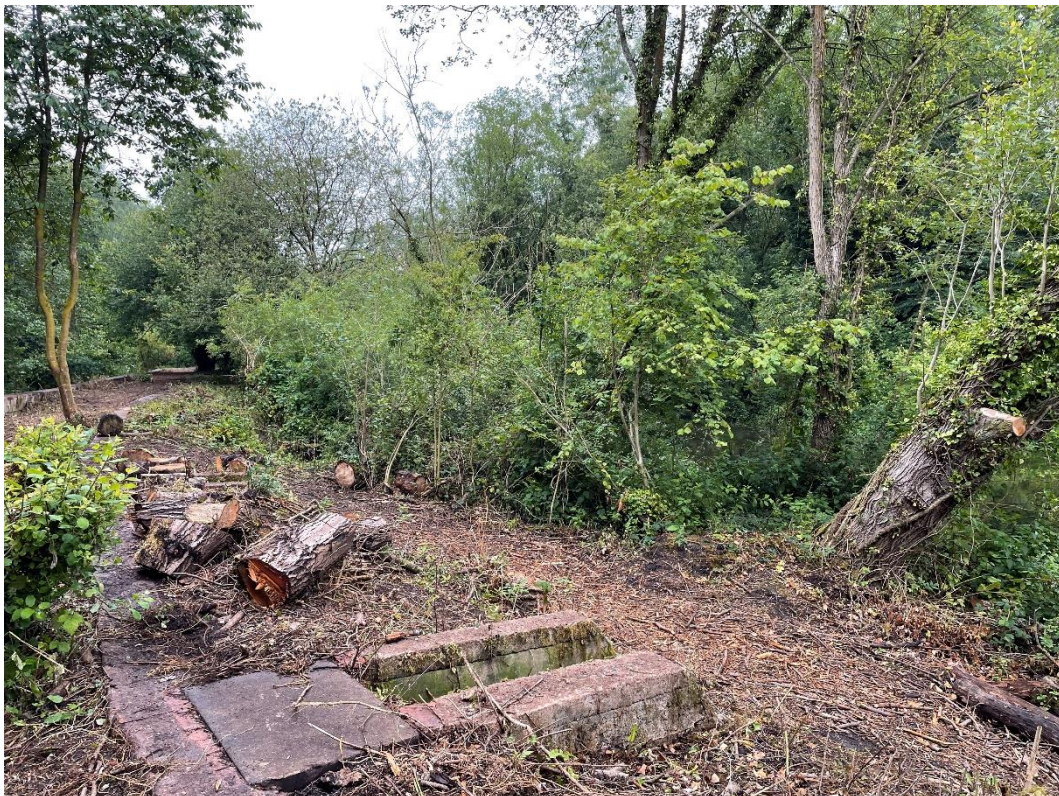
c) Continue removing trees from entire embankment, with particular attention to those impacting the retaining wall.

There are 15 mature trees growing from the wall and 6 in the centre of the embankment. There is an additional 56m of bank clearance at the edge of the lake. 56m clearance from ///chef.utter.arrival to pines.proofread.menswear

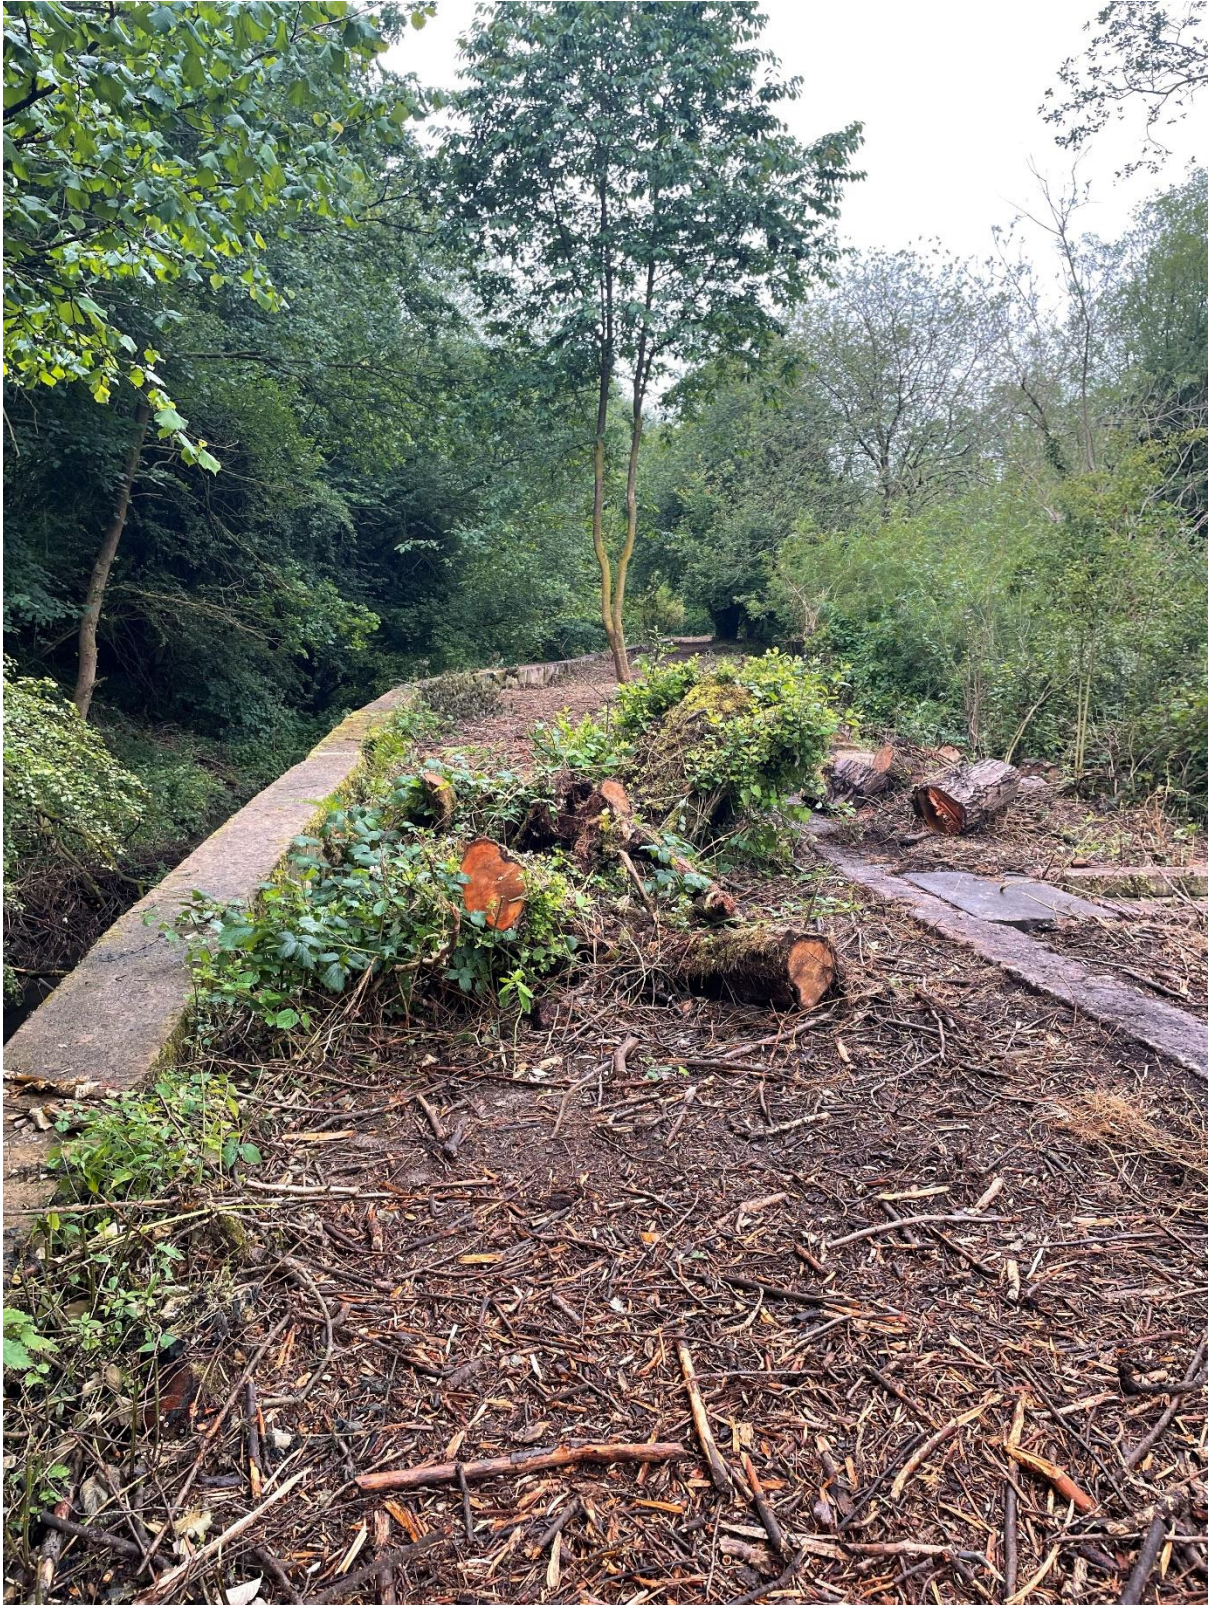
d) Remove stump at ///chef.utter.arrival to facilitate further works.

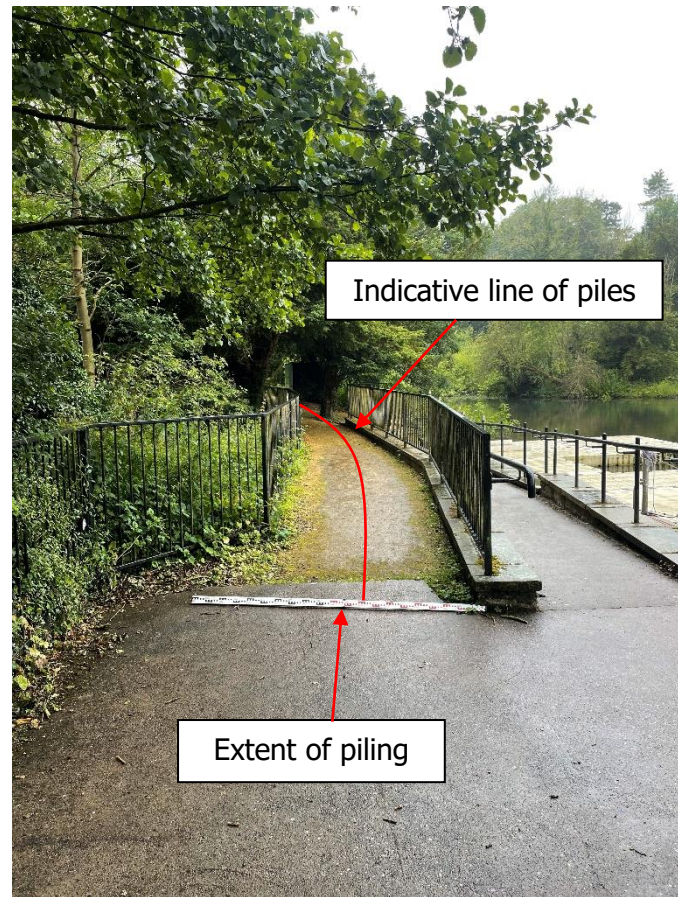
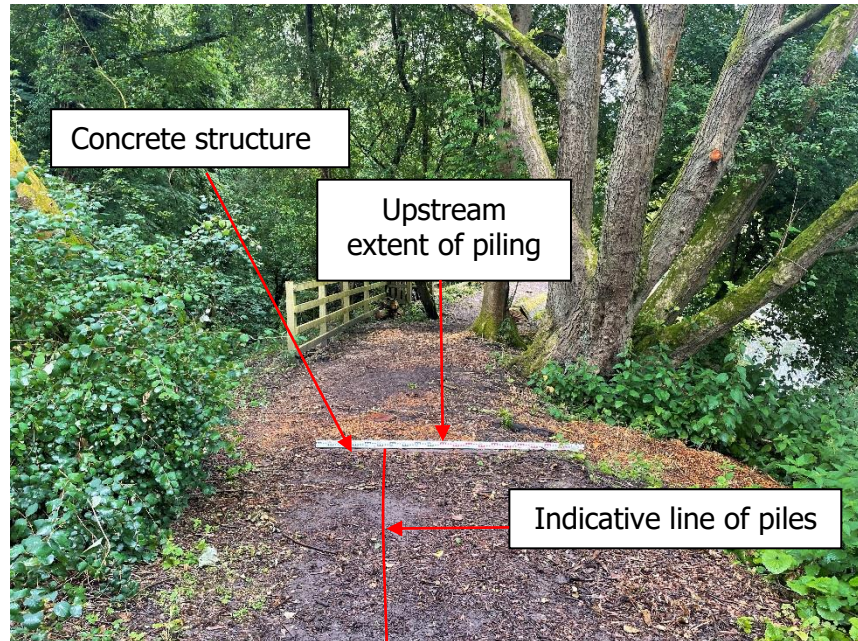
2. Install 48m of 3.5-4m piles from the edge of wall (access ramp) to concrete structure.

- a) Cap piles to impoundment crest level of 104.5 mAOD.
- b) Make good footpath surface along the extent of pilings.

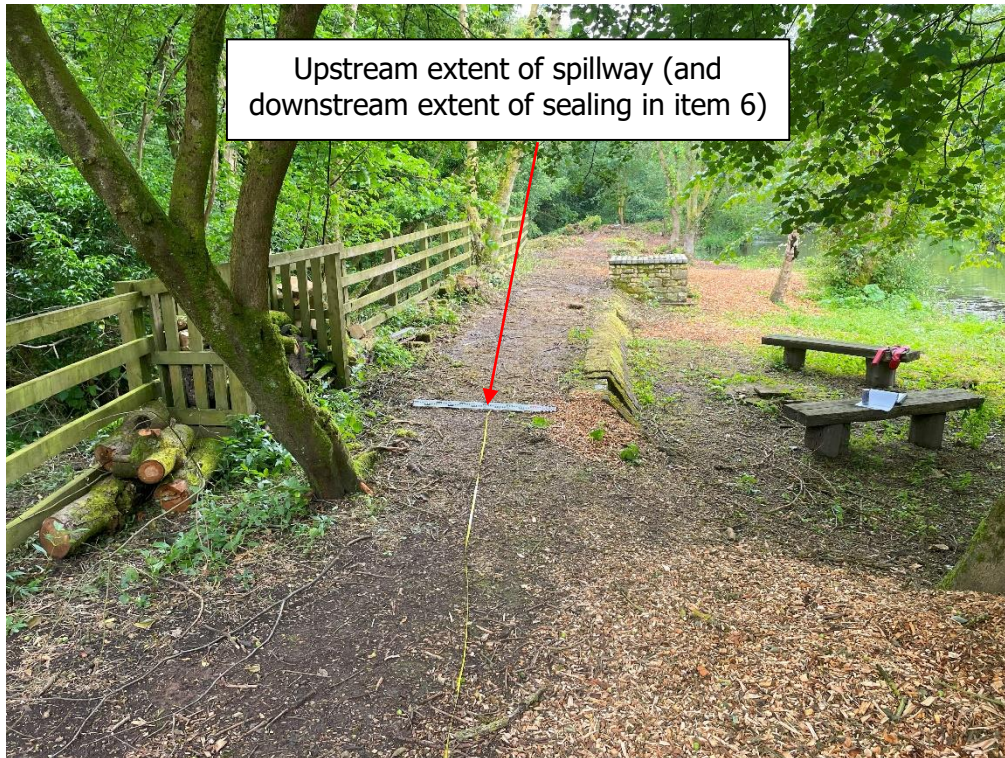
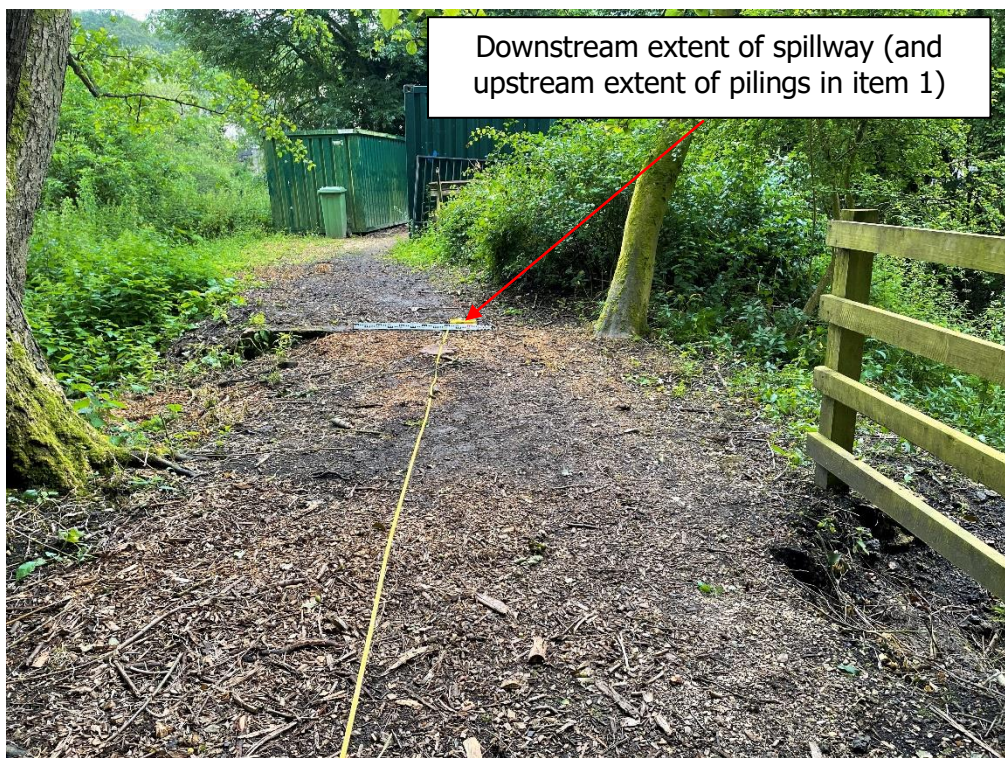
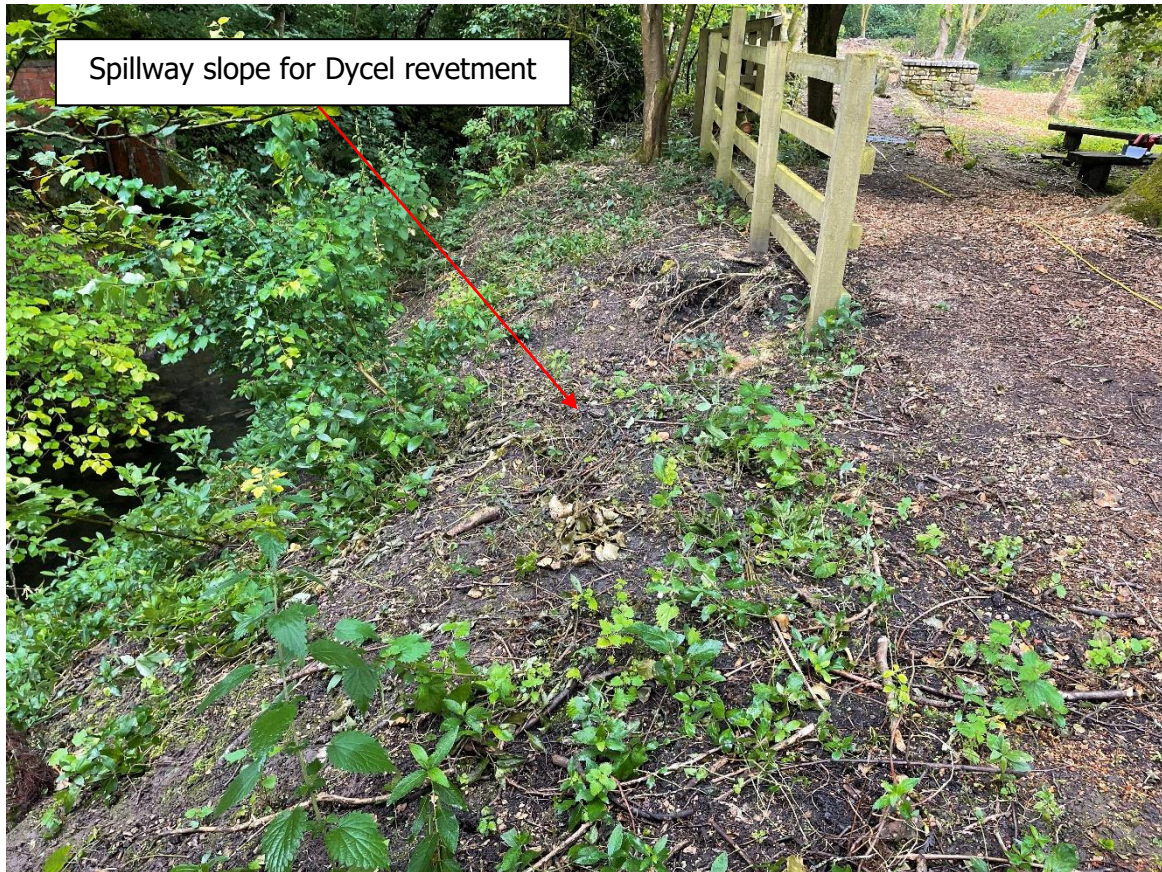
///archives.passports.caked

3. **Grade back damaged bank, remove fencing and create spillway. Install 12m long concrete crest beam and a 12m wide, ~5m long concrete spillway using Dycel concrete revetment with geotextile underlayer. All fencing, trees and stumps must be fully removed. Crest height to be confirmed.**

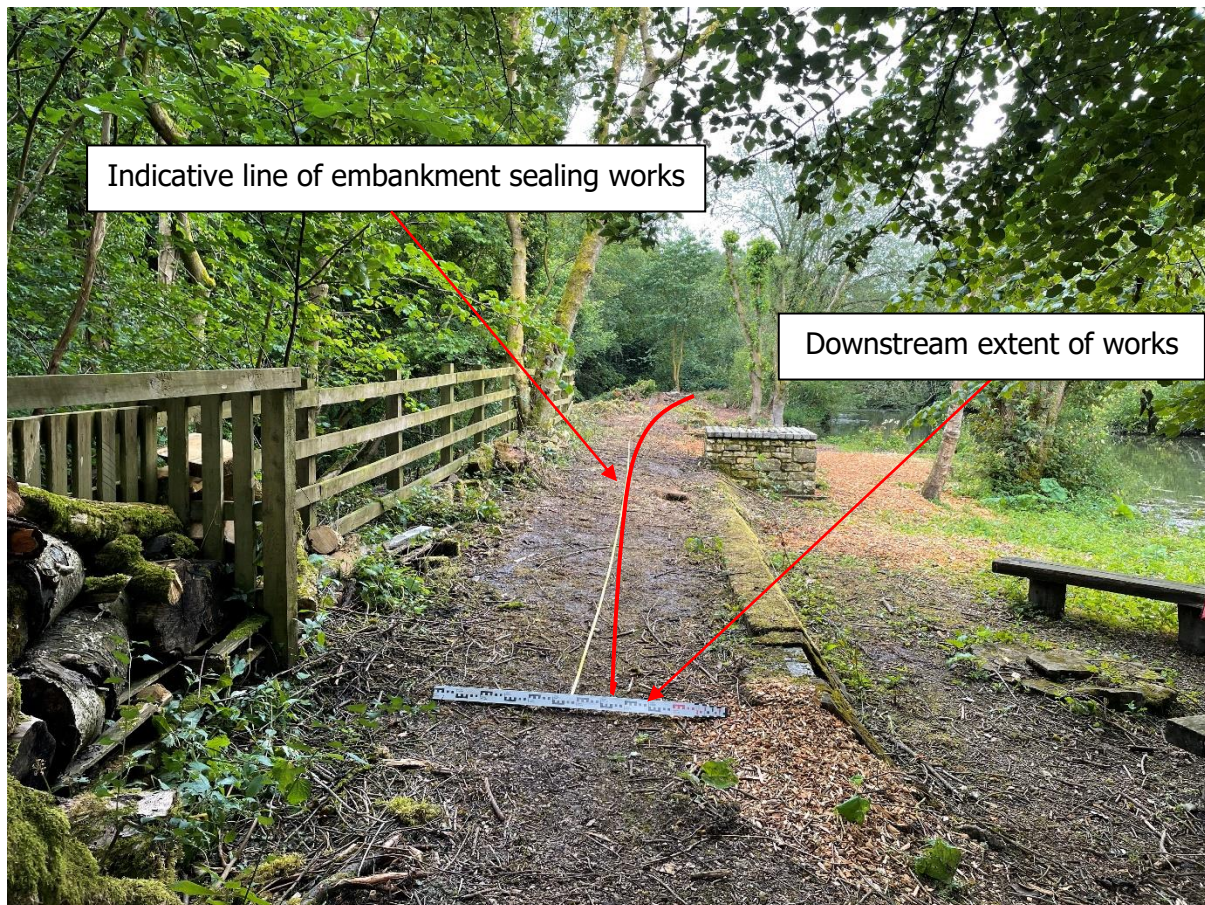
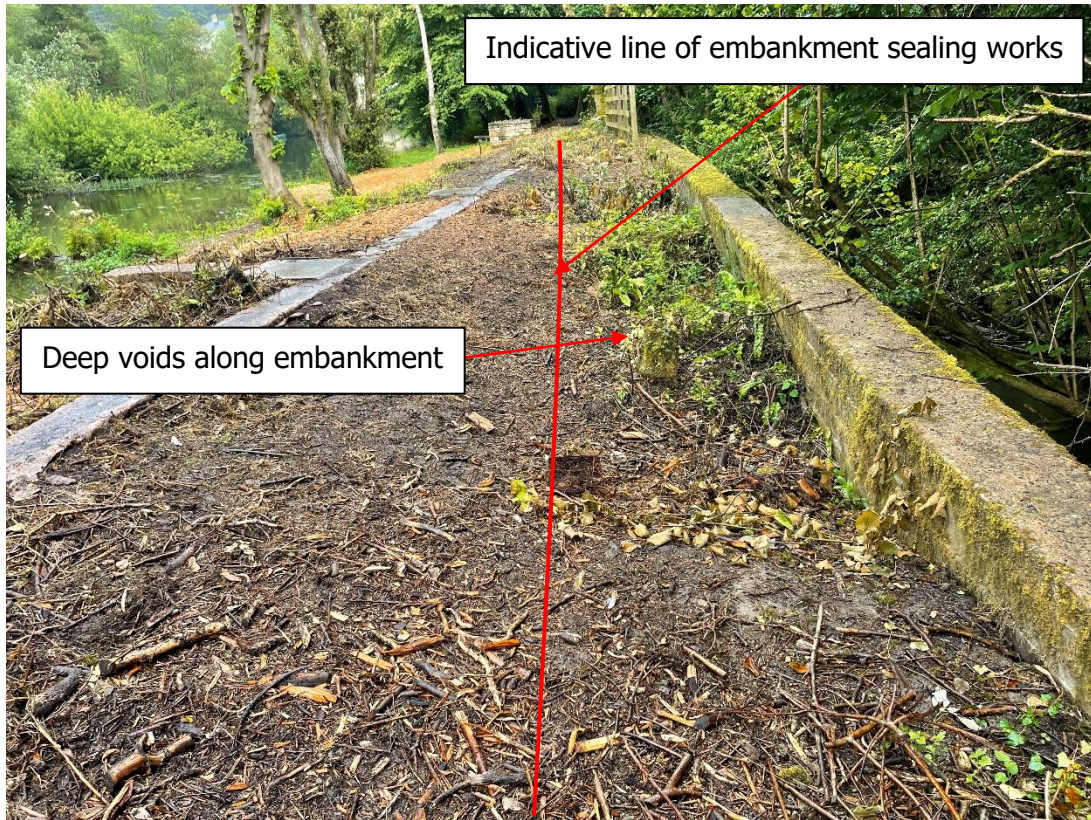
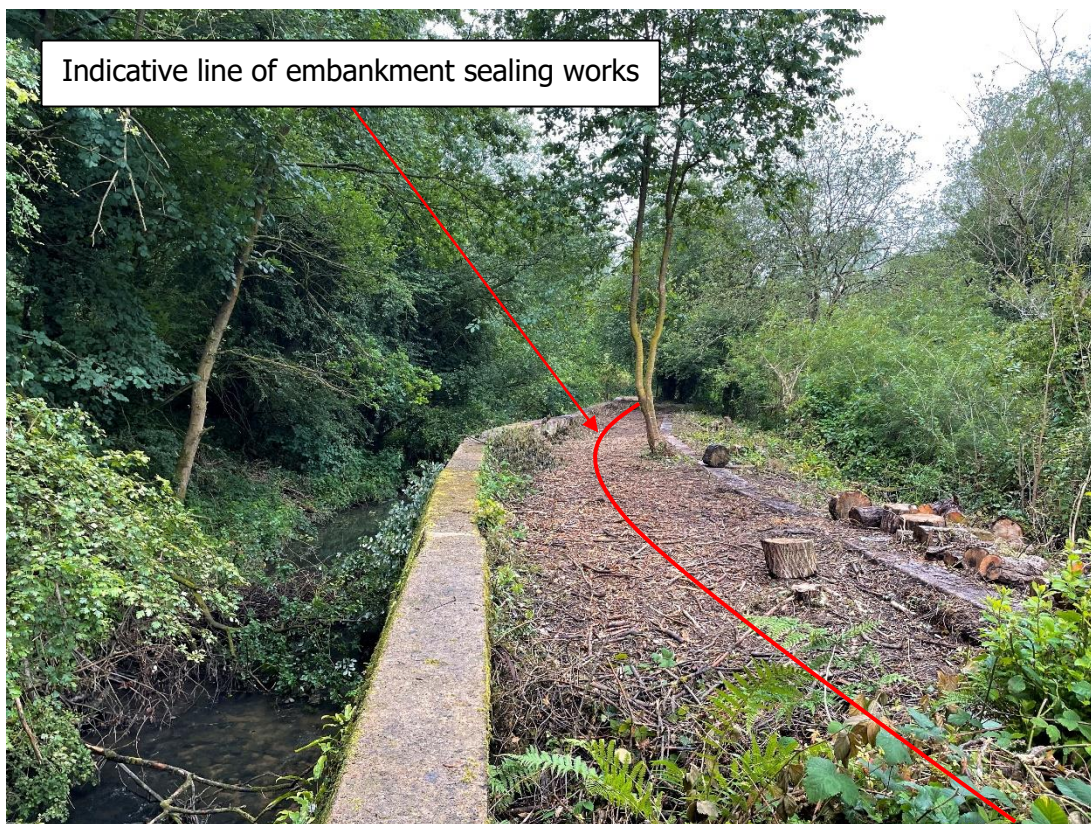
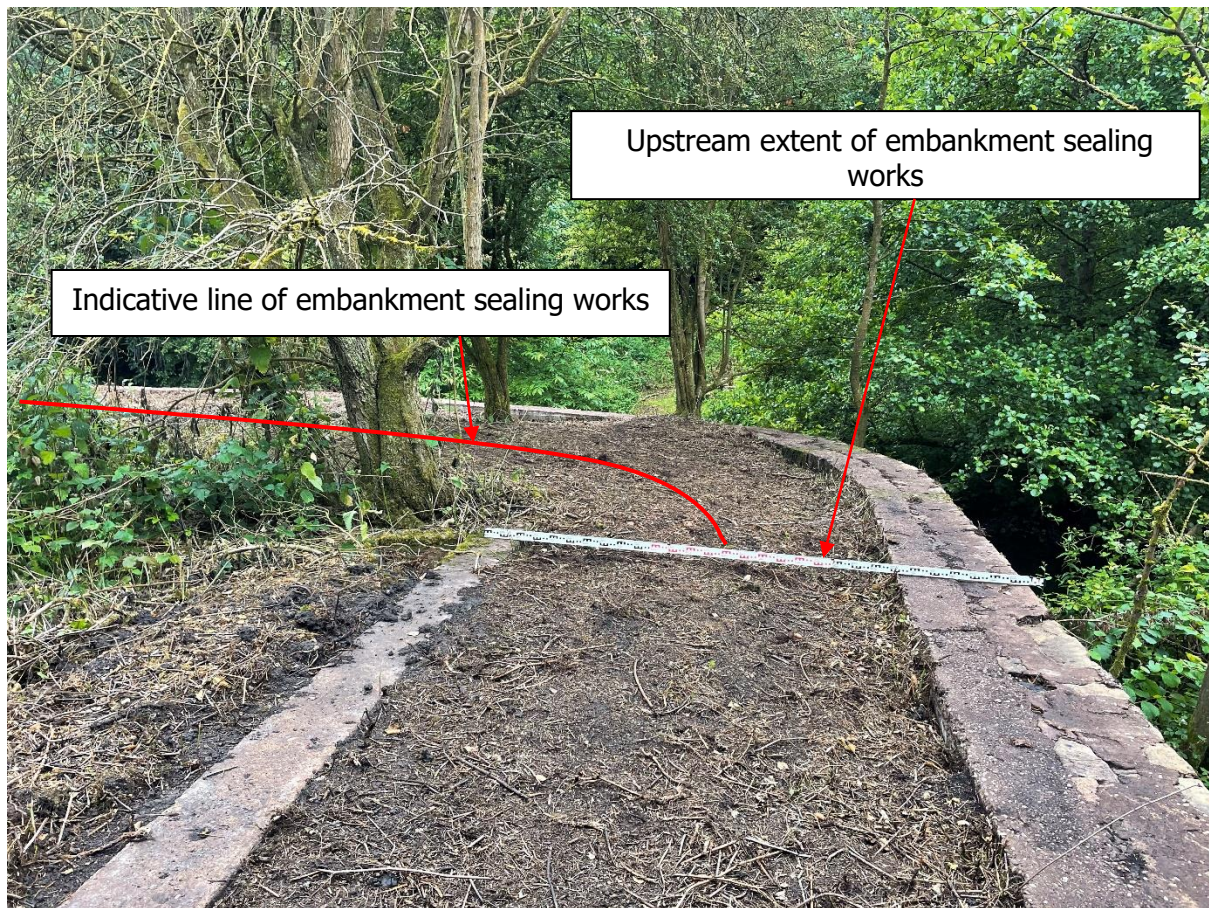
4. Seal 141.6m of the central core of the wall from the surface to 50cm below river bed level (123m emergency works, plus 18.6m to full extent) from spillway to end of structure. Works are to be between the retaining wall and concrete pipework (see photos). Riverbed level is between 3.5 and 4m below the surface.

Wall is to be sealed in one of the three methods identified below:

- Pilings
- Dig trench and fill with bentonite slurry
- Investigate each individual void, dig out, grout the inside of the concrete retaining wall to seal and infill as required. There are 8-9 voids of unknown connectivity as detailed in scope items 5 and 6A-E.

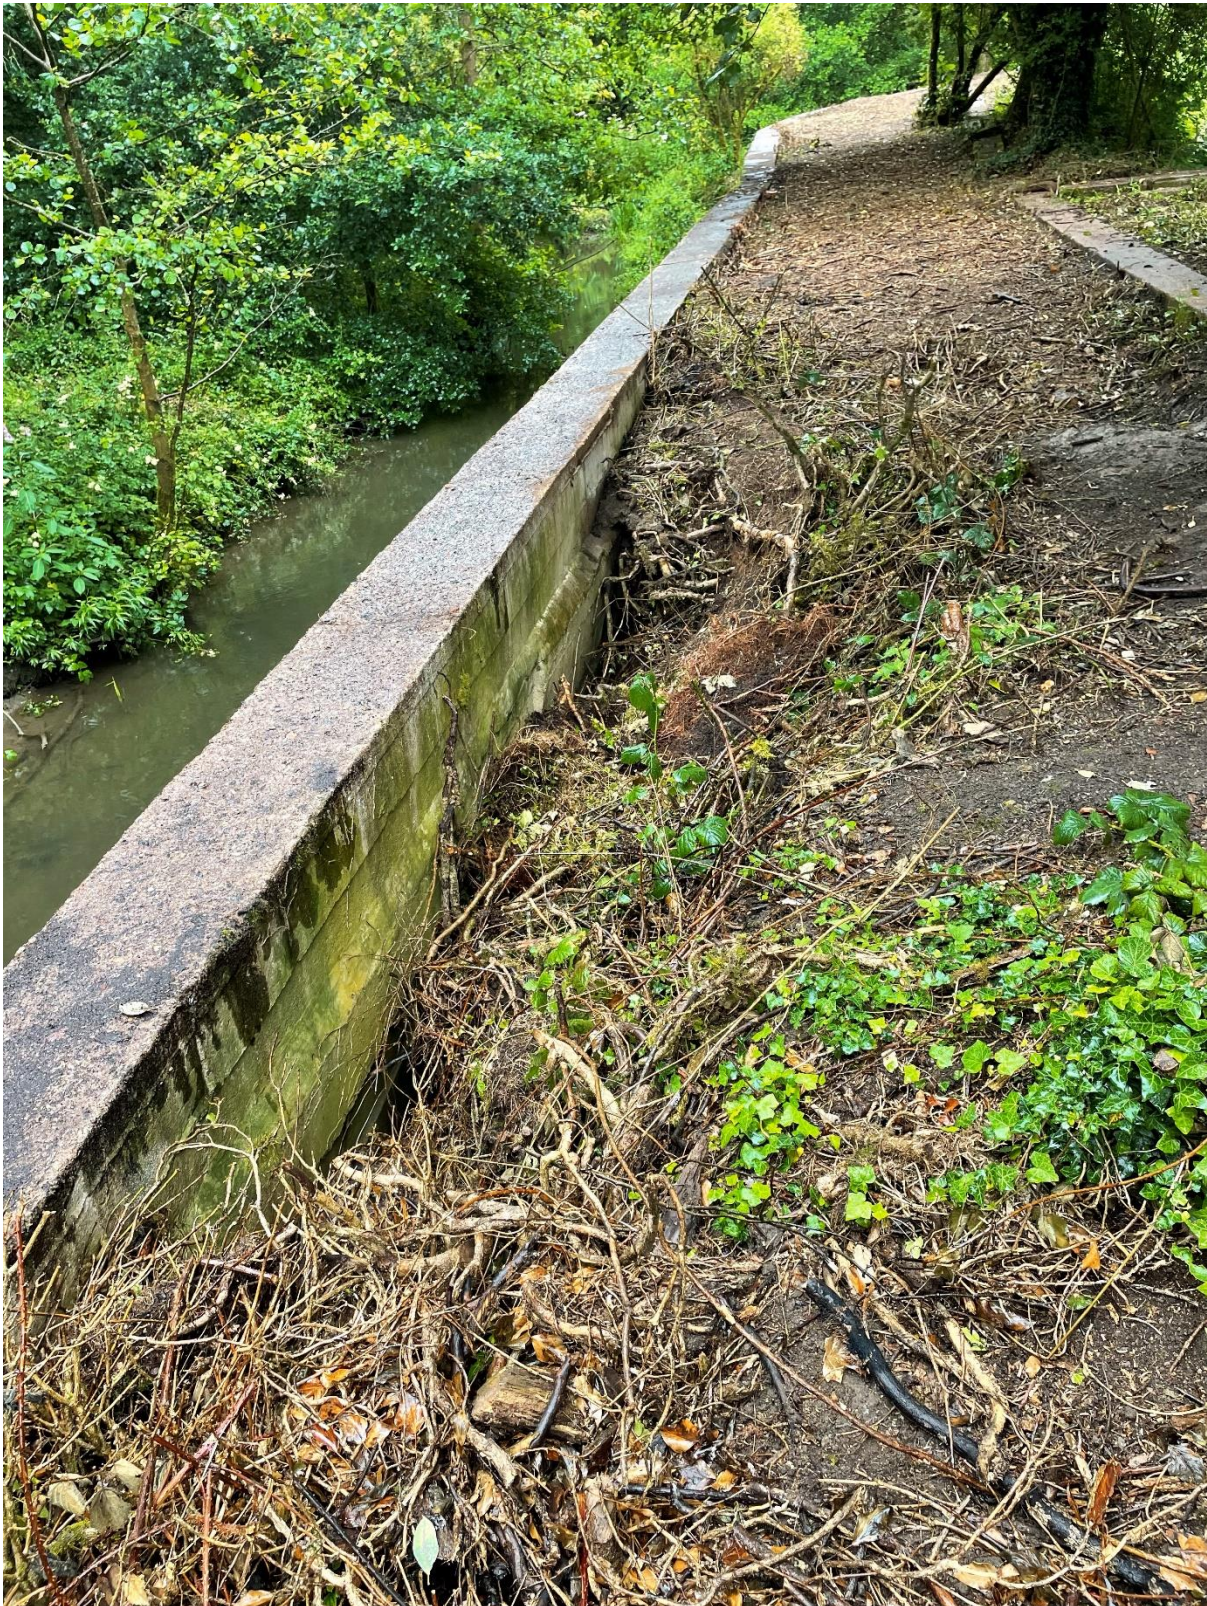
5. **Infill 8 to 9 voids to crest level with compacted clay topped with topsoil. Seed with grass mix.**

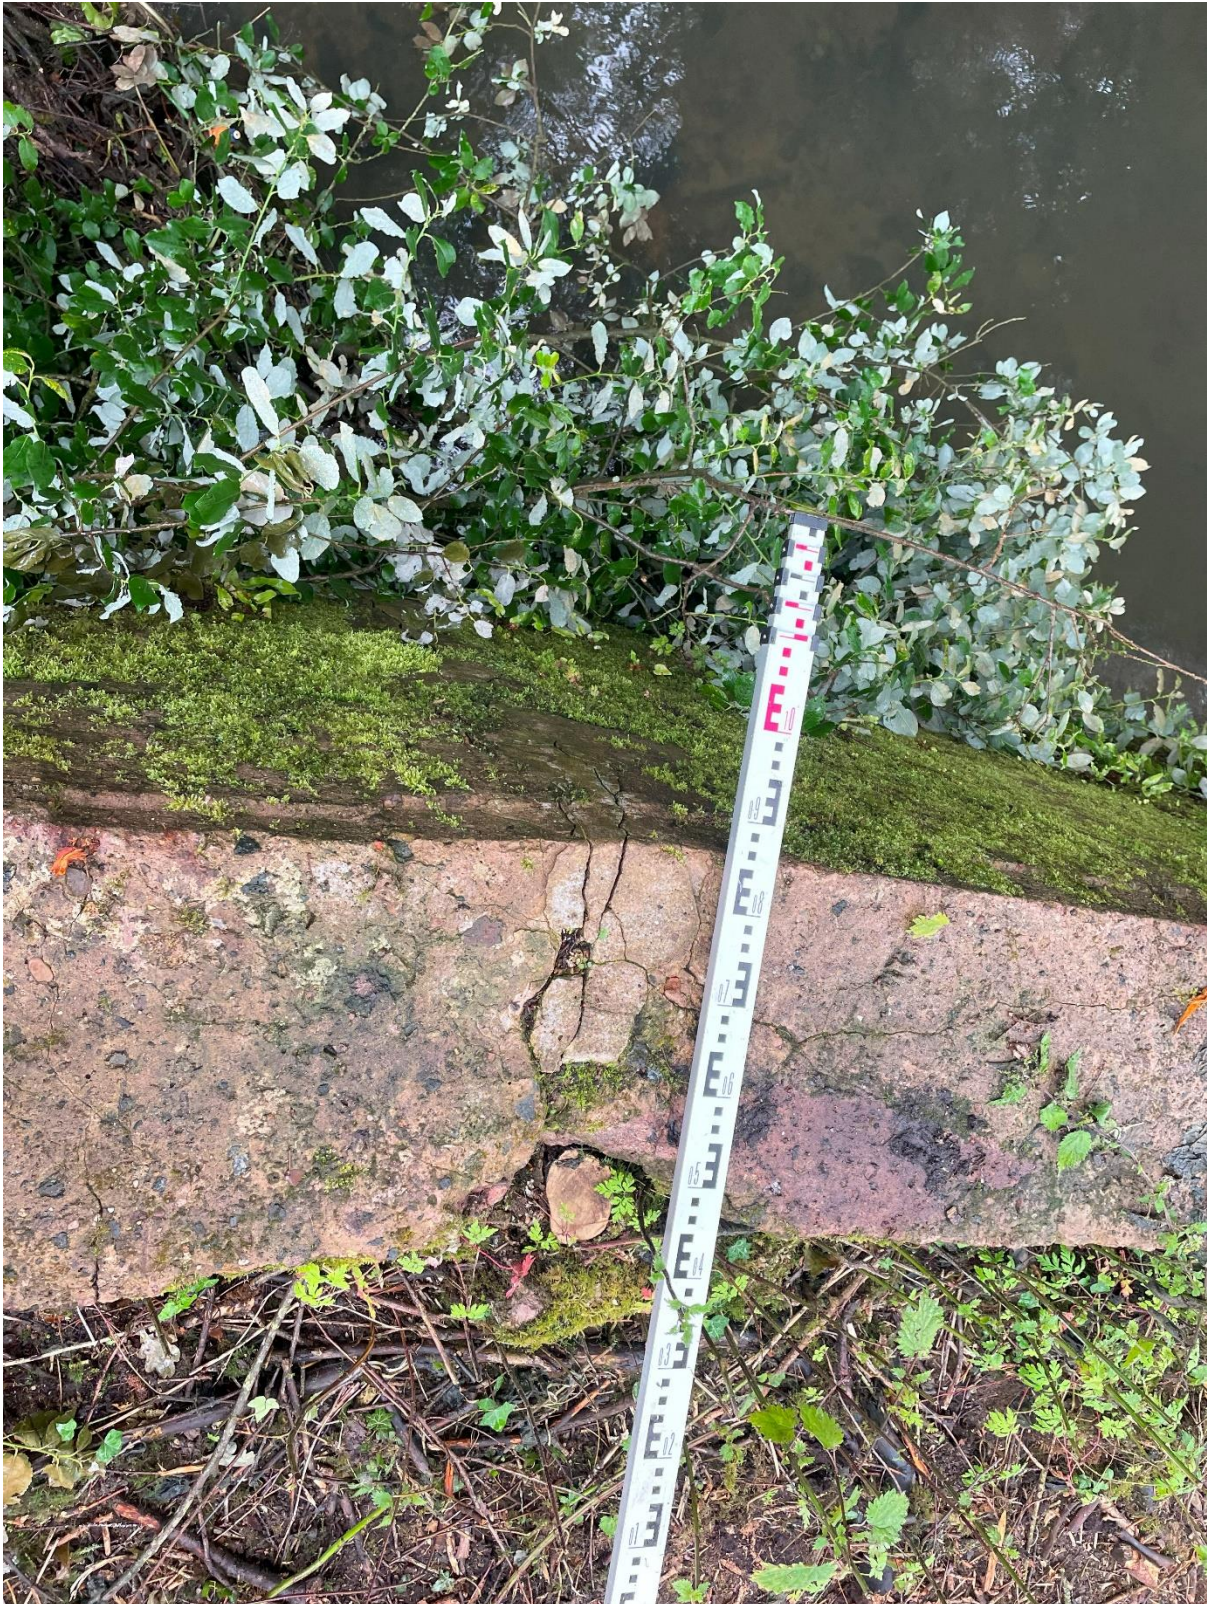
a) *///itself.wake.riskiest*

6. Drill down and grout cracks along the full height of the concrete retaining wall at the following locations:

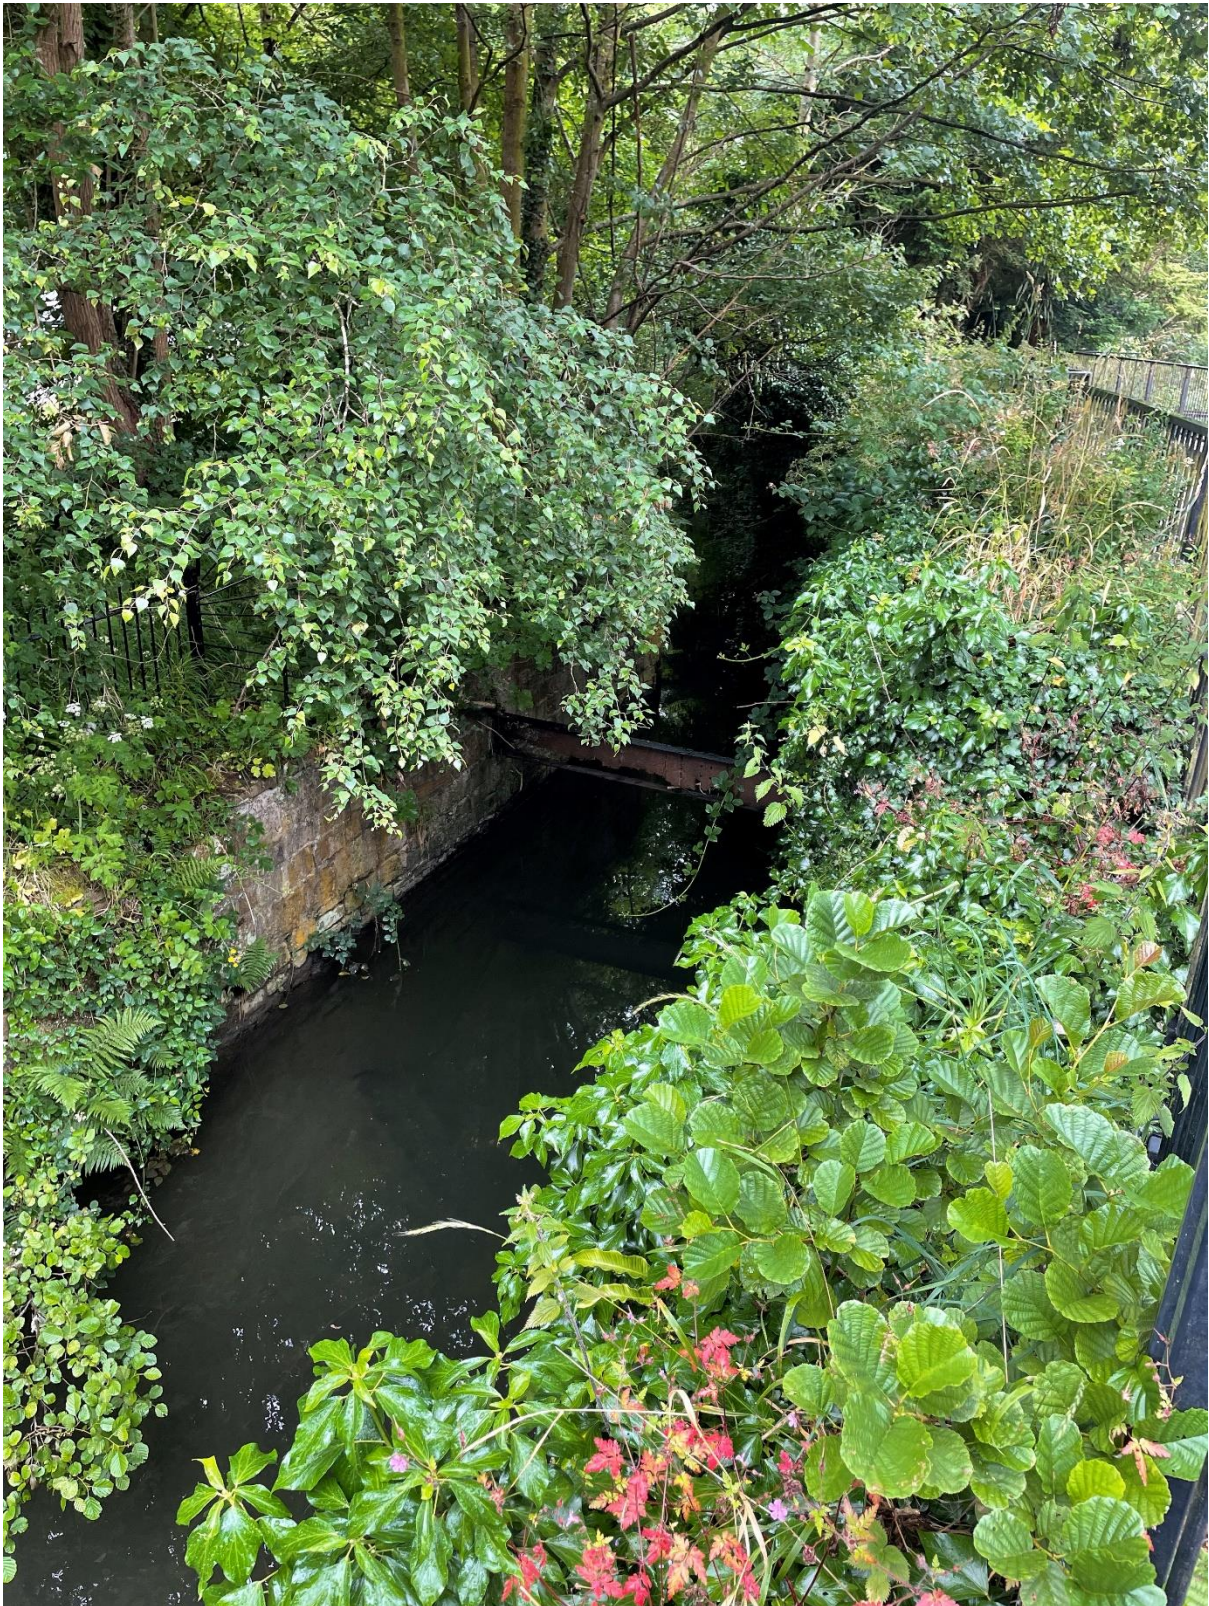
7. Remove redundant RSJ at schooling.toolbar.tribal

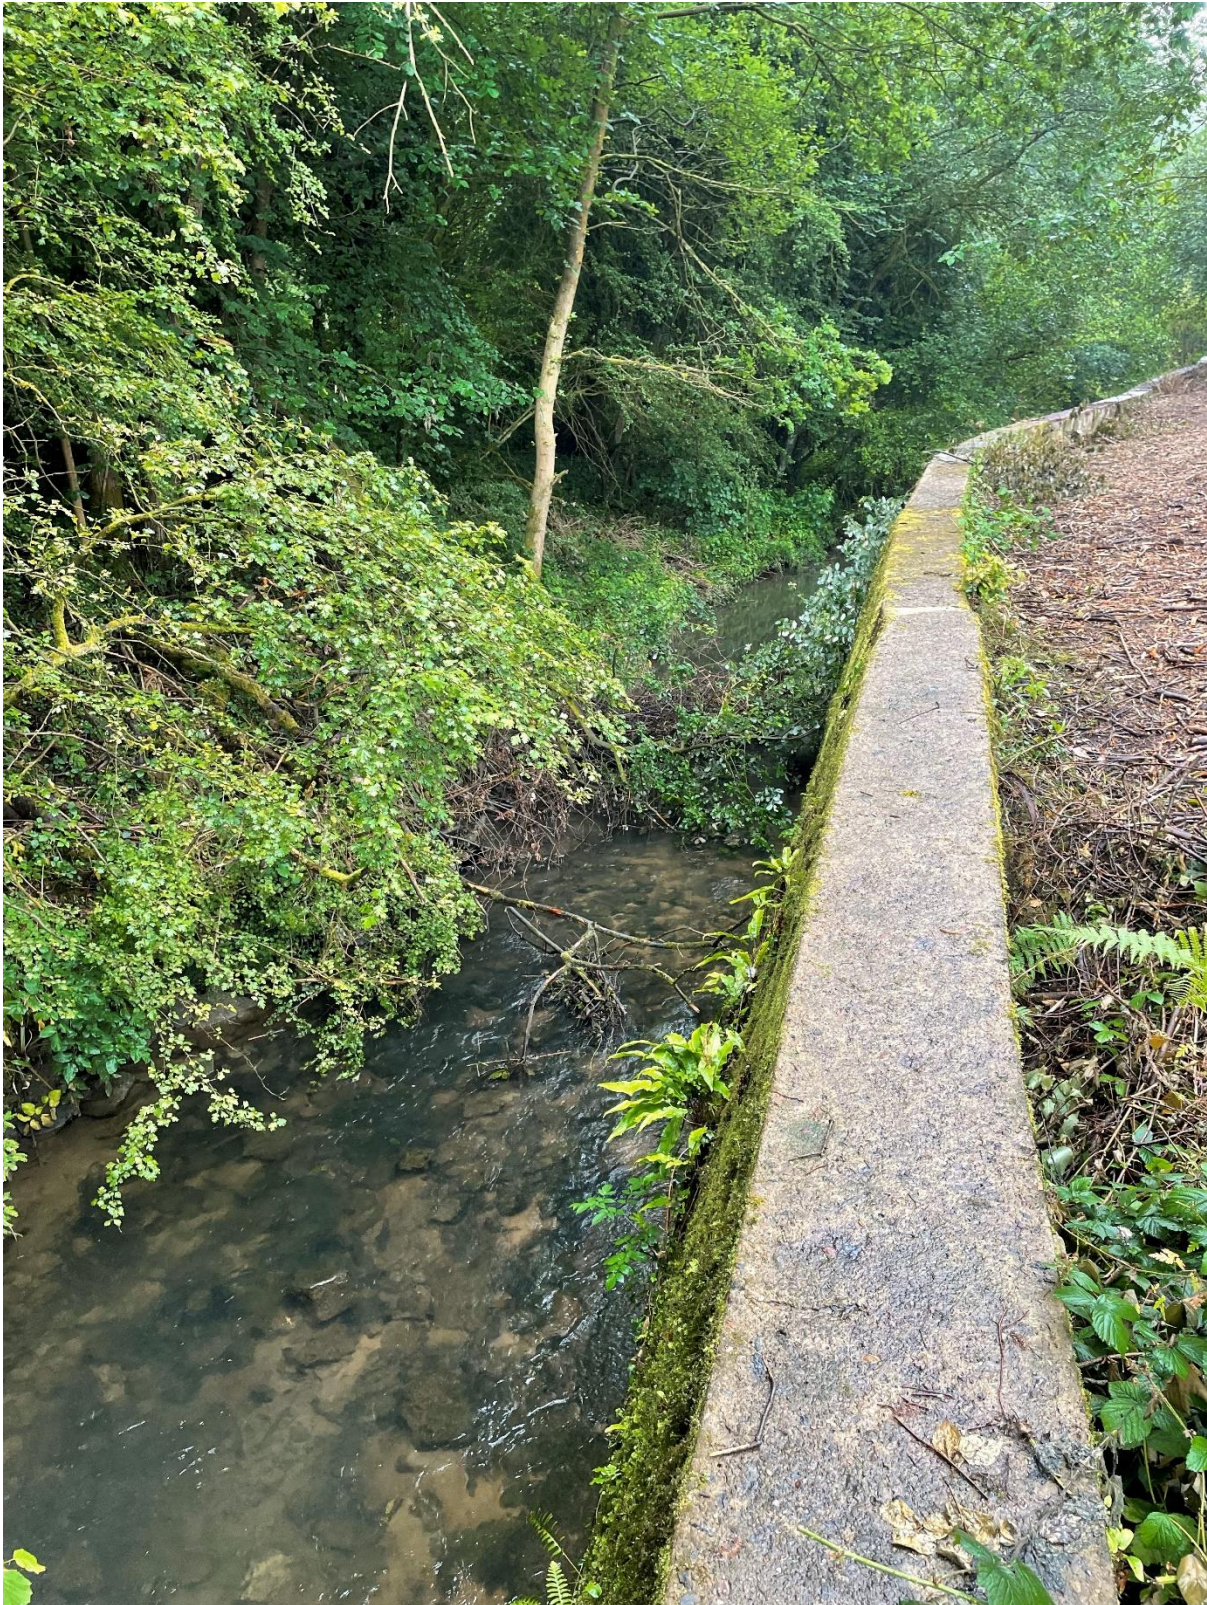
8. Clear obstructions (trees and vegetation) from bed of the channel along the retaining wall.
