BEAUMONT
RIVERS

Invitation to Tender

Pleasley Vale Phase 1 Works:

Version 2

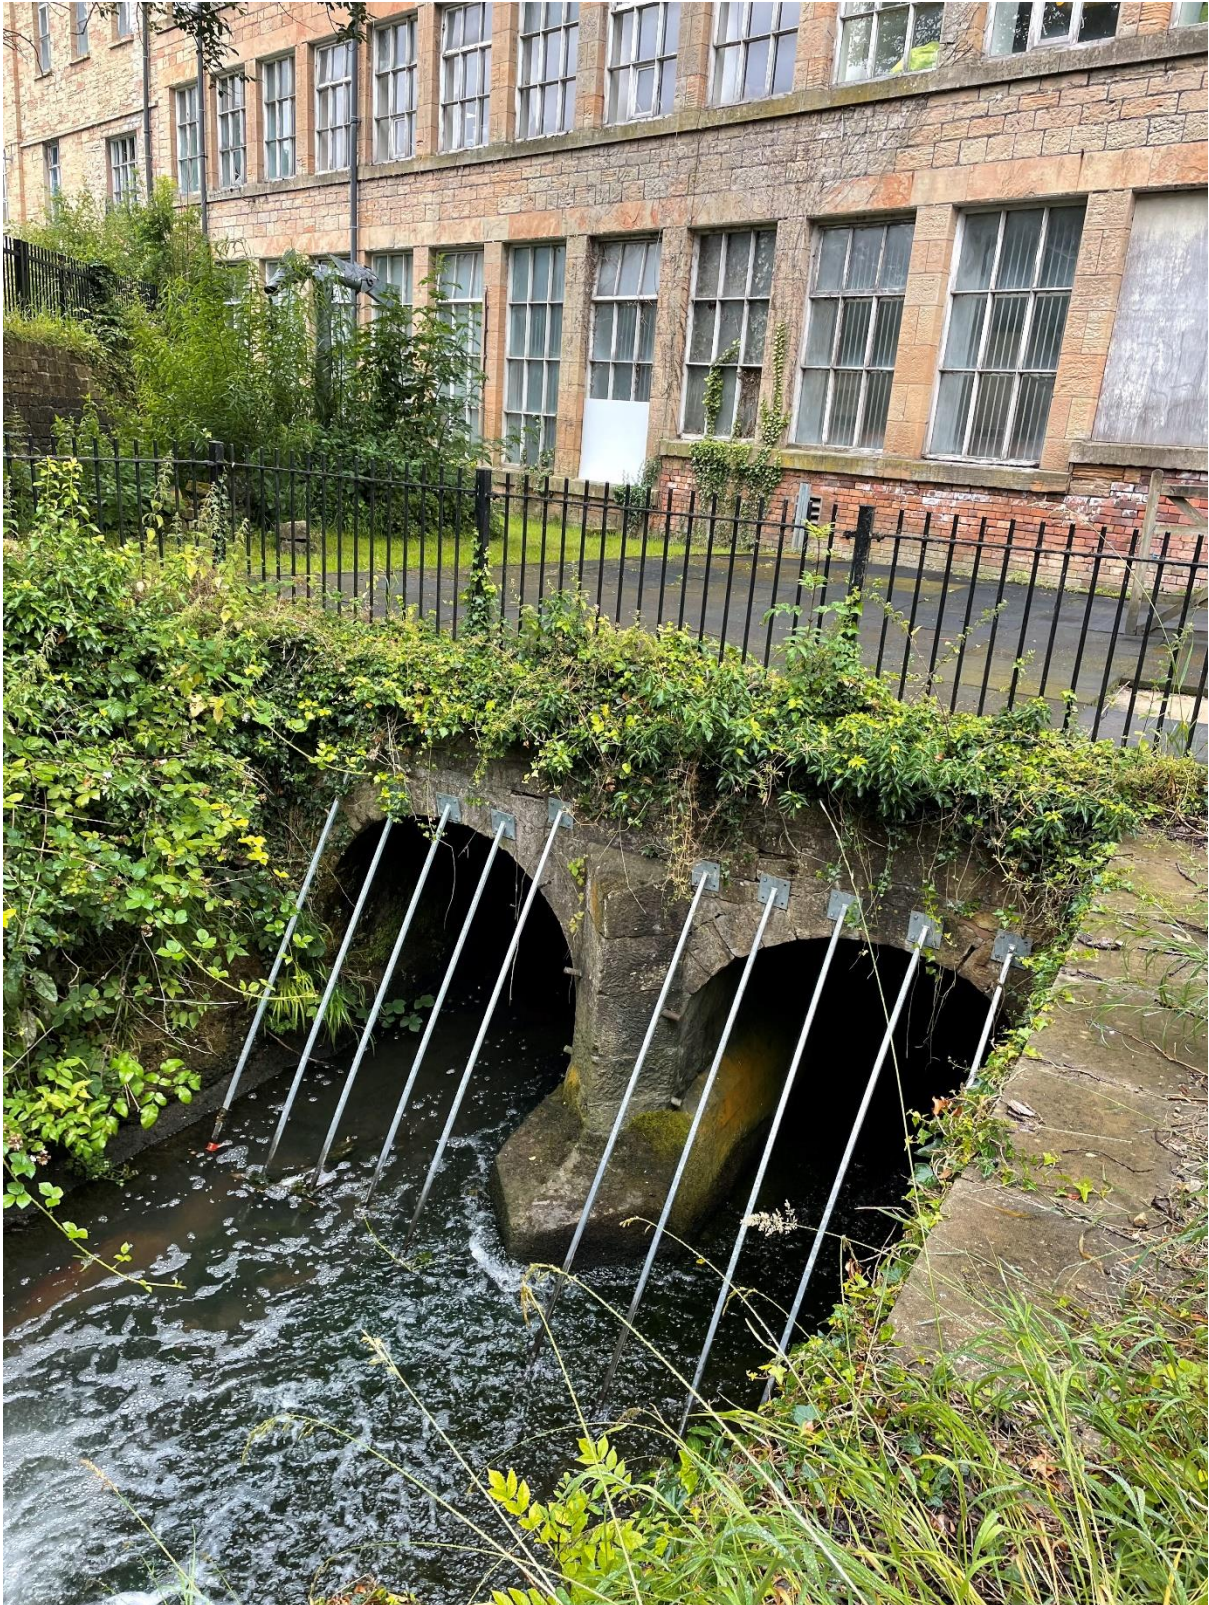
9. Clear channel and downstream trash rack of any accumulated debris on demobilisation.

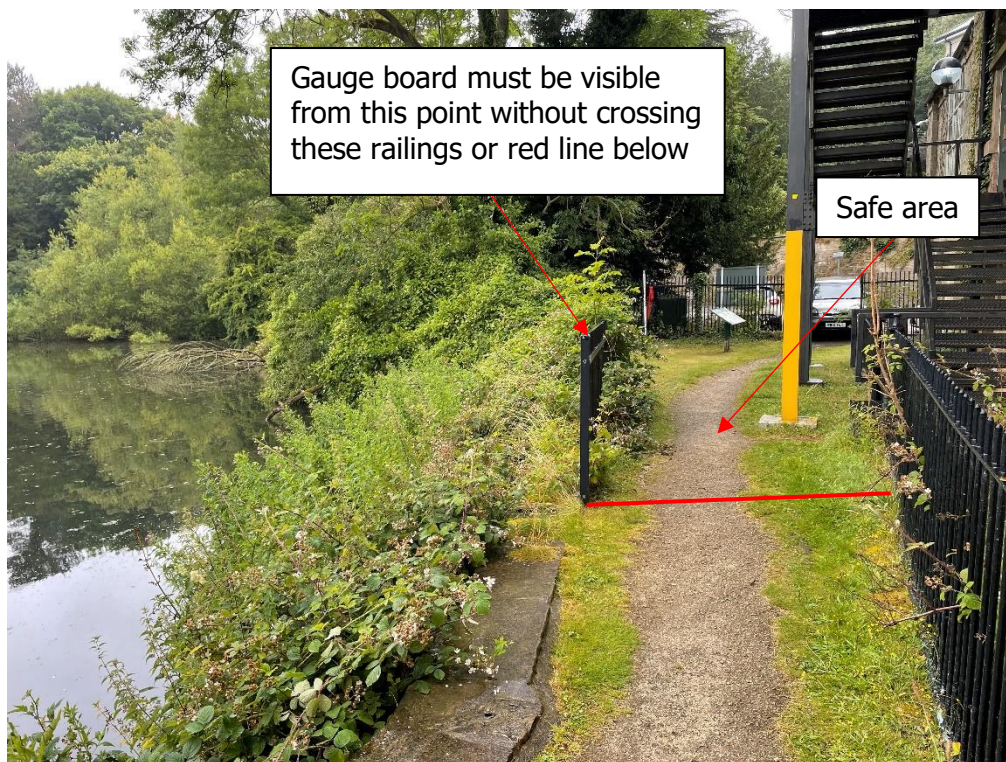
Install a gauge board levelled into grid.

Board must display crest level, spillway level, top of culvert level, and descending to bed level. Gauge board must be glow-in-the-dark and display 105mASL in red at the top (crest level is 104.5mASL). Board may need to be reinforced with marine ply if it extends above ground level

Board must be clearly visible/readable from behind the bankside black railings shown in photograph below, so anyone reading the board during a flood event does not need to walk beyond the railings (red line shown in photo).

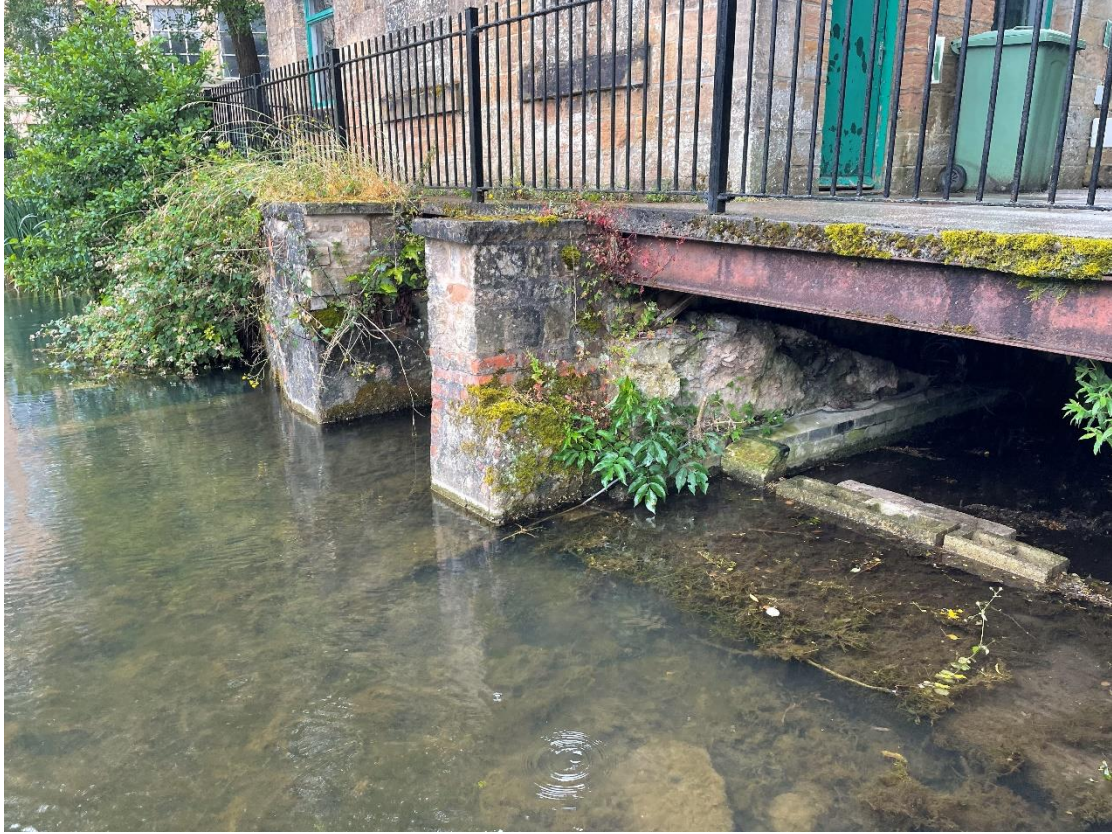
11. Install floating boom upstream of spillway culvert to catch debris and prevent blockages/unauthorised accidental access.

Boom must be easily removable for maintenance and future (phase 2) works. Boom must be a minimum of 3m away from the upstream headwall.

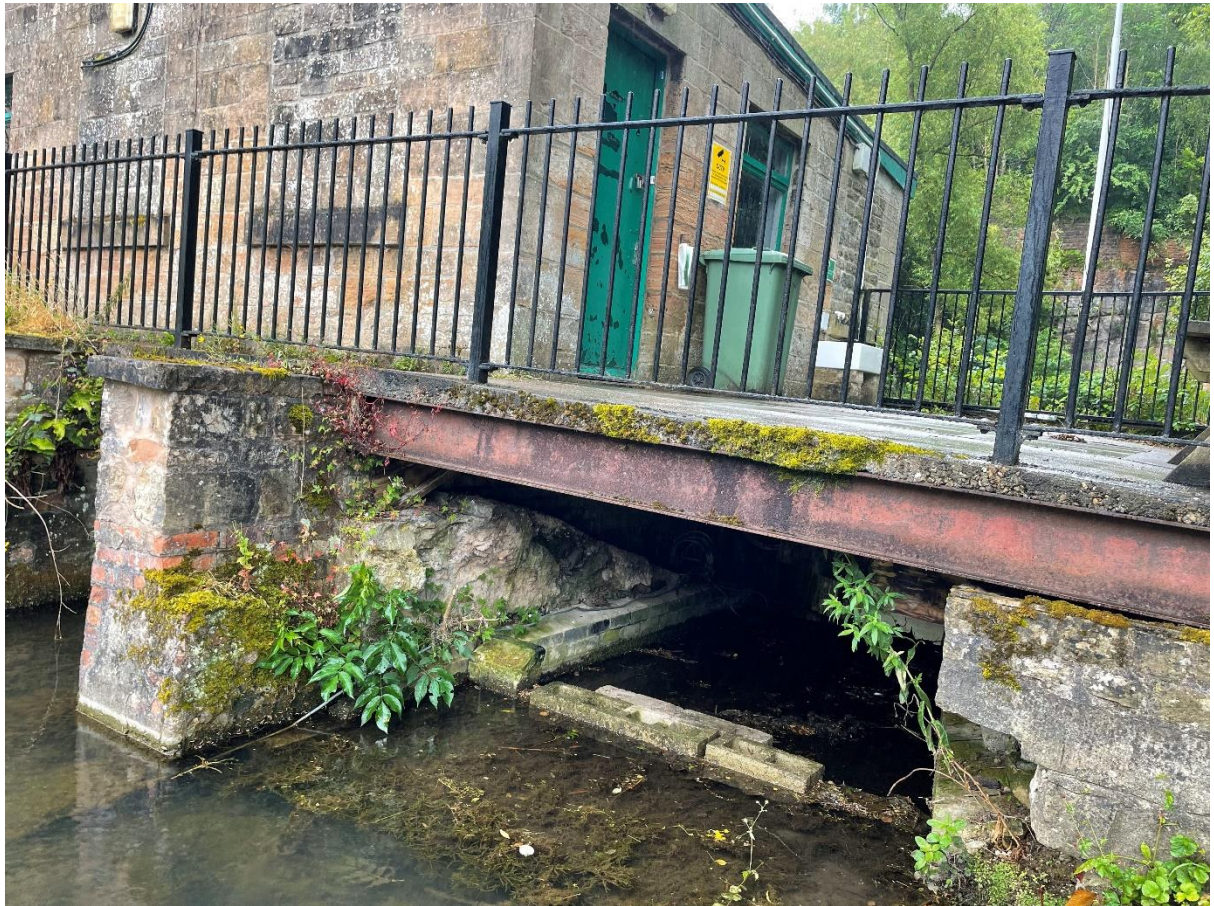
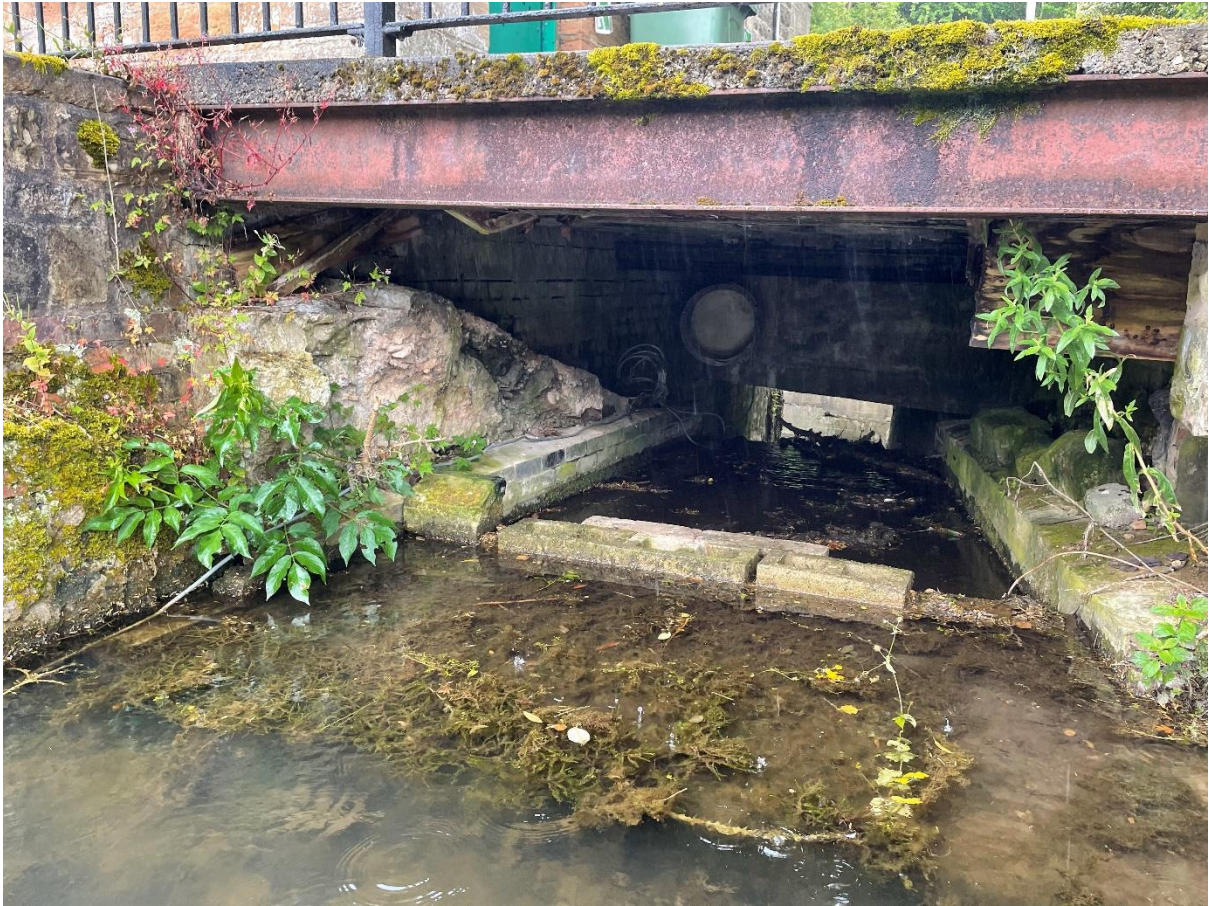
12. Repair stonework on bed and sides of damaged culvert to ensure resilience in a flood event.

Note that this will require either working in a confined space, or temporarily deculverting the asset.

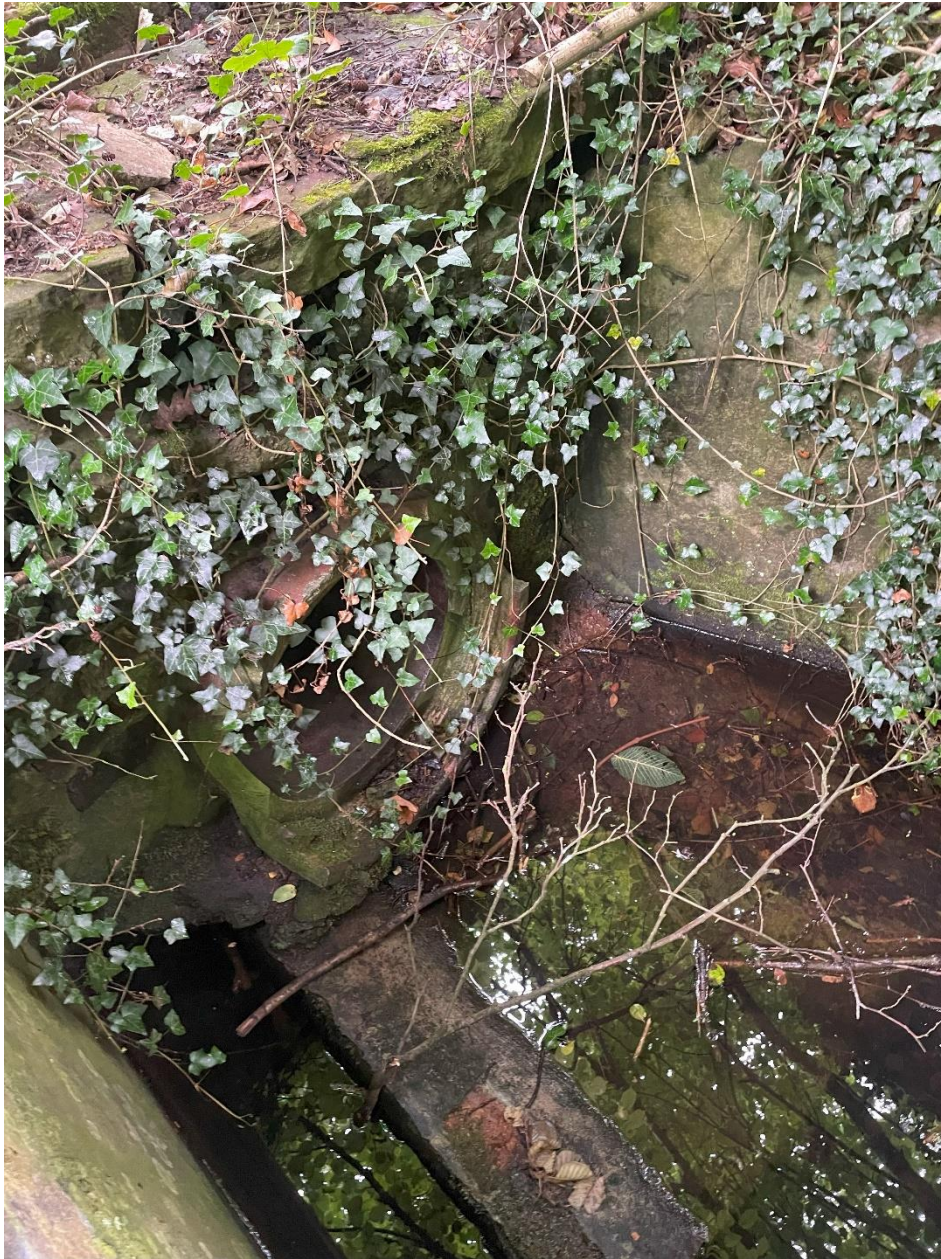
13. Block off pipe inlet structure at upstream end.

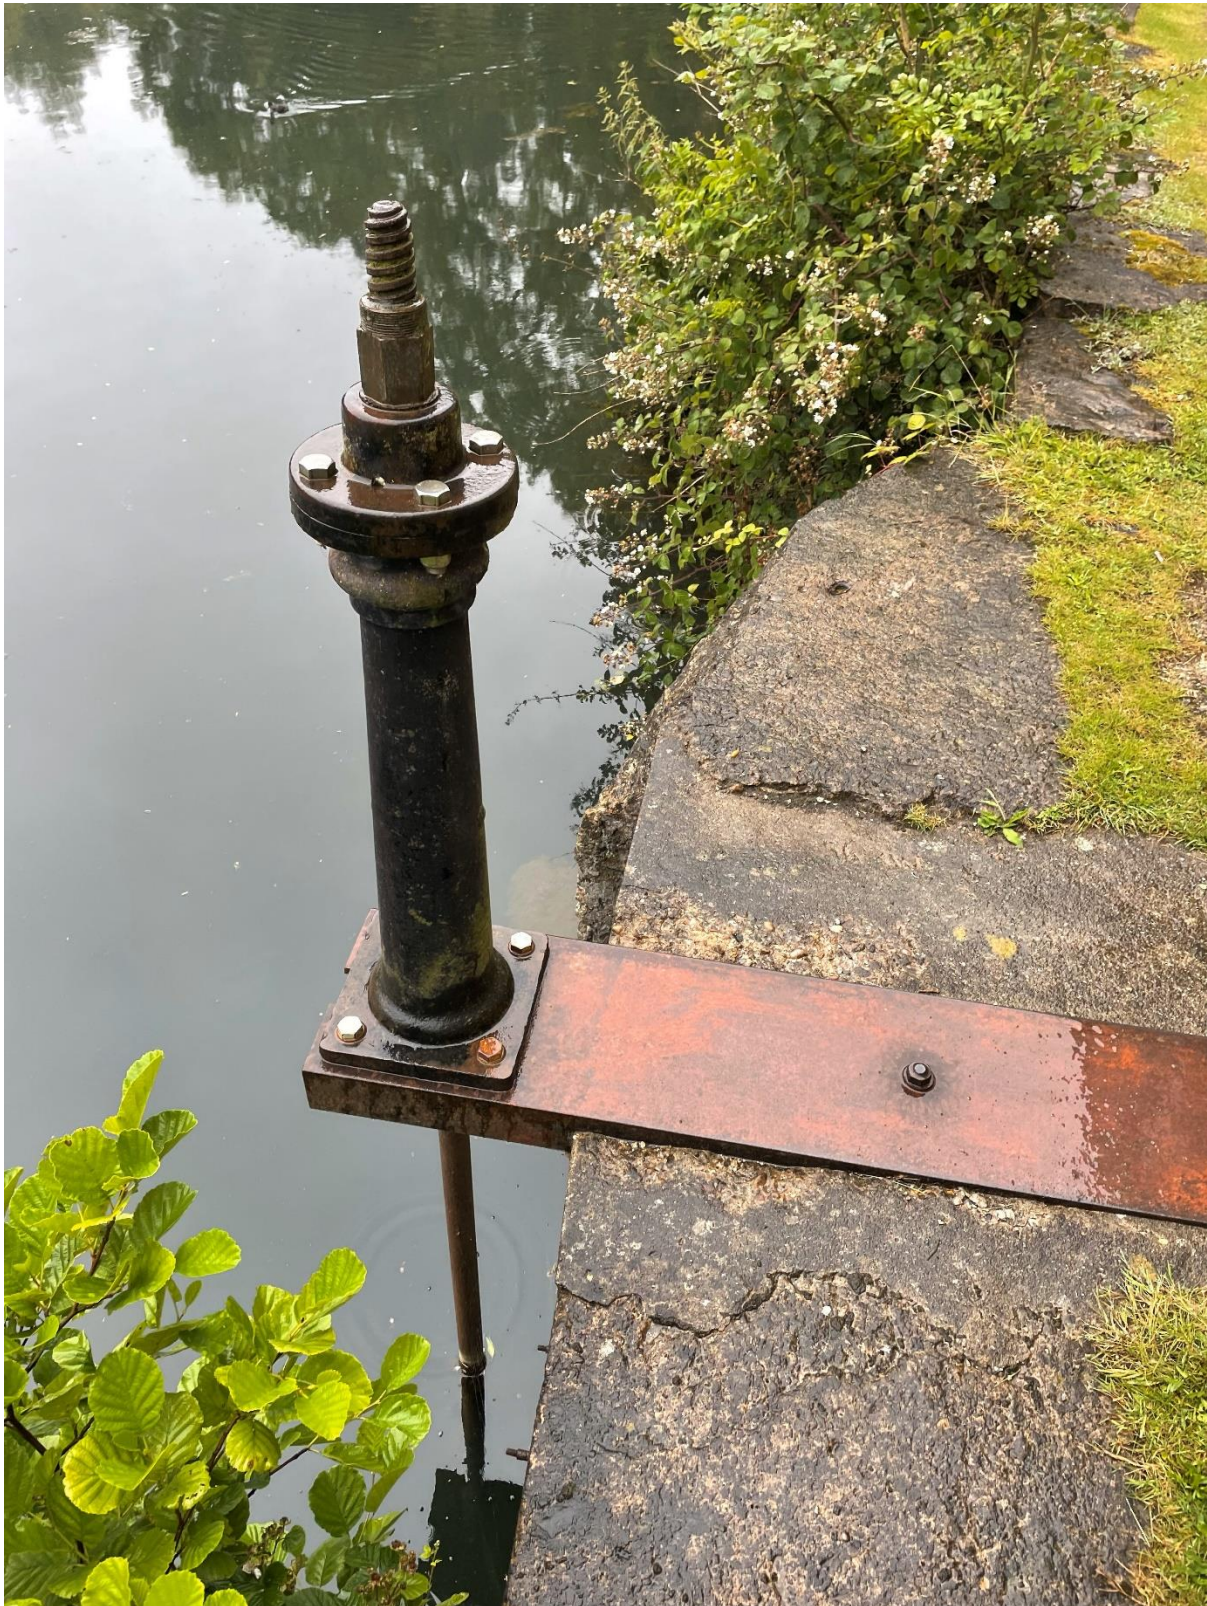
14. Investigate functionality of Mill Pond 1 drawdown sluice and service mechanism.

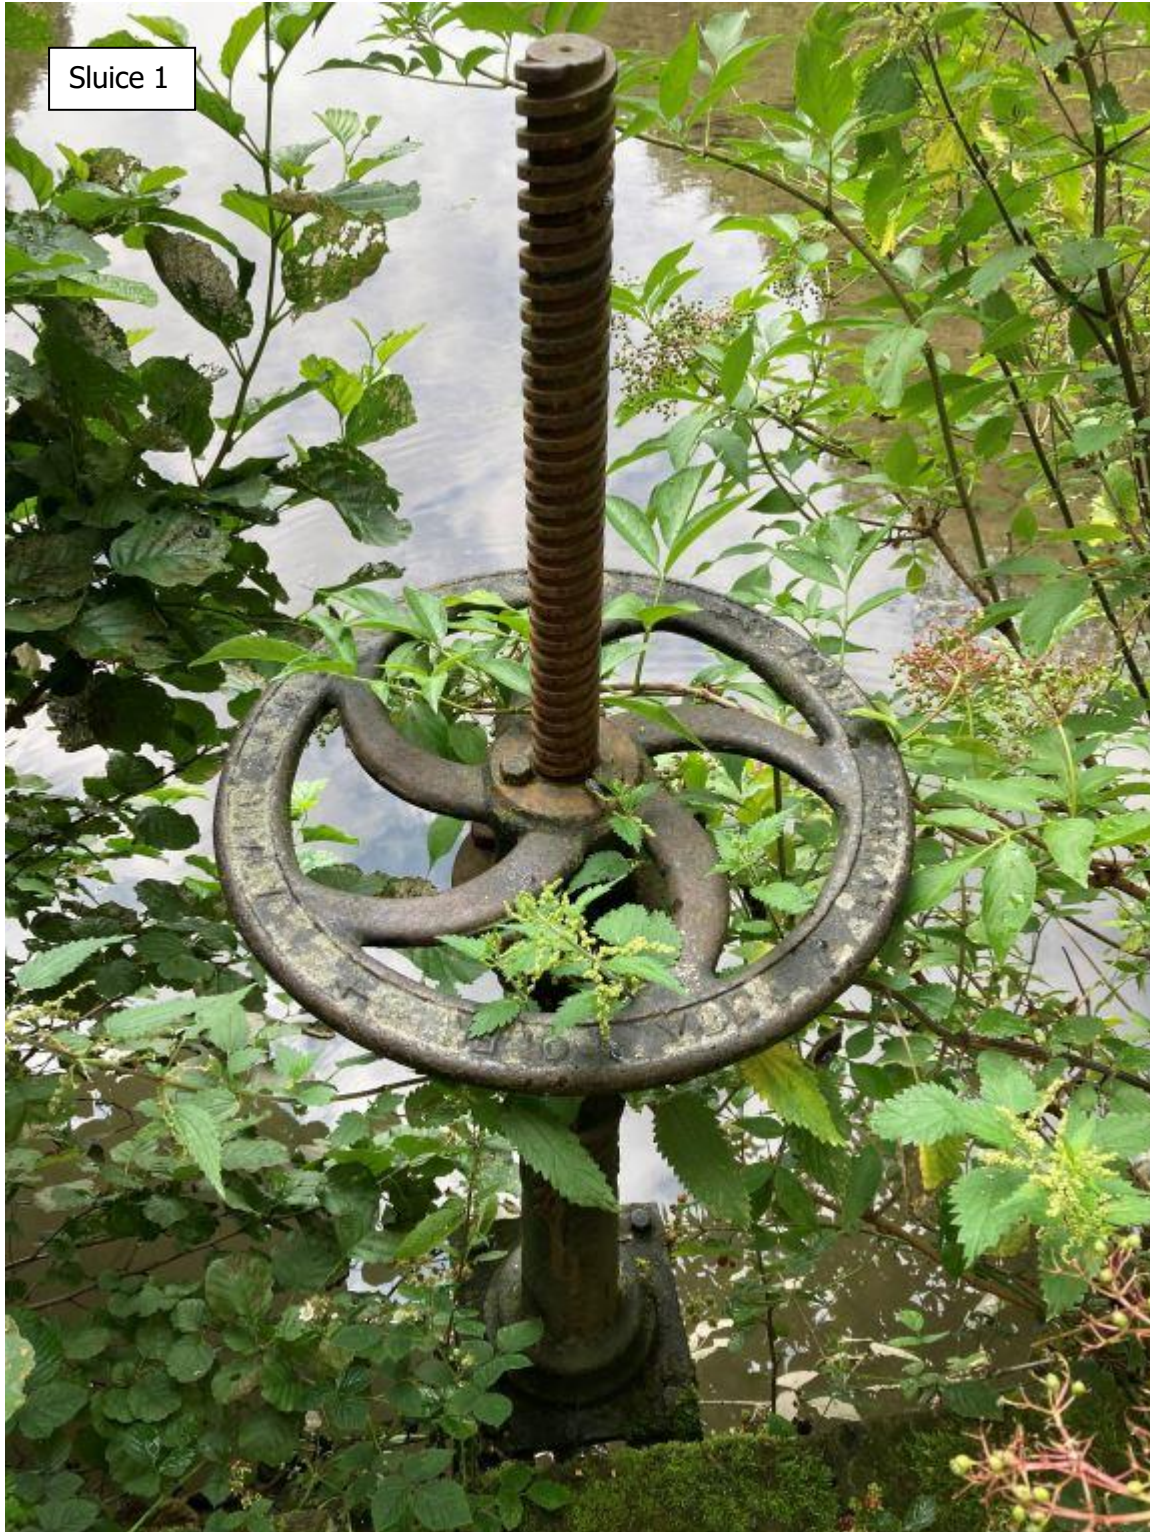
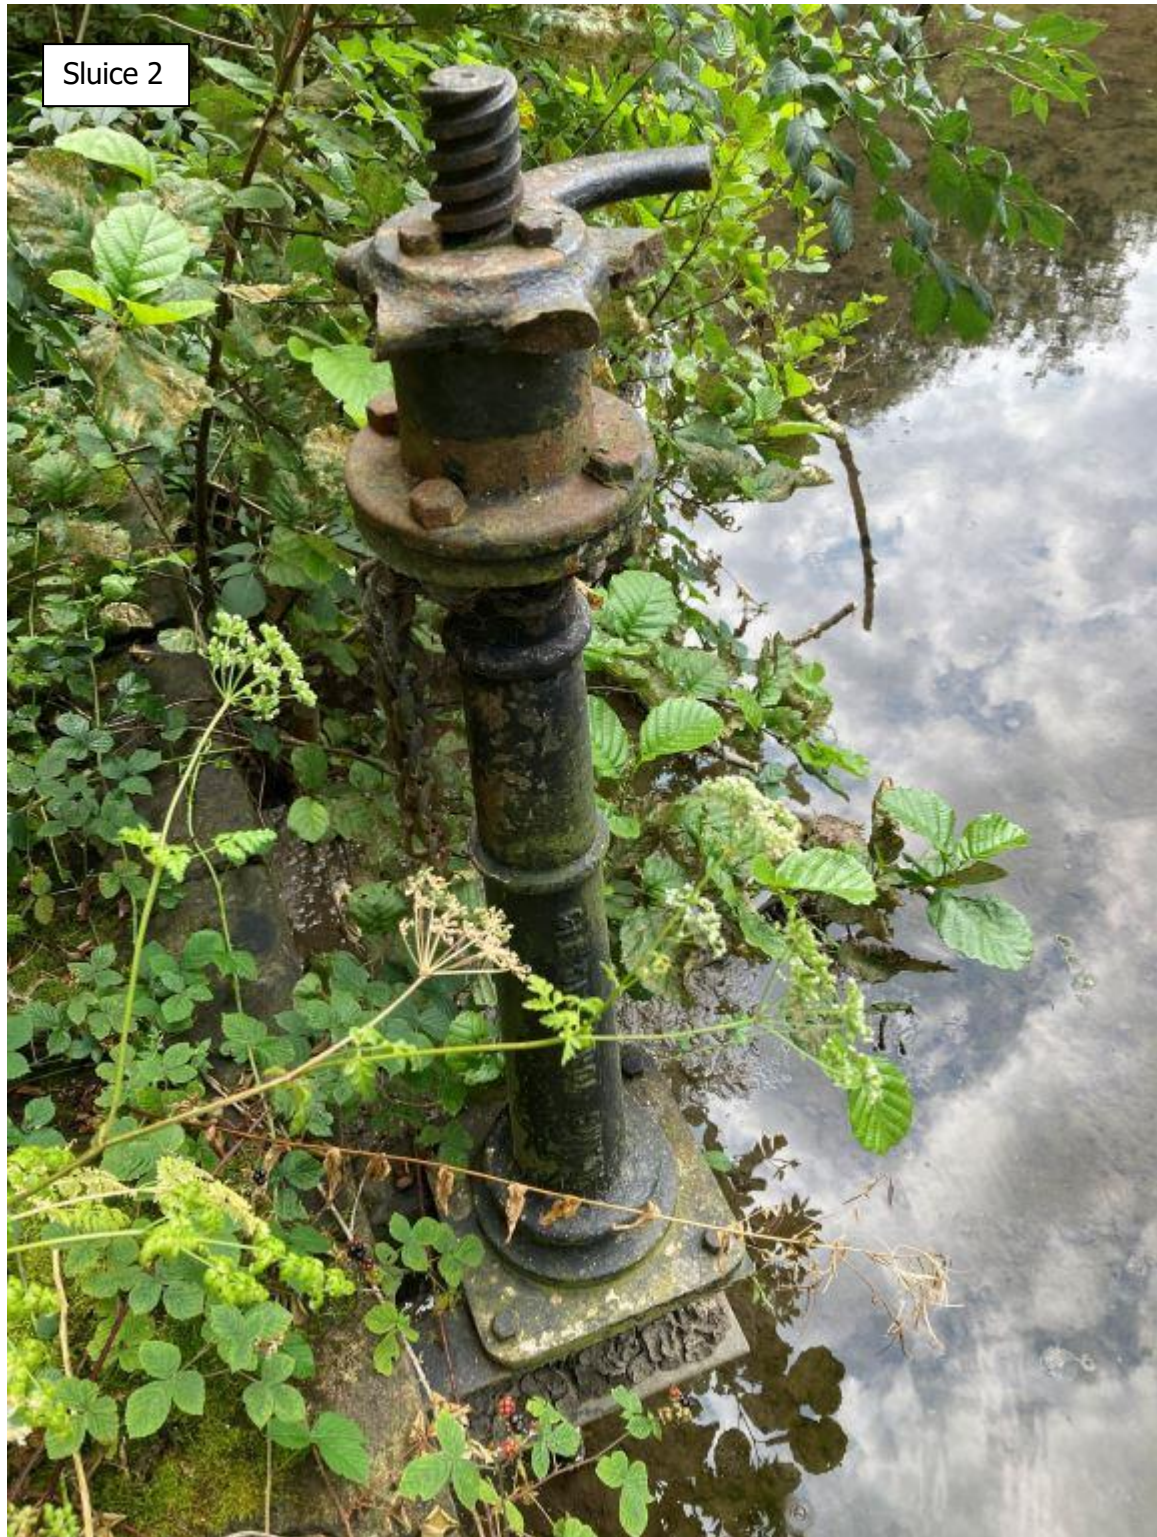
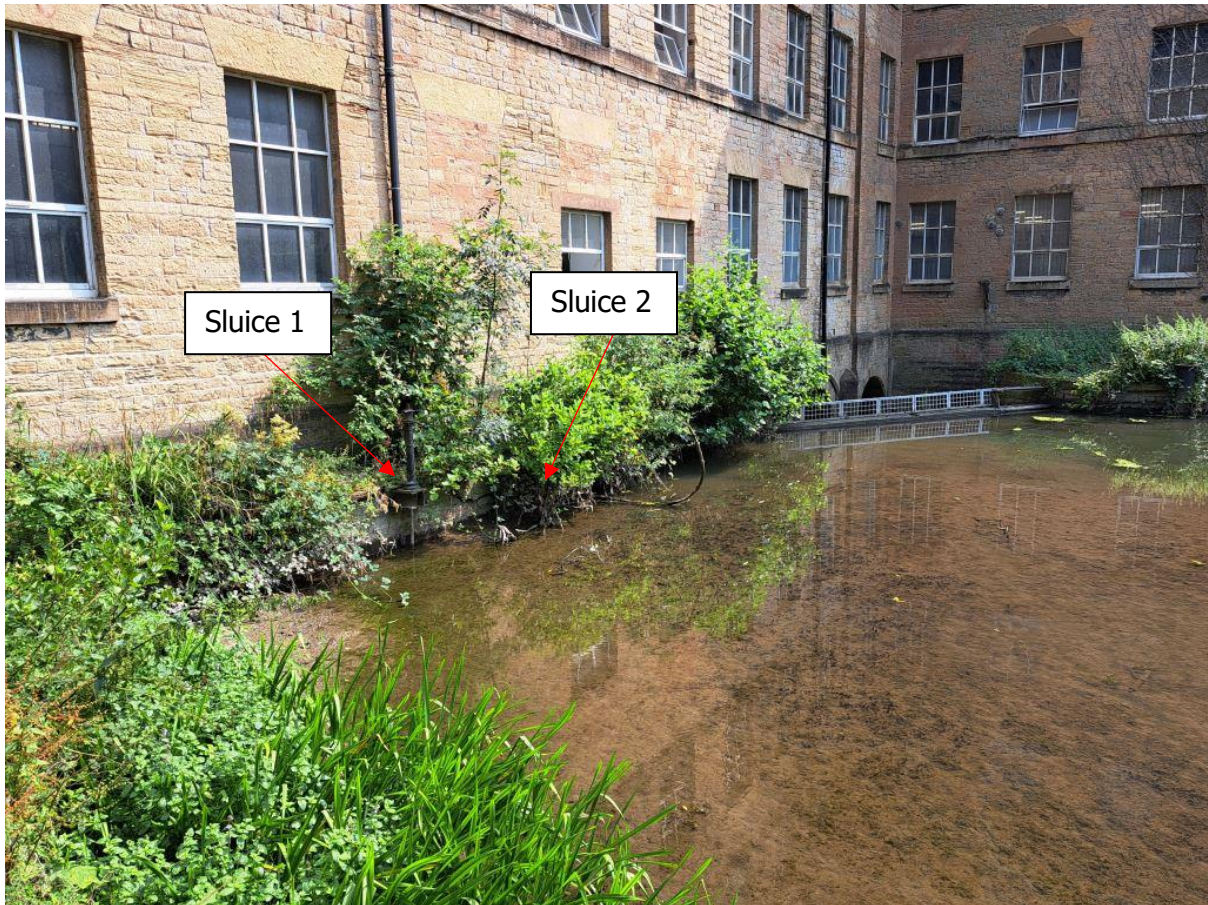
16. Investigate functionality of 2no. Mill Pond 2 drawdown sluices and service mechanisms to make operable.

- Take measurements of sluice openings at maximum aperture.
- Repair wheel on second sluice (sluice 2) to operable condition.

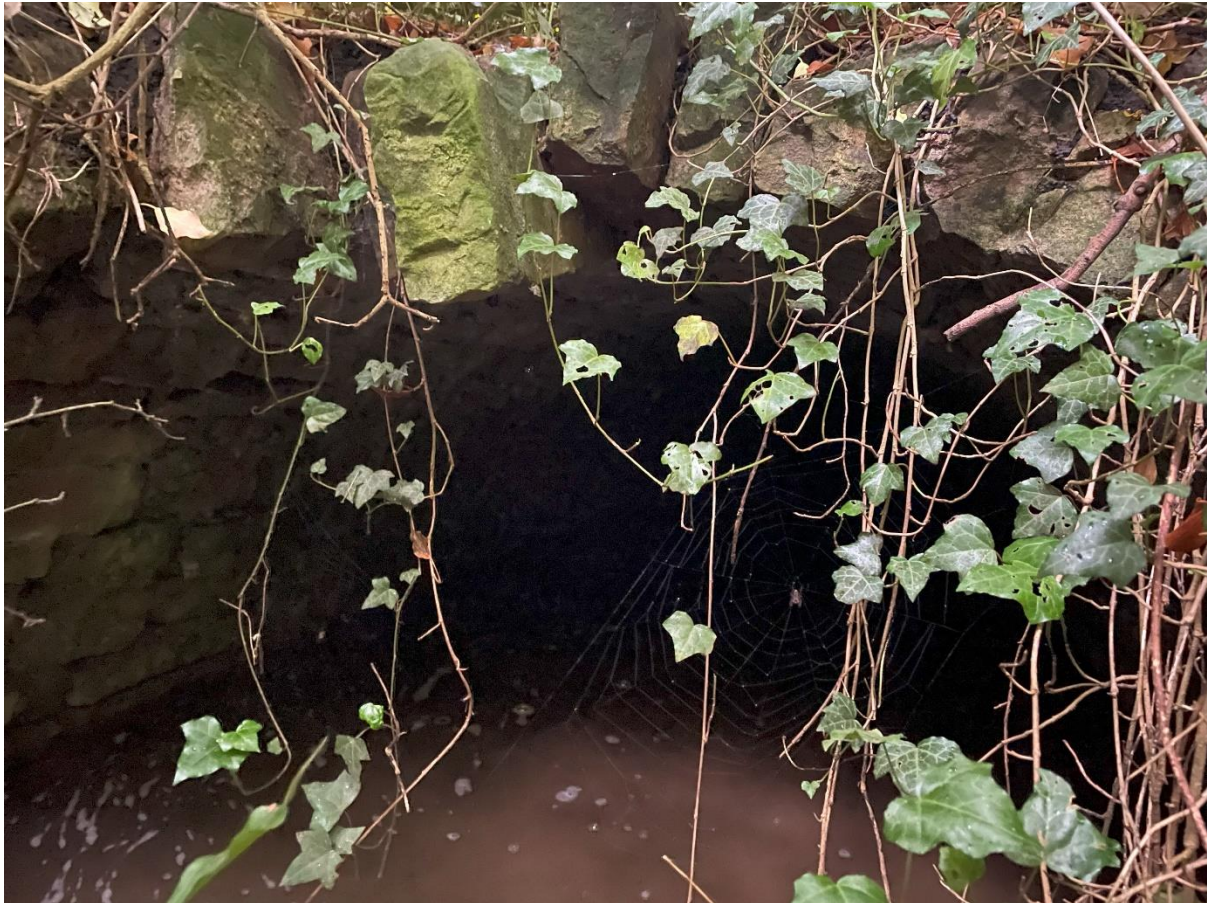
Photo below: Possible terminus @500m from culvert headwall (see map 2)

17. Inspect and trace culverts from Mill Pond 2 (from sluices in task 16) to the unknown terminus and provide a quote to restore to functionality.

This asset may be between 400-500m long. Tracking it may require use of tracer dye, ground penetrating radar or conventional pipe tracing with excavations at the extent (usually 60m) of the tracer. This may need to be facilitated by jetting to unblock the pipe to trace it.

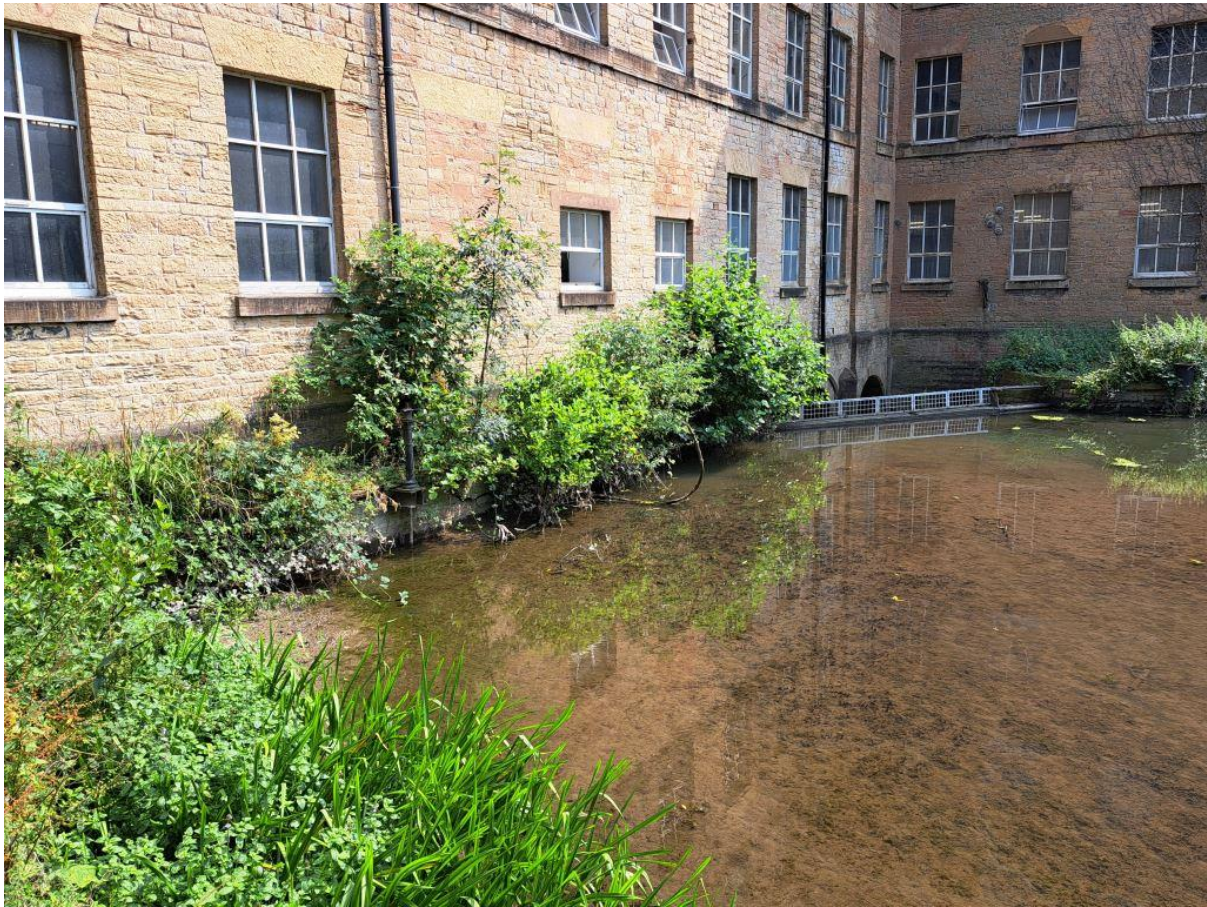
18. Provide budget quote to de-silt Mill Pond 2. There are no silt surveys at present.

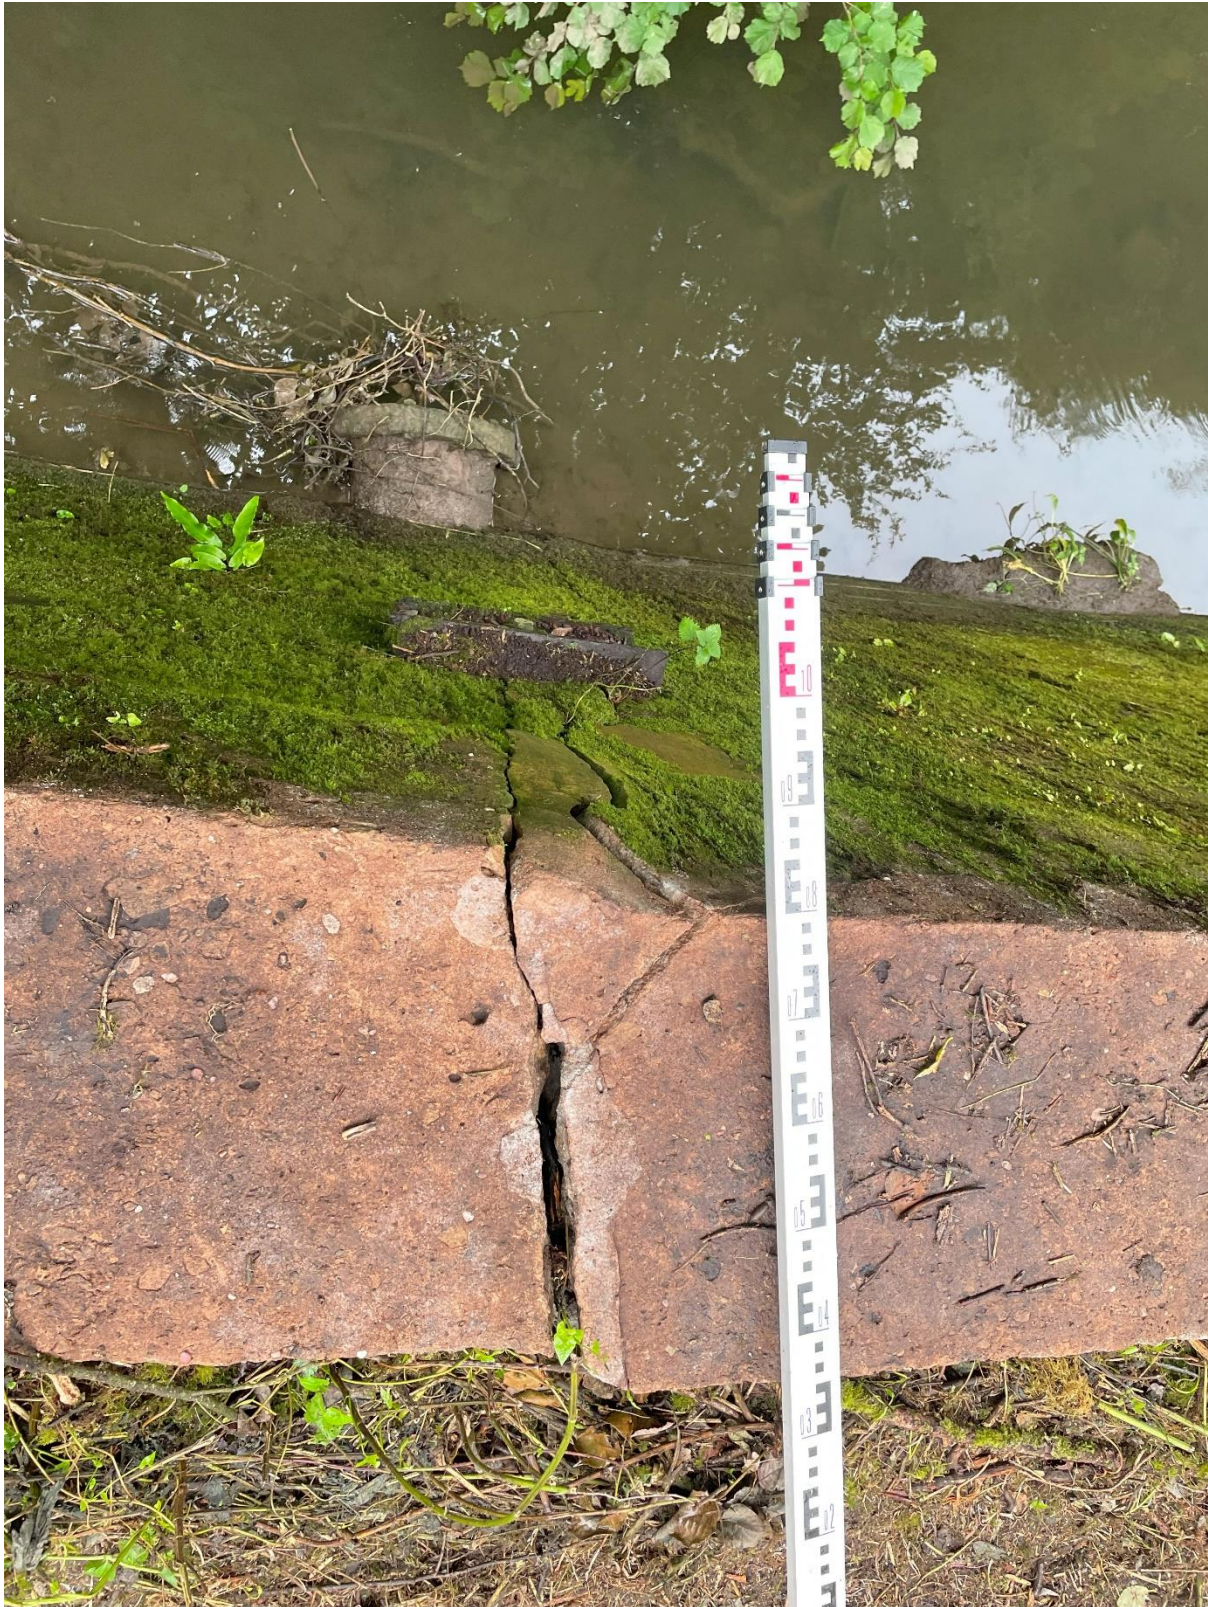
- 19. Investigate if blanked pipework at the base of the embankment is under pressure.
There are 2no. pipes to be checked.**

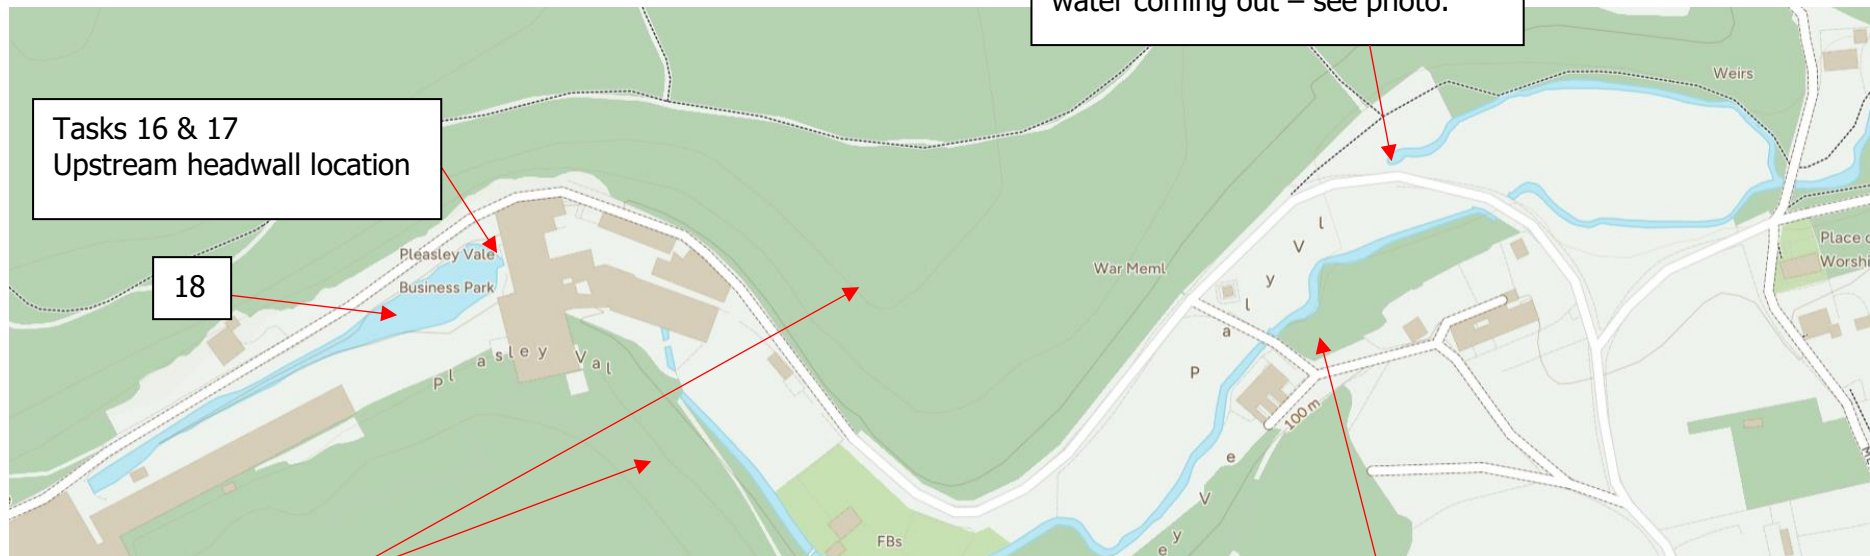
Pleasley Vale, Phase 1: Indicative Work Locations, Map 2

Tasks 16 & 17
Upstream headwall location

TASK 17: @500m from upstream headwall: Possible terminus. There's an old stone arch with water coming out – see photo.

TASK 17: Woodlands either side of the road/river are on a steep valley – culvert more likely to run along the road/river/alongside any other buried infrastructure (unknown).

TASK 17: @400m from upstream headwall: Possible outflow/unknown manhole structure near war memorial. Anecdotal reports of linkage.

As can be seen in maps 1 and 2, the majority of the works are on the embankment separating Mill Pond 1 from the River Meden.
